## Seismic Performance Assessment of a Reinforced Concrete School Building

Research Article  
10.65520/erciyesfen.1927039

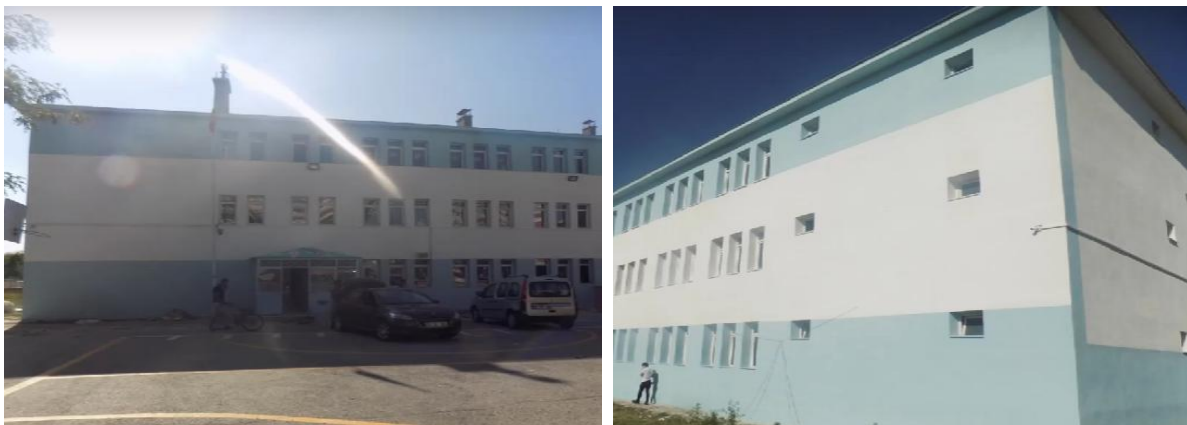
**Figure 1.** Building elevations

In this study, the investigated structure is an existing reinforced concrete (RC) school building serving public use. The building consists of three typical stories with a total footprint area of 513.71 m<sup>2</sup> and a uniform story height of 3.30 m. The structural system is composed of reinforced concrete moment-resisting frames, while the floor system consists of beam-supported slabs. General views of the structure are presented in Figure 1, whereas the building formwork plans are shown in Figures 2 and 3. Although the overall structural layout of the building is generally similar between the floors, there are differences in the arrangement of certain columns and shear walls between the typical floors and the third floor. Therefore, the formwork plans are presented separately. These graphical representations provide the basis for identifying the geometric characteristics of the building, as well as its structural system configuration and overall plan layout. The case study building is located in the Aegean Region of Türkiye.

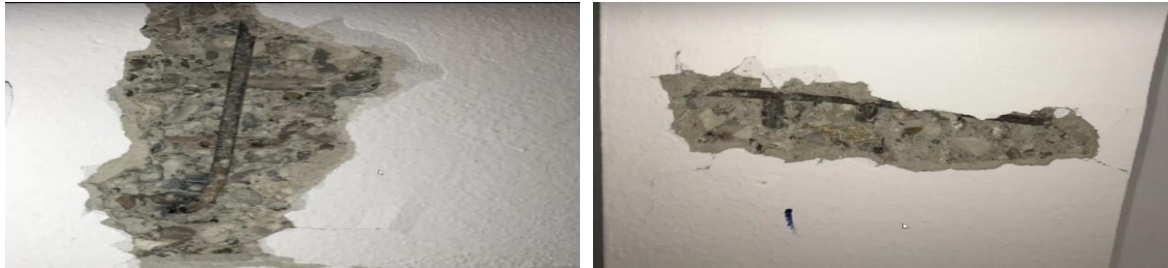
**Figure 4.** Reinforcement detection and cover removal procedures

To determine the properties of the reinforcement steel used in the structural elements, the cover removal method was applied and a reinforcement scanning device was utilized to identify the reinforcement layout and bar diameters. The investigations indicated that the reinforcement steel used in the structural members corresponds to grade S420. These findings were subsequently used to characterize the strength and ductility behavior of the structural members in the analytical model.

were irregularly spaced, and in certain regions the spacing exceeded the limits prescribed by current design codes, resulting in limited confinement effectiveness. In addition, inadequate hook details and incomplete closed stirrup arrangements were identified, which do not fully comply with the ductility requirements specified in modern seismic design codes. Such deficiencies in reinforcement detailing are expected to adversely affect the ductility capacity and seismic performance of the structural members. The field procedures used for reinforcement detection and core sampling are illustrated in Figures 4 and 5.
