Using the Ultrasonic Stress Wave Technique to Evaluate Structural Timber Members of an Old Masonry Building

Gülru KOCA^{1*}, Türker DÜNDAR², Nusret AS²

¹Işık University Faculty of Fine Arts, Dept. of Interior Architecture, Maslak/Istanbul, TURKEY

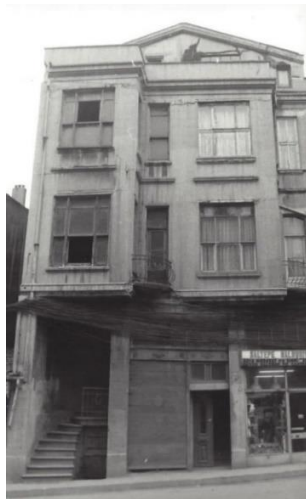
After that period, it was used as a commercial building. This type of building construction was very common at the beginning of the 20th century, and is characterized by a rectangular plan that is built semi-detached. The masonry walls were constructed with load-bearing solid brick for the lower floors. The floors were constructed with timber rafters and joists supported by masonry walls. The walls of the top floor were constructed with a timber frame covered by lath. The roof was constructed with timber framed double pitched roofing and ceramic tile covering (Fig. 1).

Figure 1. Building from the 80's

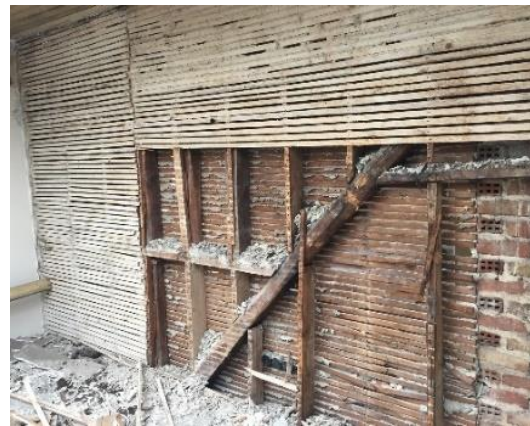
Structural wood members were extracted from the floor, wall, and roof of the building (Fig. 2). Roof and wall members were taken from the top floor and floor members were taken from the first floor of the building. Most of the wood members had a length of 1.80 m to 2.00 m with various cross sections. Some of the interior studs and diagonals were obtained directly from tree trunks, and thus their dimensions were irregular. Table 1 details the tree species, locations, dimensions, and number of structural wood members extracted from the building.

Figure 2. Top floor timber framed wall.

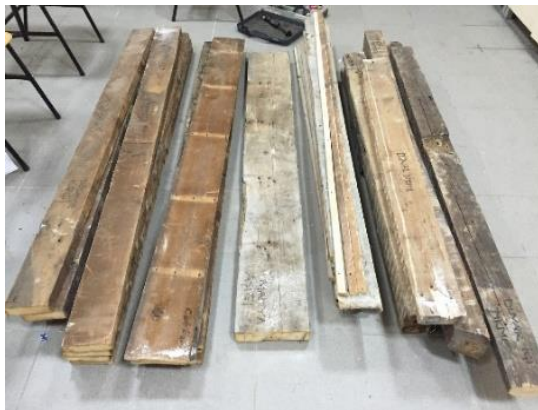
Before the laboratory tests were performed, the specimens were kept in a climatic room at a relative humidity of 65% ± 5% and 20 °C ± 2 °C until the mass variation was smaller than 0.2% (Fig. 3).

Fig. 3. Full-scale test specimens

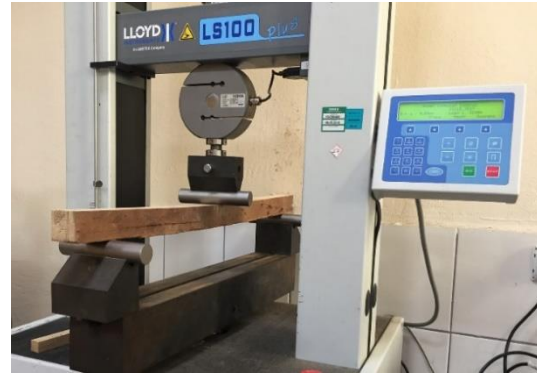
Three-point bending tests were done on the specimens with a Lloyd LS100 universal test machine (Lloyd Instruments, Ametek Company, West Sussex, UK), as is shown in Fig. 5. The specimens were prepared in the form of rectangular prisms, each having a square cross-section of no less than $20\text{ mm} \times 20\text{ mm}$ and length of 12 to 16 times the height of the test piece, depending on the full length of the structural member taken from the building.

Fig. 5. Bending test set-up

The applied force was transferred to the specimen in the tangential direction. The loading speed was set so that the failure would occur within 60 s to 120 s. The f_b (N/mm^2) of the specimens was calculated with Eq. 5,

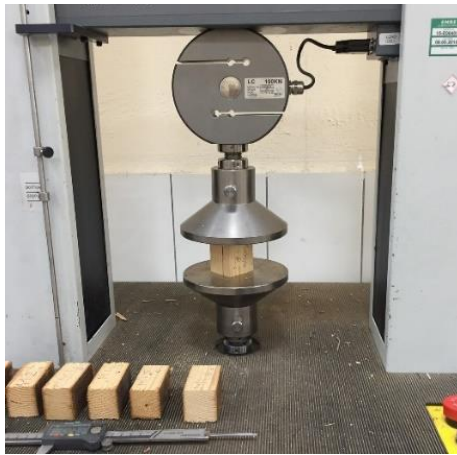
Compression stress parallel to the grain tests (Fig. 6) were done on specimens with a

square cross-section of at least 20 mm and length along the grain that was 1.5 to 4 times greater than the cross-sectional dimensions (Table 2). The loading speed was set so that the failure would occur within 60 s to 120 s.

The f_c (N/mm²) was obtained by dividing the load cell value by the cross-sectional area of the specimen (Fig. 6).

Fig. 6. Compression test parallel to the grain
