# Causes of land degradation and rehabilitation efforts of rangelands in Turkey

Gökbülak, F., Uygur Erdoğan, B., Yıldırım, H.T., Özçelik, M.S. 2018. Causes of land degradation and rehabilitation efforts of rangelands in Turkey. *Forestist* 68(2): 106-113.

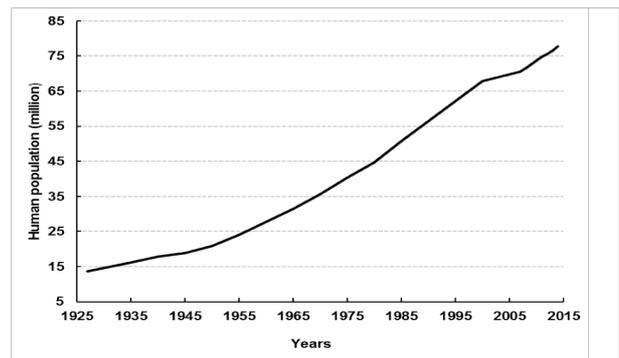
**Figure 1. Trend of human population increase by years in Turkey**

Turkey has a high annual population growth rate of about 2% and the population increased from 13.6 million in 1927 to approximately 77.7 million in 2014 (Figure 1) (TSI, 2015). Due to rapid migration from rural areas to urban areas, the rural and urban populations changed from 75.8% and 24.2% in 1927 to 8.2% and 91.8% in 2014, respectively (Figure 2).

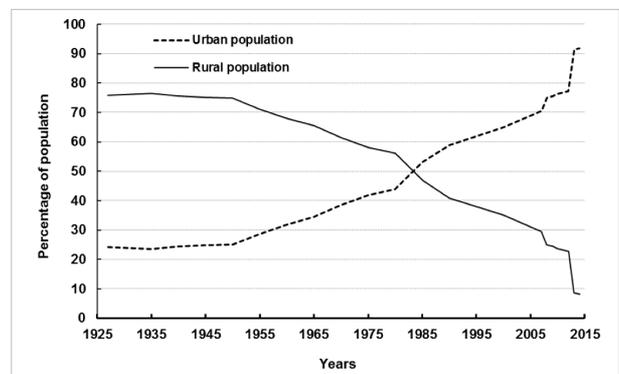
**Figure 2. Trend of changes in the urban and rural populations by years**

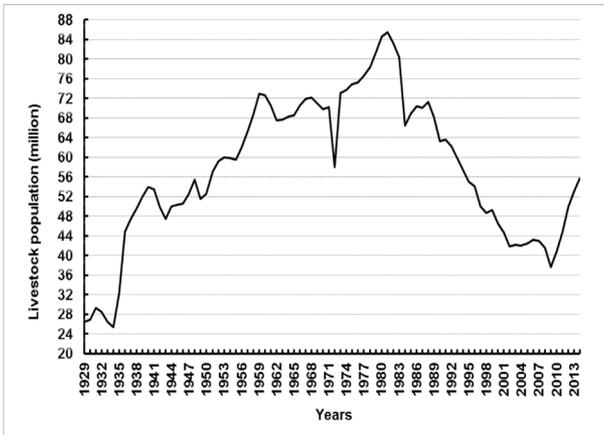
Figure 3. Livestock population changes with respect to years

Migration of people from rural to urban areas also affected livestock population. Similar to human population, the total number of livestock including cattle, sheep, and goats was approximately 26.5 million in 1929, in the early years of the Turkish Republic and increased to 85.5 million in 1981 and then dramatically decreased to 37.7 million in 2009 (Figure 3) (TSI, 2015). However, livestock population has started to increase in recent years due to changes in the rural development policies of the Turkish government and increases in subsidies paid to farmers for encouraging farming, livestock production, and preventing rural migration.

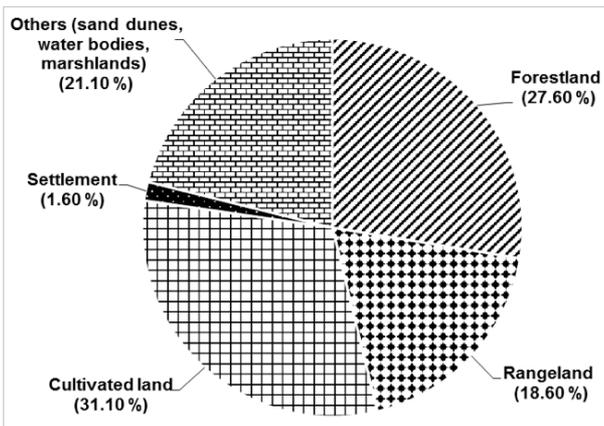
Figure 4. Actual land use in Turkey (GDCDE, 2015)

Although the size of cultivated land was used to coincide with the size of arable land with respect to land capability classification in the mid 1900's, the amount of cultivated land decreased to 31.10% over the last decades (Figure 4). Decreases in the size of the cultivated land can be attributed to abandonment of ar-

able lands due to migration of people from rural areas to urban areas, and allocation of arable lands for new settlements and industrial plants. According to present land use classification, almost one third of the country is used for agricultural purposes while 27% is covered with forest vegetation and about 19% is rangeland (Figure 4).

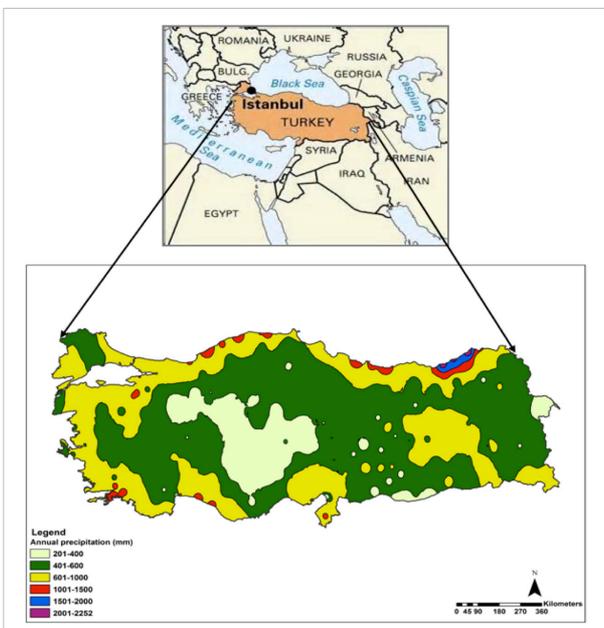
Figure 5. Distribution of annual precipitation in Turkey

According to the General Directorate of State Hydraulic Works (GDSHW, 2015), mean annual precipitation is around 643 mm with a runoff coefficient of 37% and most of it falls in winter months (Özhan, 2004). Precipitation regime is uneven and its annual amount varies from 200 mm in Central Anatolia to 2250 mm along the Northeast Black Sea coast. About half of Turkey (53%) receives annual precipitation of less than 600 mm and 12.5% receives less than 400 mm (based on 41 years of Turkish State Meteorological Service data covering a period from 1970 to 2011 years (TSMS, 2012). This means that semi-arid conditions prevail in an area equal to greater than half of the country (Figure 5). Mean annual temperature is around 13.1°C and varies from 2.2°C to 24.3°C. Also, temperatures can drop as low as -45.6°C in January and reach 48.6°C in July months in Southeastern Anatolia which is one of the warmest and driest regions on the Anatolian peninsula (TSMS, 2015).

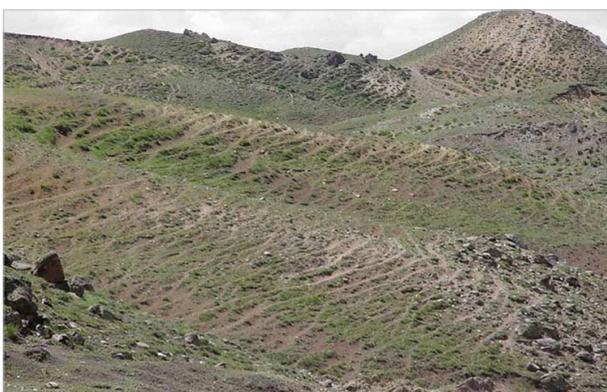
**Figure 6. A general view of degraded rangelands in Turkey (GDCDE, 2015)**

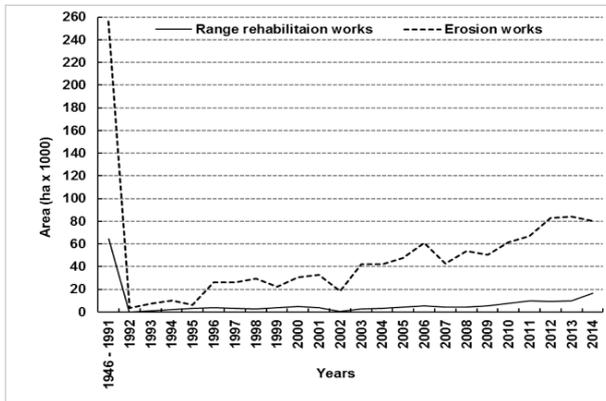
Figure 7. Sizes of rehabilitated rangeland, and the land erosion control works performed per year

Both the Ministry of Food, Agriculture and Livestock (MFAL) and Ministry of Forestry and Water Affairs (MFWA) are responsible for land rehabilitation works in Turkey but most of the range rehabilitation works have been carried out by MFAL. MFAL rehabilitated 506,560 ha of land (MFAL 2015) while MFWA rehabilitated 76,512 ha of rangeland (GDCDE, 2015) between the years 2000-2014. As seen from Figure 7, the area of land rehabilitated only by MFWA is increasing from year to year but these efforts are not enough and land degradation still remains a big issue in Turkey. For instance, the areas of rangeland rehabilitated and land protected from erosion by MFWA was 880 and 7,458 ha respectively in 1993.

These areas reached 16,383 and 80,517 ha in 2015 (Figure 7). Erosion control works are also mostly carried out on lands that were

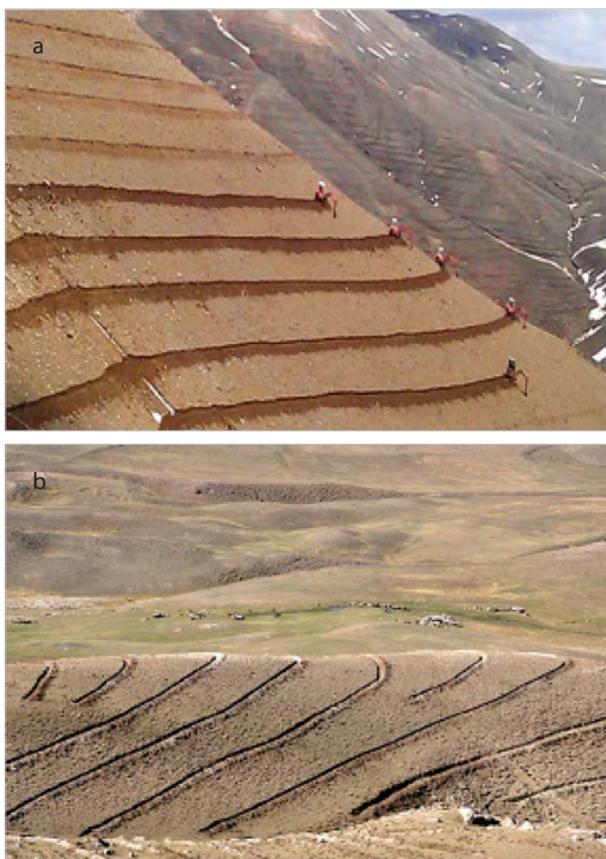
Figure 8. a, b. Contour terracing for erosion control (a) and improving soil moisture recharge and forage production (b) (GDCDE, 2015)

In most of the rehabilitation works in rangelands, in contrast to MFAL, MFWA prefers contour terracing and planting these terraces with local native tree species to increase species diversity, range productivity, and minimize soil and vegetation disturbance by maintaining native vegetation in the areas between terraces (Figures 8a, b) (GDCDE, 2015).

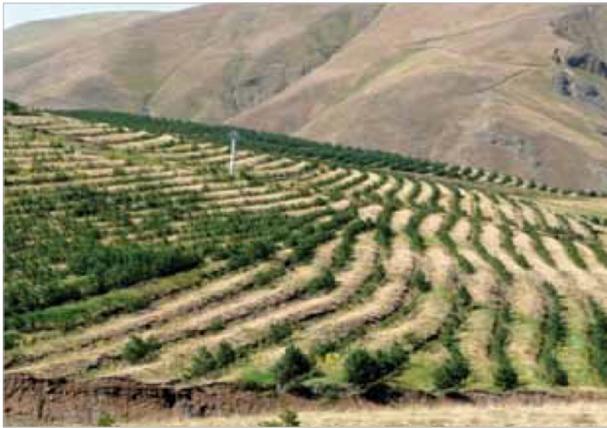
Figure 9. A combination of afforestation and contour terracing works in range rehabilitations (GDCDE, 2015)

Depending on site conditions, MFWA carries out afforestation on contour terraces with the saplings of drought tolerant native tree species in some rangelands with the purpose of protecting them from human intervention and soil erosion (Figure 9). In general, herbaceous vegetation and shrub species are not preferred in large scale range rehabilitation works. Afforestation of rangelands in some regions of the country is an effective strategy in Turkey for protecting the lands from misuse, occupation and human interventions because the lands with tall trees are much more valuable and respected by people and receive less disturbance than herbaceous vegetation covered rangelands in Turkey. That is why, the Turkish forest service prefers to rehabilitate some rangelands by afforestation.

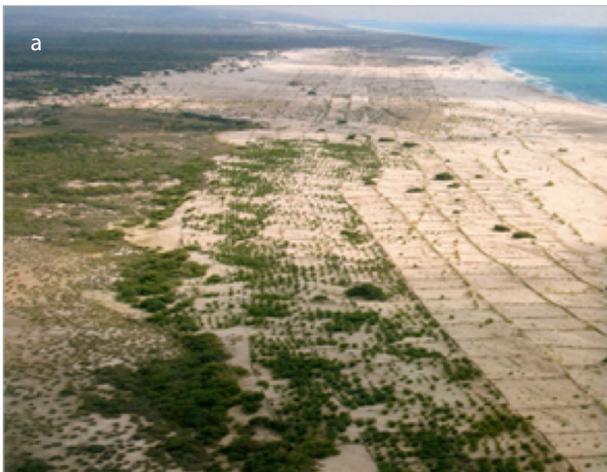
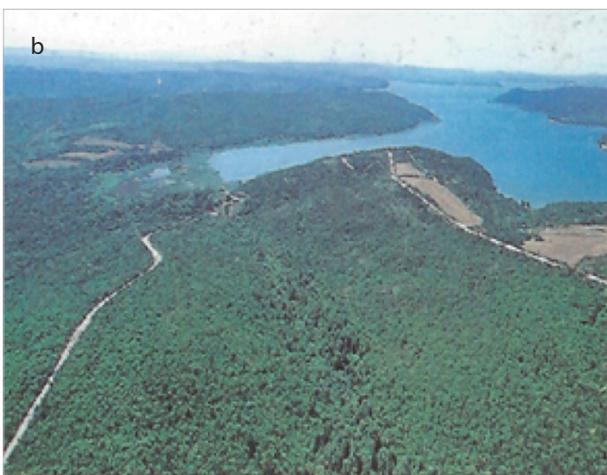
Figure 10. a, b. Sand dune stabilization works along the Black Sea coast of Northeast Thrace: (a) fence as a combination of herbaceous vegetation and woody material, (b) same site after afforestation (Anonymous, 2015b)

Additionally, a lot of wildfires occur every year in the hot dry summer months, especially in the southern and western parts of the country where the Mediterranean climate type is common. As ruled in Turkish Forest Law, the forest service has to afforest burned sites immediately after wild fires. Consequently, Turkey is the leading country in the world for increasing forest covered land due to intensive afforestation works in forest lands and partially in rangelands. Forest areas increased from 20.7 million ha in 1972 to 21.7 million ha in 2012 (GDCDE, 2015). In contrast to forestlands, rangelands covered about 56% of the country in 1940 (Karagöz, 2006) but have decreased to below 20% today (Figure 4). Decreases in the rangelands can be attributed to encroachment of urbanization, conversion of rangelands to croplands, deficiencies in the application of agricultural policies and laws (Sayar et al., 2015). Even though wind erosion affects a small portion of the country (Table 3), the forest service has made some successful sand dune stabilization works and Figure 10 shows one such example from Black Sea coast of Northeast Thrace (Anonymous, 2015b). In these works, fences either as a combination of herbaceous vegetation such as *Ammophilla*

*breviligulata*, *Isatis arenaria*, and *Allicum spp.* and wood material together or alone were established and sand dunes were stabilized and then planted with saplings of tree species such as *Pinus maritima*, *Pinus pinea*, *Pinus brutia*, *Cupressus pyramidalis*, *Alnus glutinosa*, *Robinia pseudoacacia* (Figure 10).
