An Evaluation of Gazi University Faculty of Architecture Buildings with Regard to Turkish Standards Related with Accessibility for People with Disabilities

Can GÜNGÖR^{1,✦}

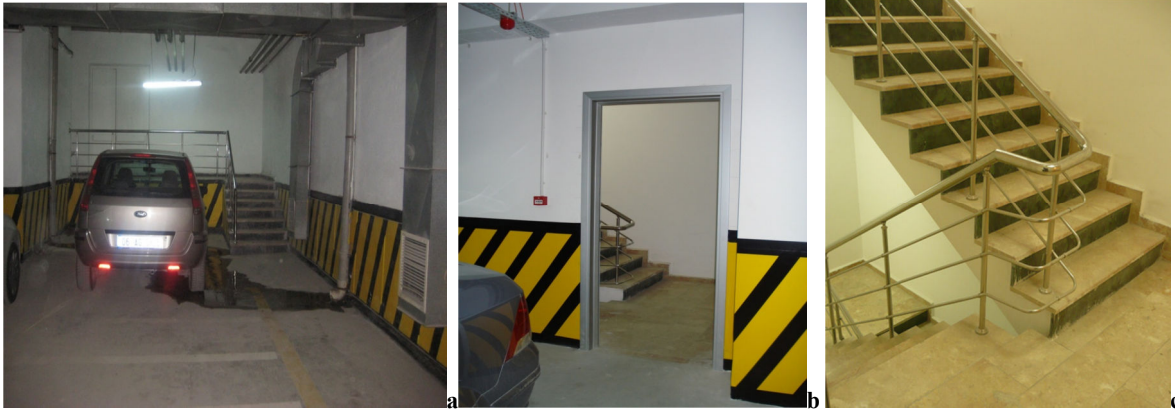
still no accessible routes from the public transportation points or there is no parking space reserved for an accessible user compatible with TS 9111 in either parking area. No drop off area has been reserved and none of the sidewalks around the building are connected to roads or to each other with curb-ramps that are compatible with TS 9111. The signage and information at site entrances and the accessibility of the car parks, public transportation points and near surroundings have only slightly improved after renovation in 2011. Both closed parking areas has still no means of access to ground level by an elevator, stair ramp, platform lift or a ramp.(Figure 1) After the renovation in 2011 the site entrance 1 is equipped with curb ramps on the pavement and handicapped accessible gates.(Figure 2)

Figure 1. Closed Parking Areas (From SEN-3) a: 2012 , (From SEN-2) b: 2012, c: 2012

The closed car parks should be equipped with stair lifts and platform lifts where necessary if the handicapped user is to use the closed parking areas without any constraints. As there are no spaces designated for the handicapped user, either a student or a staff of the faculty, the existing condition shows that they are not considered as a possible user to this facility.

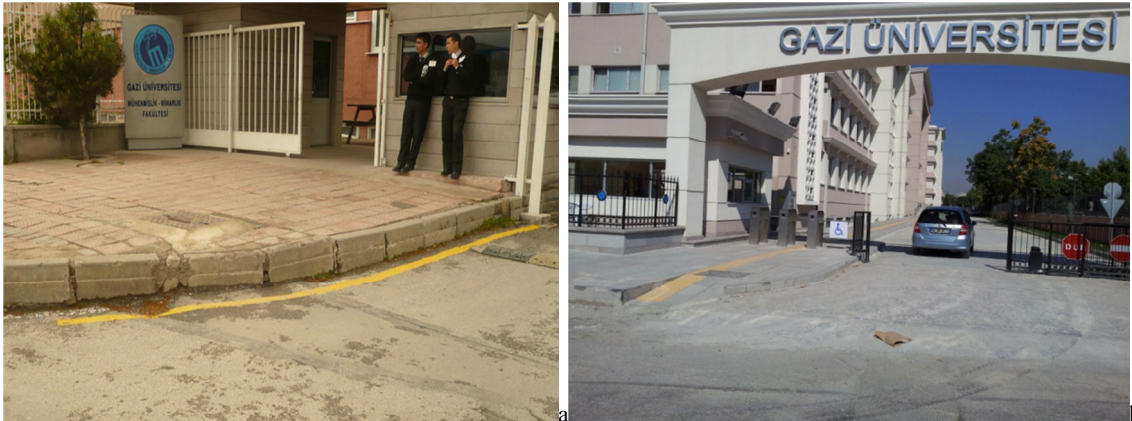
Figure 2 Site entrances (to Yükseliş street) a:2011, b:2012

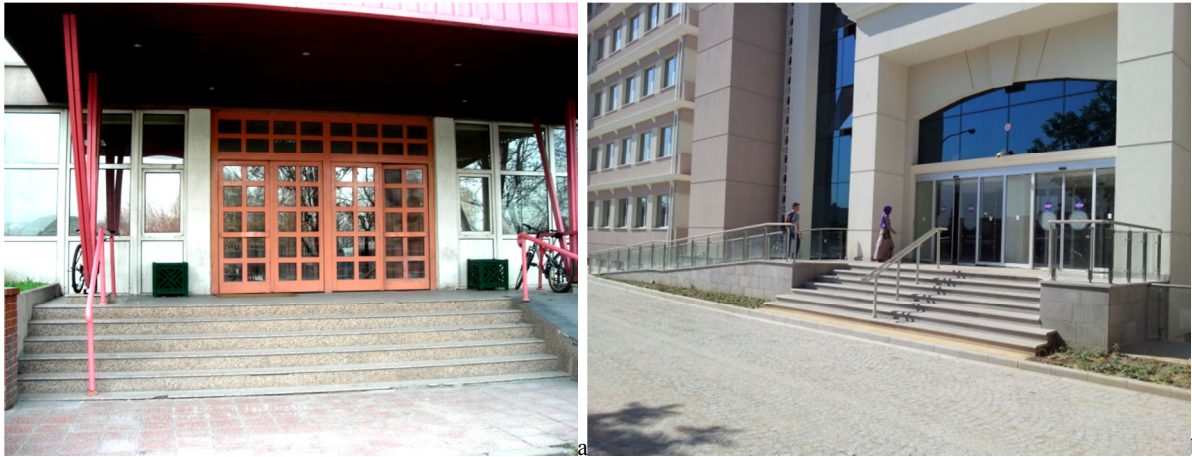
Access from the site entrances to building entrances have slightly improved after the renovation. Primary building entrance of the education building has been equipped with a proper ramp and is now directly linked with the site entrance with an un-obstructed accessible route. (Figure 3) The entrance doors at the primary entrance were operated by hand and were not sufficient in width. They are now operated automatically and are compatible with standards in width, maneuvering areas and signage. Secondary building entrance is still operated by hand and not easily graspable by handicapped users. A ramp that

Figure 3. Primary Building Entrance (to-OPA-Site Ent-1) a: 2011, b: 2012

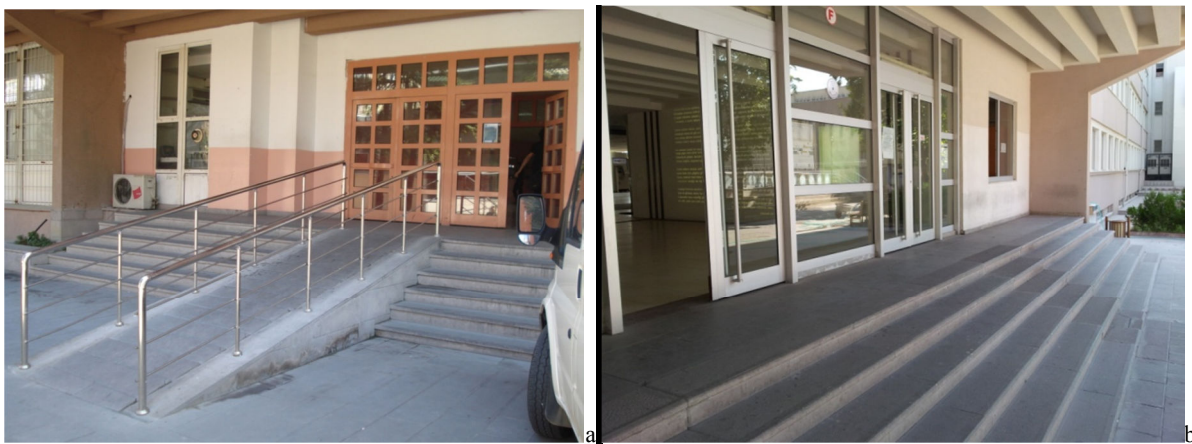
existed in 2011 has been removed in 2012 (Figure 4) Secondary building entrance to external yard has been equipped with a ramp in 2011 (Figure 5) Other entrances to buildings are automatically operated and level entrances without obstruction. However the other routes to secondary site entrances and open parking area to the secondary building entrances are still not linked with a ramp or a stair lift. This is still a major obstruction for handicapped users that will come by metro station to the building. Also there is not enough signage leading to an accessible entrance in either of the secondary entrances or secondary site entrances. The accessibility related with the means of access, ramps, entrances doors and windows have only slightly improved after the renovation in 2011.

Figure 4 Sec. Building Entrance (to Site Ent-2-Closed CPA) with ramp a:2011, without ramp b:2012

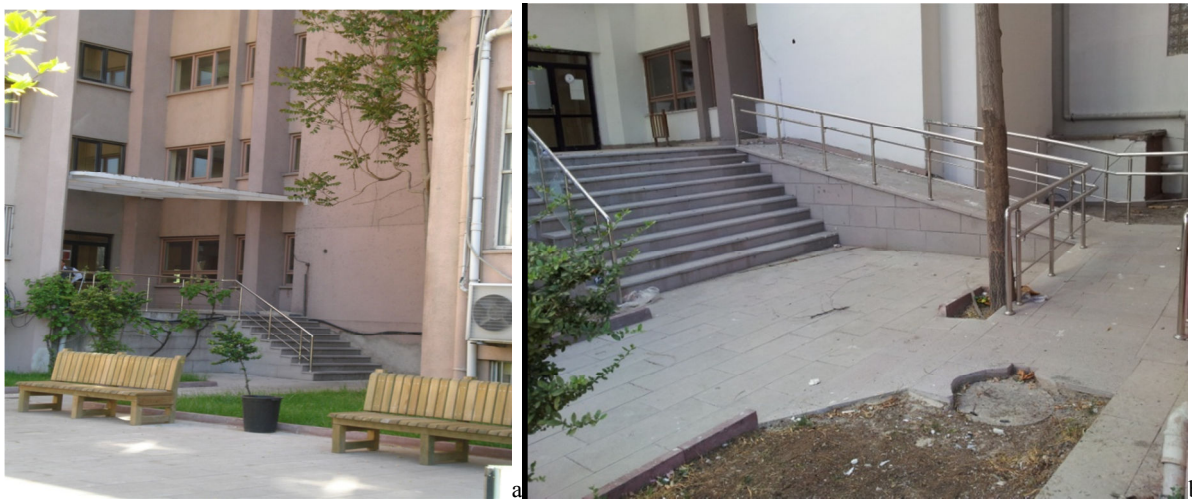
Figure 5 Sec. Building Entrance (to External Yard) a:2011, b:2012

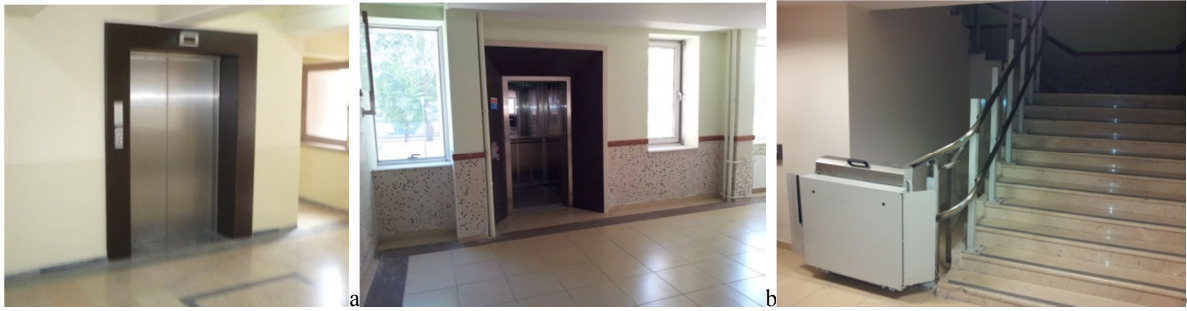
As a major change in vertical circulation a working elevator has been installed after the renovation in 2011.(Figure 6) This elevator links all the levels of the educational building together with the existing elevator that links the administrative building and the part of the educational building. Another major improvement has been the installation of a platform lift on the stairs to the

Figure 6. Elevators (Secondary Entrance) a: 2011, Newly installed elevator (Primary Entrance) b: 2012, Newly installed Platform Lift(Stairs-Conference Hall) c: 2012

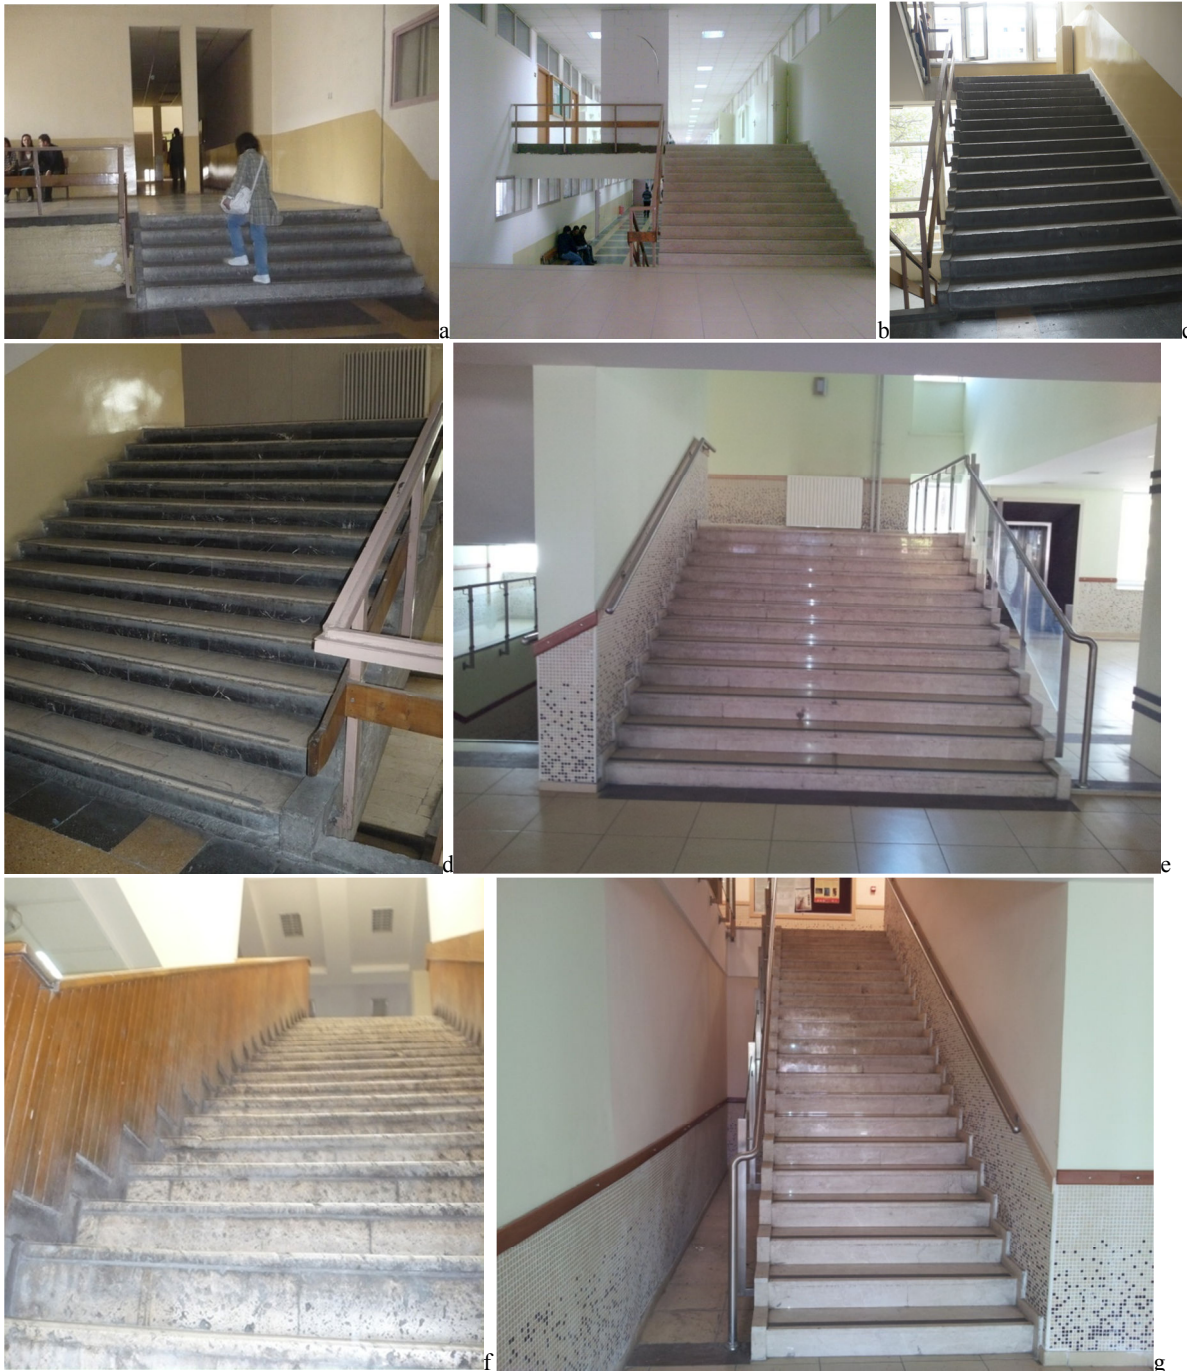
basement floor where social activities and library is situated (Figure 3). The general condition of the stairs and the railing has been improved significantly after the renovation but there are still missing handrails on large staircases that link half-floors. Another problem is that there are no ramps or automated platform lifts or stair lifts are installed on the stairs of the building that link half floors which education takes place. A handicapped student has to go down 3 floors to the ground floor and get on another elevator to reach the studios situated on

half floors such as 301 and 302. (Figure 7) Although there are still some problems, the accessibility of the

Figure 7. Half-Stairs (1st to 1a (6 steps)) a:2011, Half-Stairs (2a to 3rd (12 Steps)) b:2011, StairSE Bas.-Sec.Ent.-Gro.-1a-2a-3a (Sec.Entr Hall), c:2011, StairME Bas.to 4th (Primary Entrance Hall) d:2011, e:2012, StairUT Bas.to 4th (One-legged Utility stairs) f: 2011, g:2012

The most important issue that should be solved must be the continuity of the accessible route within each level and half levels of the building. The level changes between the floors and half floors due to the different level heights of the education building should be repaired at once. There should be stair lifts, and platforms lifts between half floors of the building and also the stairs linking half floors should be equipped with handle bars and railings for users with limited mobility.

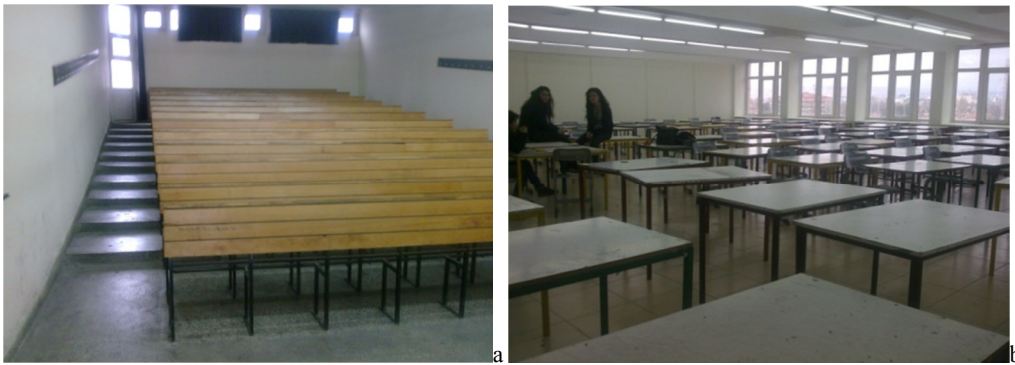
The internal accessibility of the classrooms, ateliers and the laboratories of the Department of Architecture, have not changed radically with regard to accessibility issues. The worn-out desks and chairs of the amphi-type lecture room has been changed in 2011 but there are still no spaces reserved for handicapped user in amphi-type lecture room 314 and 316. The ateliers at the 3rd floor of the education building are still equipped with same desks and chairs. (Figure 8). The major change is the location of the library which has been relocated to the basement floor where there are accessible stairs and a stair lift that can carry handicapped students to that level. Before the

Figure 8. Amphi-type lecture rooms (314) a:2011, Atelier (307) b: 2011

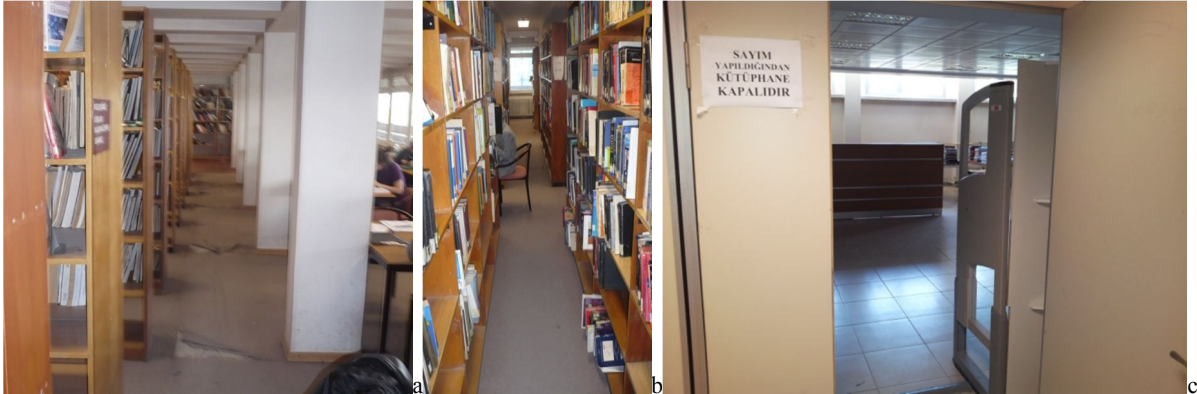
renovation the library was located on the 4th floor and there were no means of access to that level by an elevator or a stair lift. Along with that the surface materials of the library on the floor level was worn out carpeting that had obstructed easy movement in the library. This has been removed in the new library on the basement floor. (Figure 9) Also the renovation in the internal activity areas has changed due to the removal of partitions in social areas. The conference rooms on the ground floor were and are still not very accessible to handicapped users. Both conference rooms do not have ramps leading to the podium and there are no spaces left for handicapped users in either of them. (Figure 10) These improvements have altered the accessibility of the Internal Accessibility of Activity areas very slightly.

Figure 9. Library (4th floor) a:2011 , b:2011 , Library (Basement) c:2012

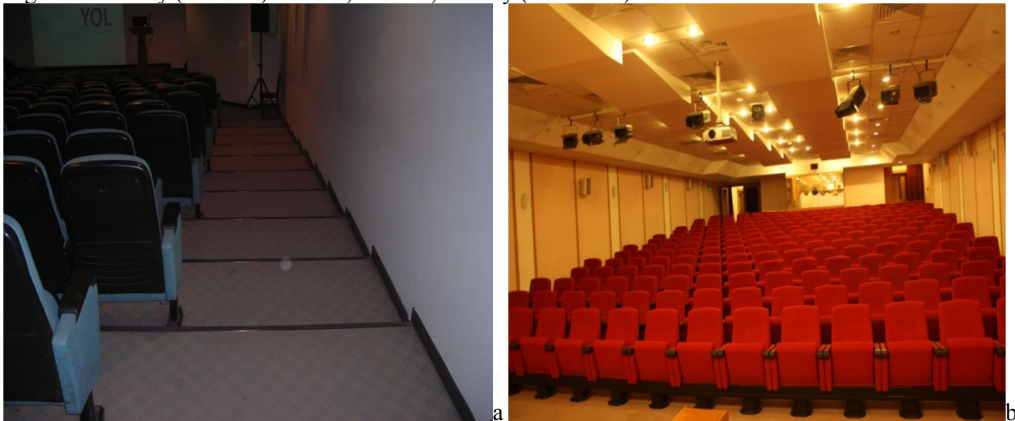
Figure 10. Conference Rooms (Akademi Salonu / Gr.Floor) a:2011, Conference Rooms (Yükseliş Salonu / Gr.Floor) b:2011

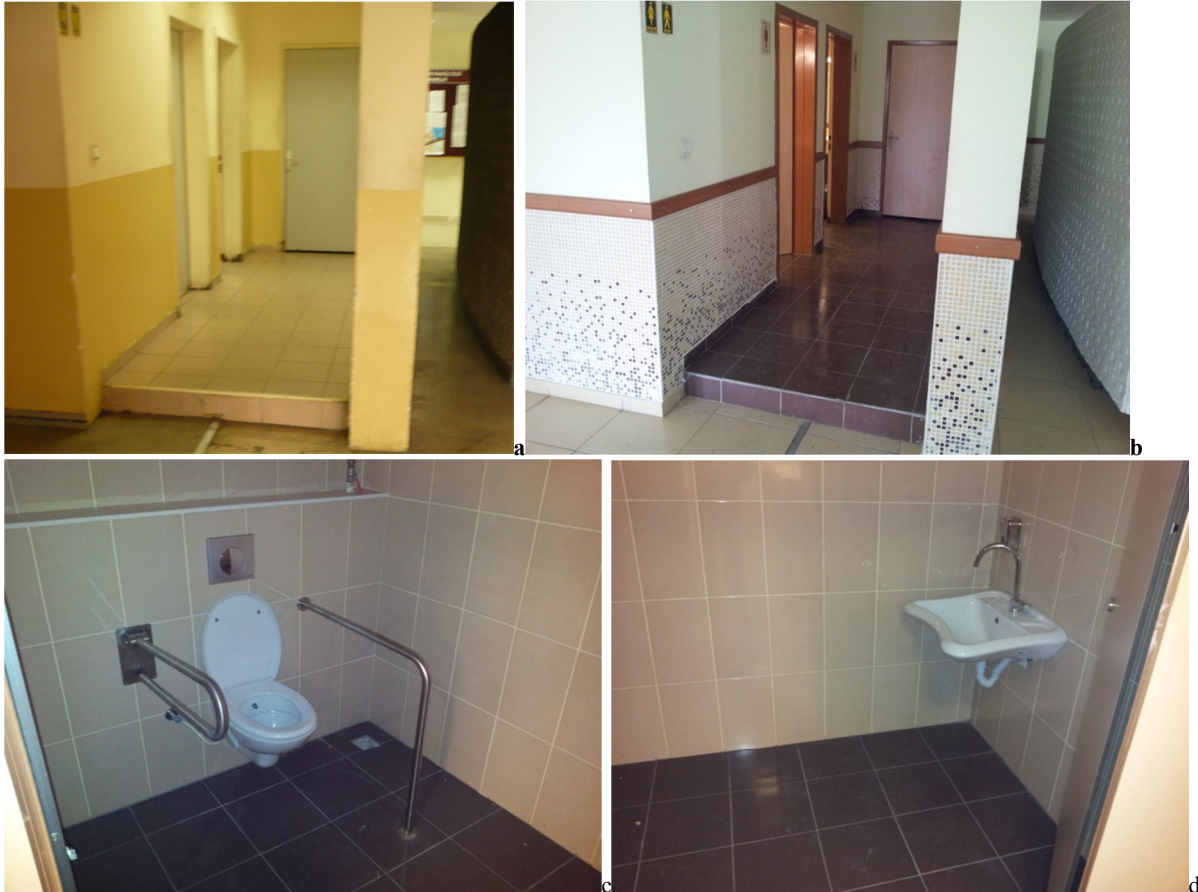
The renovation in 2011 did not really affect the accessibility values of the wet spaces as they have already been installed appropriately for handicapped students in 2011. The major problem that still exists in every floor and in every toilet is that they are not level with the floor that they are on. At least a 10 cm height is

raising the toilet areas from level and no ramps are linking the toilets. (Figure 11) Another issue is that these cabins prepared appropriately for handicapped users are used as storage areas for cleaning equipment as there is no handicapped student attending the school. Minor improvements should be applied in order to have these wet spaces arranged appropriately for the handicapped students.

Figure 11: Water Closets (Ground Floor) a:2011, b: 2012, c: 2012, d: 2012

Along with all this positivity some problems still exist, such as the inaccessible state of the wet spaces throughout the building that may be repaired with minor construction.
