Investigation of Architecture and Structural Defects of Historical Halfetih Minaret

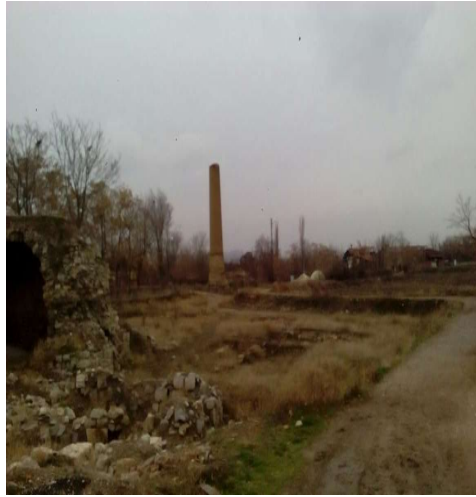
Figure 2. Current state of Halfetih Minaret [11]

Today, the structure belonging to the minaret was demolished, and square and rectangular spaces, which are believed to belong to the demolished structure of the research excavations around it, have been discovered.(Fig 2)

If this historical work is to be restored one day; The temperature changes in the region should be carefully examined and the building materials to be used should be selected accordingly. The damage from the main course should be corrected with natural stone and processed with horasan mortar. The gaps between the joints of the wall material of the building should be sanded and filled with horasan mortar. The spaces under the foundation should be filled with rubble stones and then be filled with horasan mortar. The ornaments and ceramics on the body are the aesthetic elements of the minaret and their restoration is important. The ornaments and ceramics on the body should be restored properly and should be reconsidered according to the work being done.

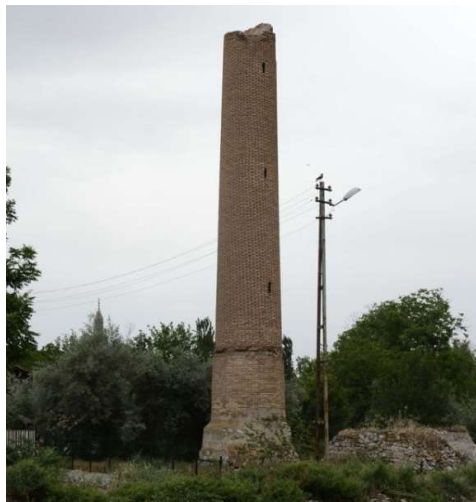
Figure 3. Current state of Halfetih Minaret [11]

The minaret is an octagonal structure on a square base. The base is made of rubble stones and the body is made of bricks. A large part of the foundation has been buried today.(Fig. 3 and 4)

There are many factors affecting the Halfeti Minaret to become its present state. These can be listed as follows: climate structure, type of material used, geological location, earthquakes from past to present. Besides all these, the human factor is the most damaging factor.
