Araştırma Makalesi
(Research Article)

Ege Üniv. Ziraat Fak. Derg.,2020, 57 (3):401-411
DOI: [10.20289/zfdergi.637793](https://doi.org/10.20289/zfdergi.637793)

**Examination of Urban Values of Kaleiçi Old Town in Terms of
Landscape Architecture and Suggestions for Effective Use of
Historical Sites**

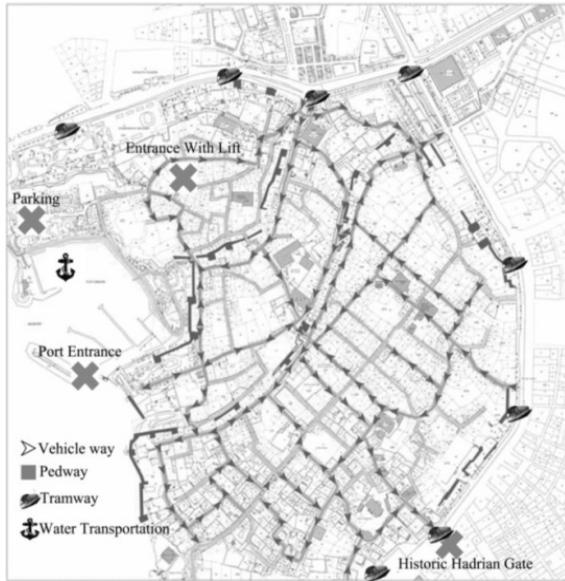
Transportation to study area is provided by the main roads coming from the Kaleiçi and the Republic Square. People also go to the region by sea transportation. The dominant transportation circulation within the boundaries of the study area is provided by pedestrian route (Figure 3).

Figure 3. Transportation analysis

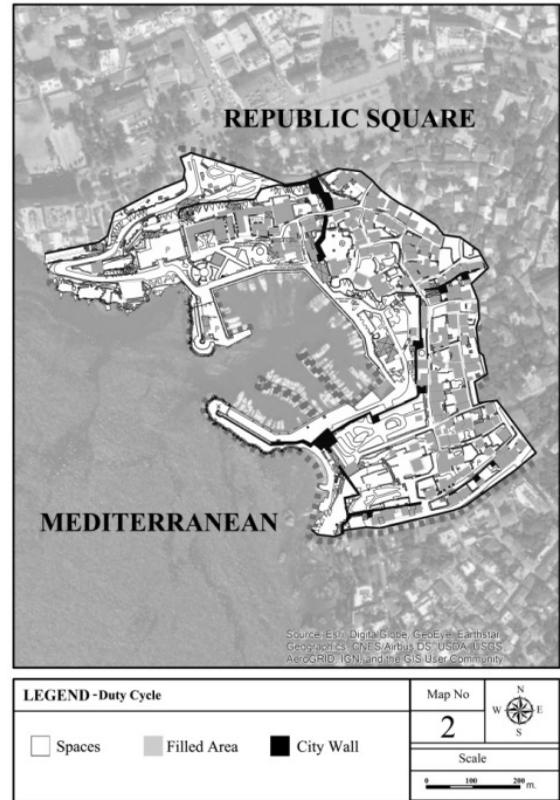
Duty cycle analysis was done to determine the density of buildings in the study area. It is determined that while increase the building density towards the Kaleiçi region, the marina and its immediate surroundings have open and green areas (Figure 5).

Figure 5. Duty cycle

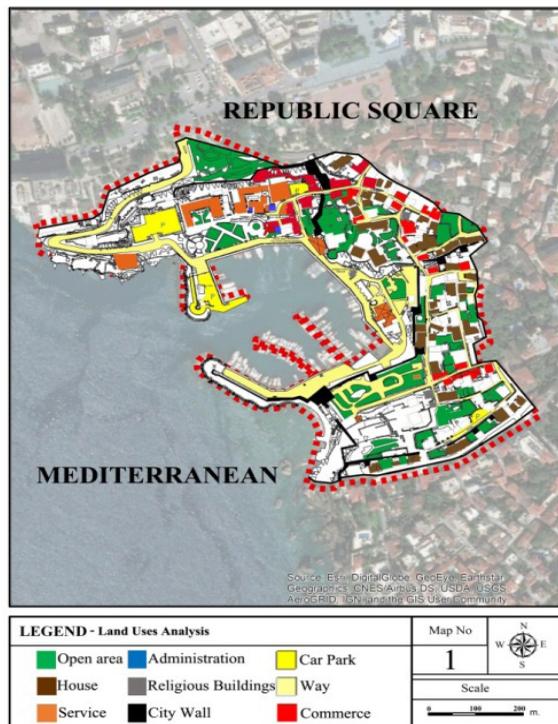
According to the data obtained from the land use analysis, there are 3 car parks in the study area. There are many trade and service areas around the harbour. As administrative buildings in the region; Kaleiçi Inspection Bureau, Marina Port Police Station, Tourism Branch Directorate are located in Kaleiçi (Figure 4).

Figure 4. Land use analysis

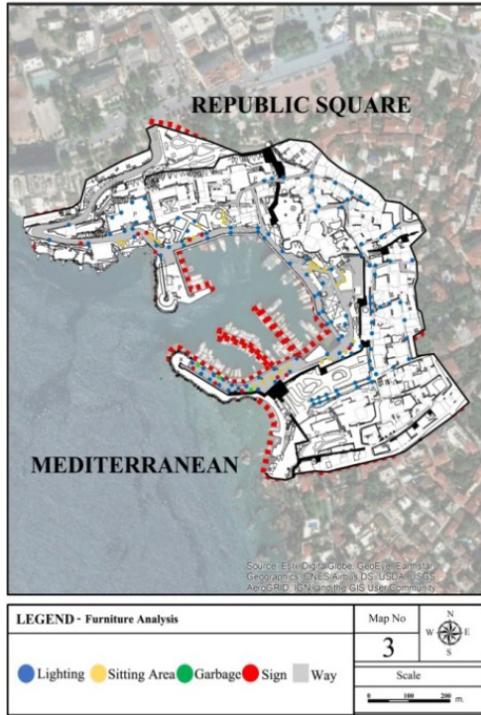
According to the analysis of urban furniture in the study area; lighting elements were determined to be sufficient. Considering the density of the area, the seating elements and garbage were determined not sufficient. It has been determined that the number of information boards is quite low. The buildings in the study area were analyzed in terms of quality and height. As a result of the analysis, the buildings in the study area are mostly 1, 2 or 3 storeys. It is considered that this case will provide an advantage in the visual landscape projects to be made in the area.

Figure 6. Furniture analysis

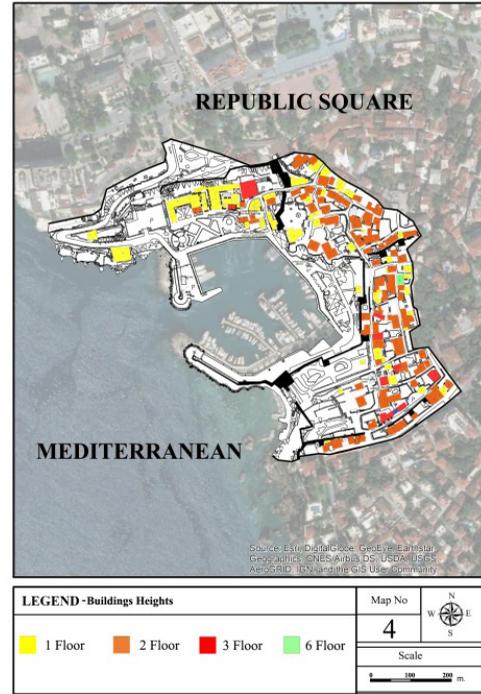
Figure 7. Buildings heights

57 of the buildings are 1 storey. 78 of the buildings are 2 storeys. 9 of the buildings are 3 storeys. 1 of the buildings is 6 storeys. Most of the buildings are made of masonry and wood (Figure 7). After analyzing the height of the buildings, quality of the buildings was analyzed as classified ruined, middle, and good. It was determined that 6 of the buildings are ruined, 67 of the buildings are good, and 72 of the buildings are middle (Figure 8).

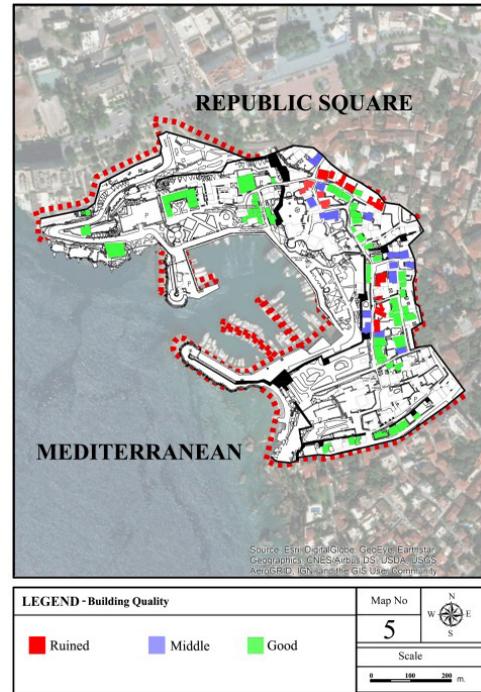
2-storey buildings are in good condition and 1-storey buildings are in bad condition because they are old. Example buildings in the area used for quality evaluation of buildings are given in Figure 9.

Figure 8. Buildings quality

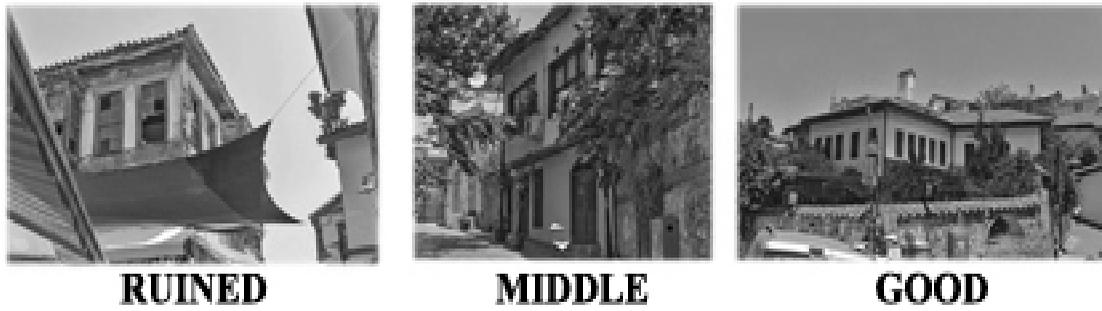
Figure 9. Example buildings in the area used for quality evaluation
Şekil 9. Binaların kaliteleri için kullanılan örnek yapılar

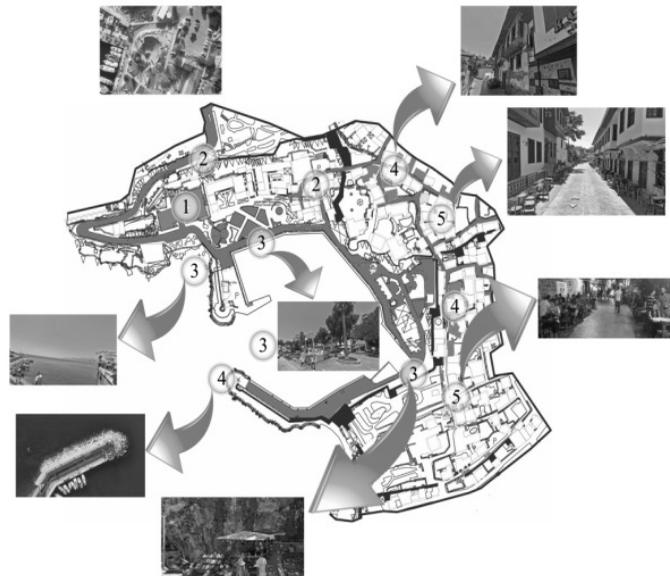
In order to determine the solution suggestions to be brought to the study area, problem analysis was conducted (Figure 11). The problems are grouped under 5 main factors as parking (1), transportation (2), marina (3), revision (4), noise (5).

Figure 11. Problem analysis

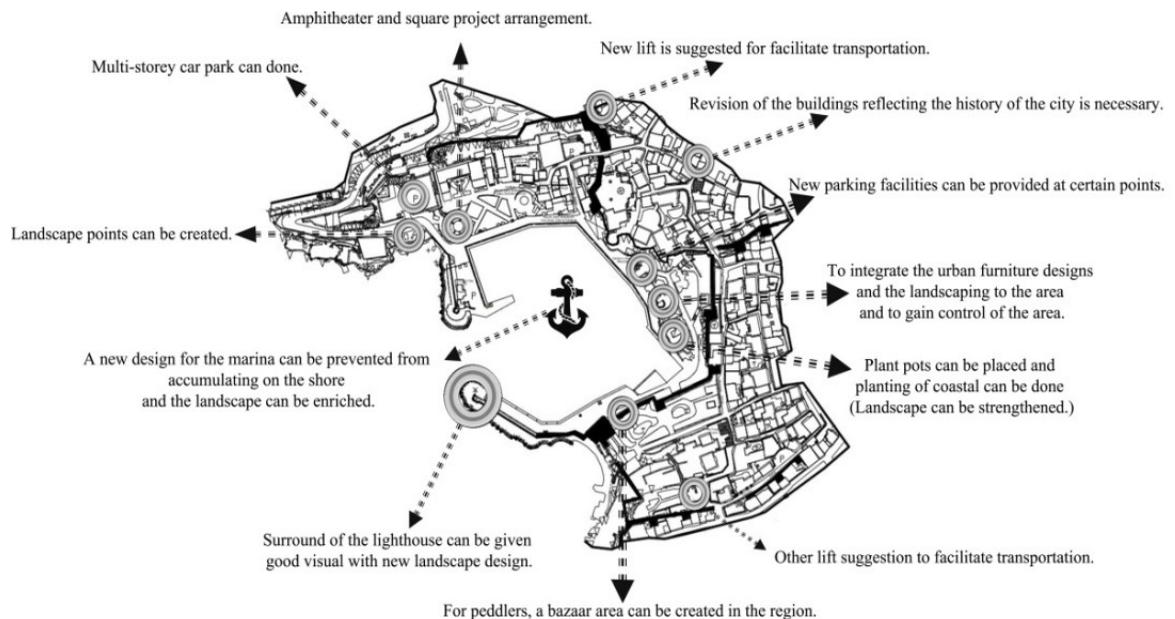
Figure 12. The solution suggestions for the study area – 1

The number of seating elements should be increased for the monitoring and rest. The number of signs and garbage in the area should also be increased. It was found that the structures in the area are under protection. Therefore, no changes can be made to the structures. As a result of this, the structures are worn out and abandoned. These buildings must be restored in accordance with the historical fabric and the law. The solution suggestions for the study area are given in Figure 12, Figure 13.

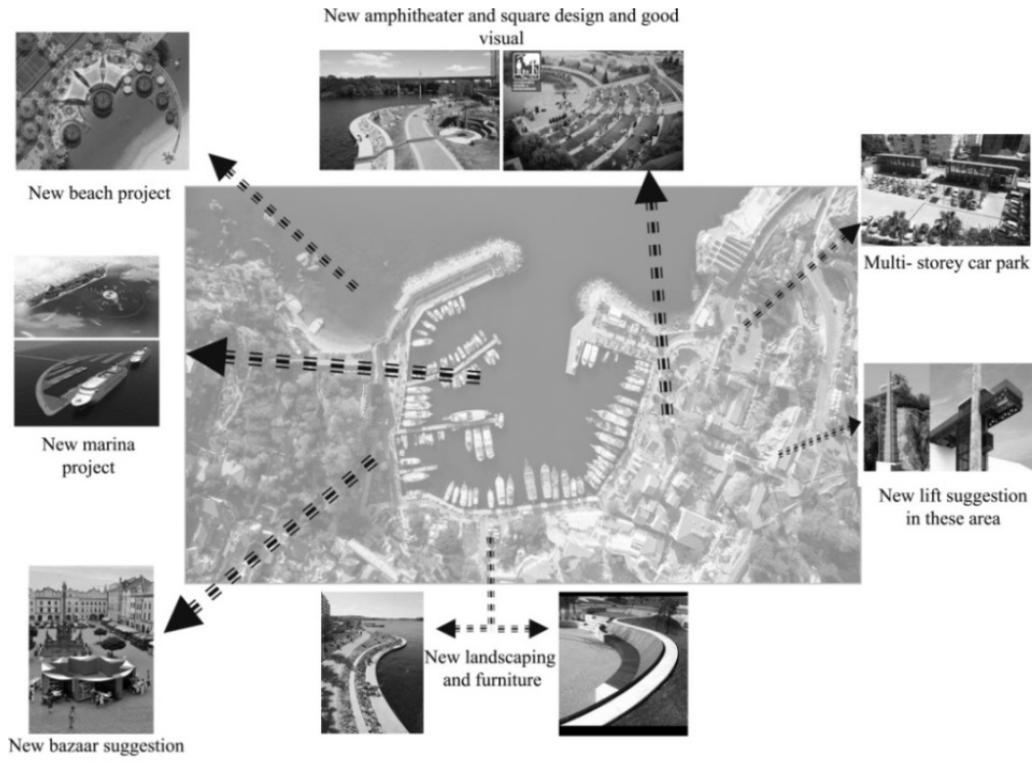
Figure 13. The solution suggestions for the study area – 2

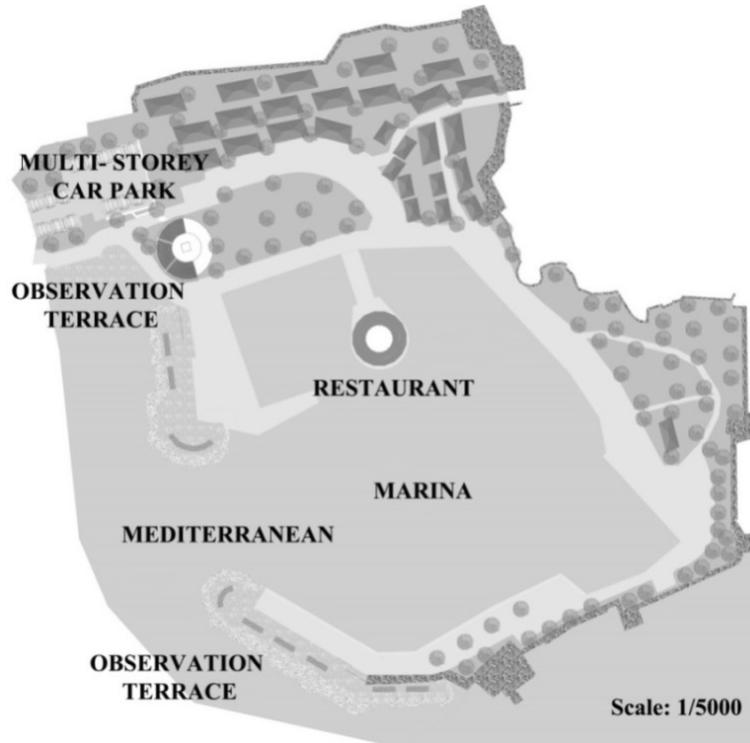
14, Figure 15). In the urban design project; suggestions were made to solve the parking problem and to meet the need for use in the area. The lack of landscape points in the area was identified and a suggestion was made. This suggestion is that people can interact to sea owing to new route. The parking problem was solved without changing the area used as parking in the project area. Mechanical parking analysis was proposed. A restaurant suggestion was brought to the location where people can see historical environment and the sea view. The restaurant was located in the marina, is intended to be a symbolic structure in the marina. It considered that the marina will be more active and useful.

Figure 14. Landscape project for harbour area

Landscape project and 3D modelling was made for the port area and its immediate surroundings (Figure

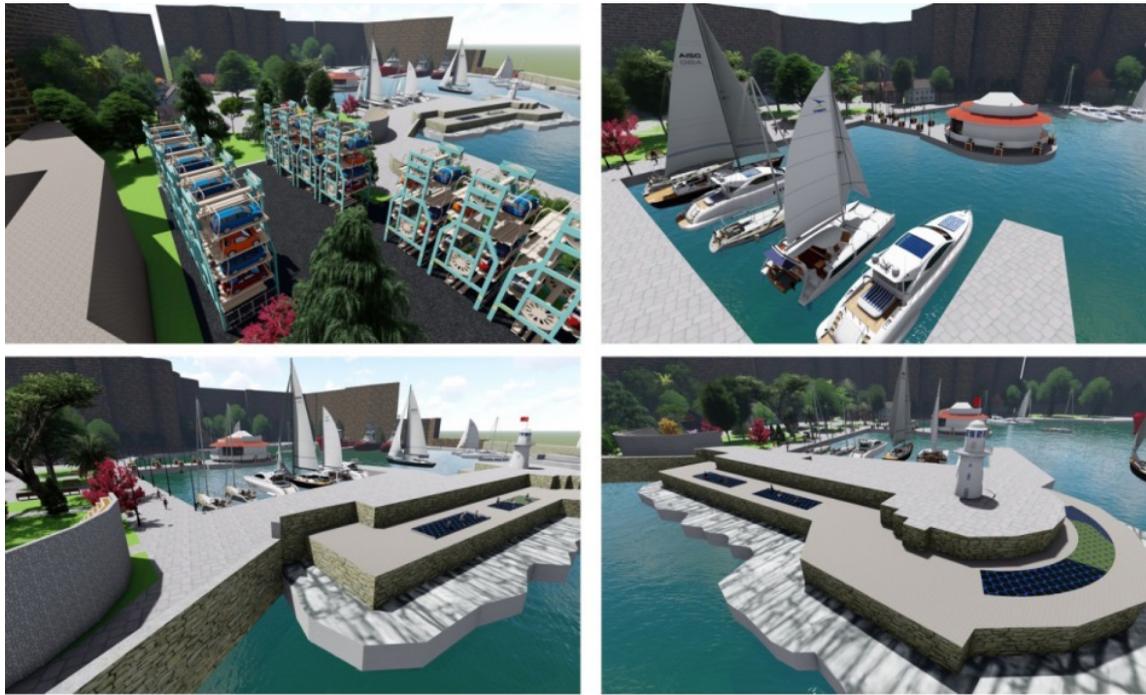
Figure 15. 3D modelling
