# DISASTER SCIENCE AND ENGINEERING

VOL: 7, NO:1, 2021

## Damming Rishiganga in Chamoli District on the aftermath of Flash Flood Disaster of February 7, 2021: Case Study

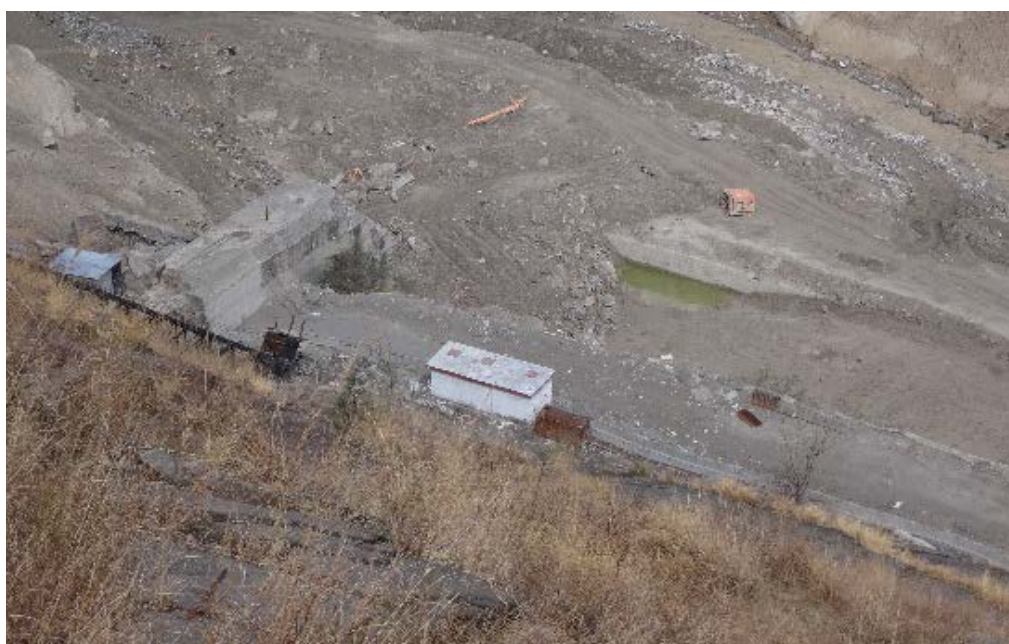
**Figure 2.** Washing away power house of Rishiganga hydropower project of 13.2 MW capacity upstream of Rini

Multipule intermittent damming and ensuing flash flood of Rishiganga and Dhauliganga river caused washed off a functional hydropower project of 13.2 Mw capacity on Rishiganga upstream of Rini (Figure 2) along with a RCC bridge of 60 m span over Rishiganga on Joshimath – Malari road at Rini in which disrupted connectivity for the people of 13 villages (Figure 3). To the downstream of this the floodwaters caused severe damage to another under construction hydropower project of 520 Mw of NTPC at Tapoban on Dhauliganga river (Figure 4). 204 people went missing, including 9 local people and 2 Police personnel, of these body of 83 persons could be recovered. Besides this heavy losses were incurred by public infrastructure and other properties.

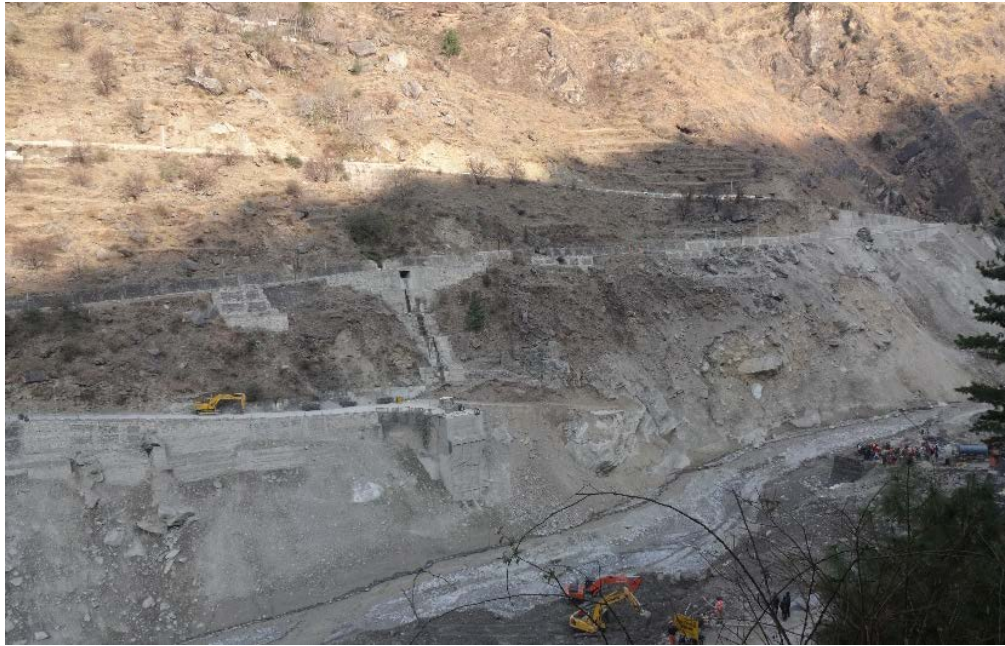
**Figure 3.** Washed off motorable RCC bridge over Rishiganga on Joshimath – Malari State Highway at Rini

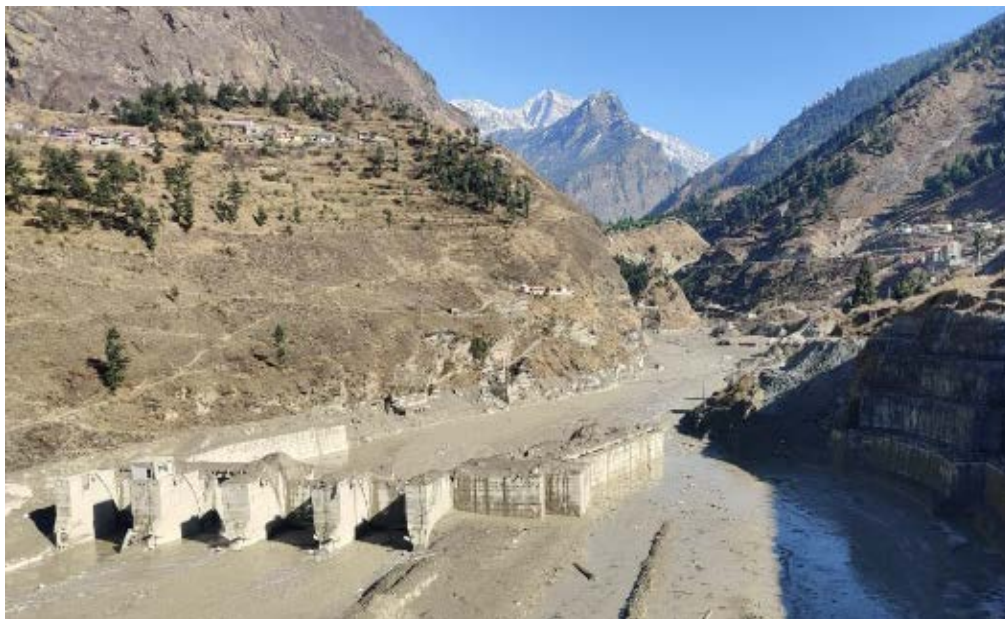
**Figure 4.** Severely damaged barrage of Tapoban-Vishnugad hydropower project with aggradation of river bed at Tapoban

The flooded water of Rishiganga resulted in swiping away of an operational hydropower project of 13.2 Mw capacity on Rishiganga upstream of Rini and severe damage to another under construction hydropower project of 520 Mw of NTPC at Tapoban on Dhauliganga river. As many as 204 persons went missing, of these 83 bodies could be recovered while 12 persons injured and 360 farm animals were lost in the flash flood incidence together with another property and infrastructures.

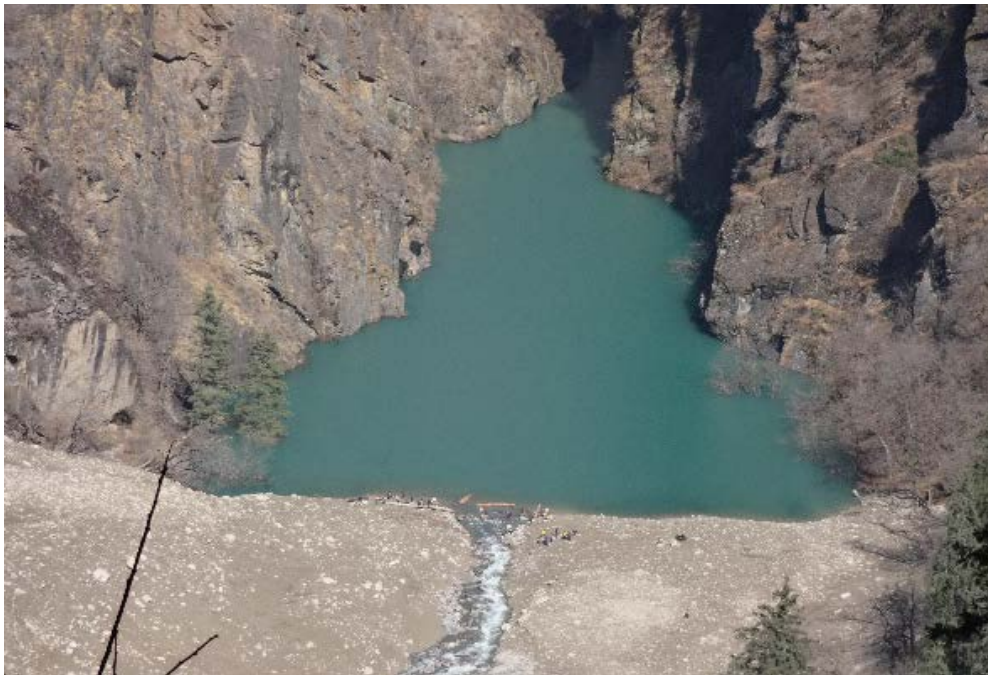
**Figure 6.** Rishiganga lake curved out channel from the center of the lake through which water is continuously draining out

This reverse flow of a huge volume of water saturated bouldary debris was deposited over Rishiganga and blocked the course of the same for 3 days between 9 and 11 February, 2021. This debris comprising of a mixture of ice blocks, rock fragments, morainic materials and boulders of quartzite, granitic gneiss and mica schist with silty-clayey matrix. The Rishiganga was curved out channel from the center of the lake through which water is continuously draining out on February 12, 2021 (Figure 6).

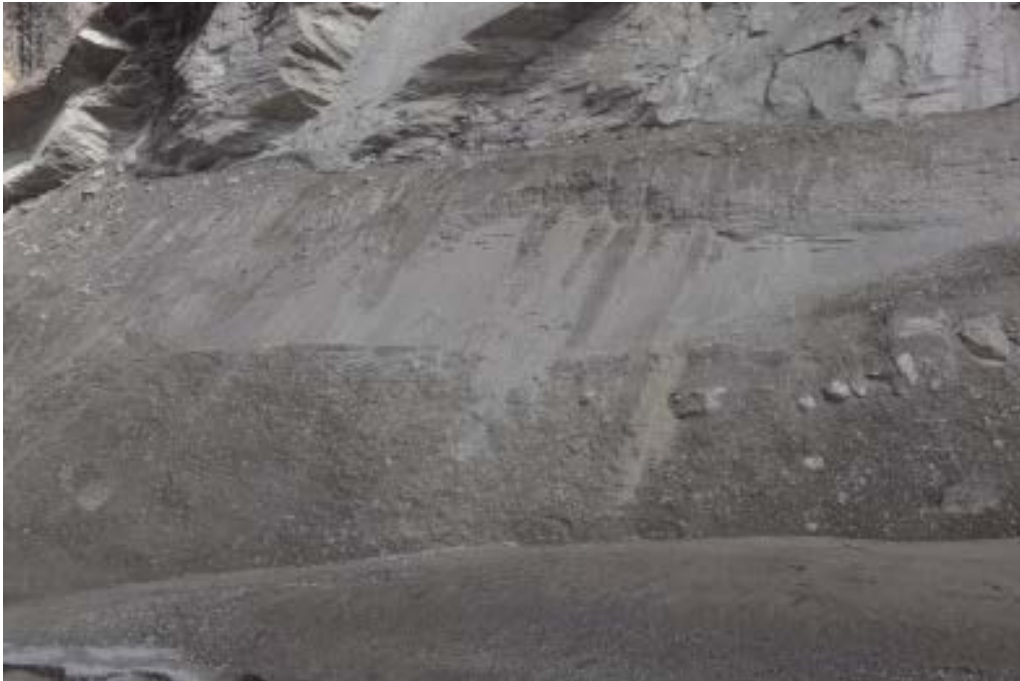
**Figure 7.** Evidence of paleo lake showing lacustrine sediments on the right bank of Raunthi Gadhera near its confluence with Rishiganga

It is important to note that just upstream to confluence of Raunthi Gadhera and Rishiganga, occurrence of lacustrine deposits that consist a layers of sand and pebbles on the right bank of Raunthi Gadhera which was indicating evidence of paleo lake in the same region. These deposits has now been mostly eroded in the flash flood of Raunthi Gadhera (Figure 7).

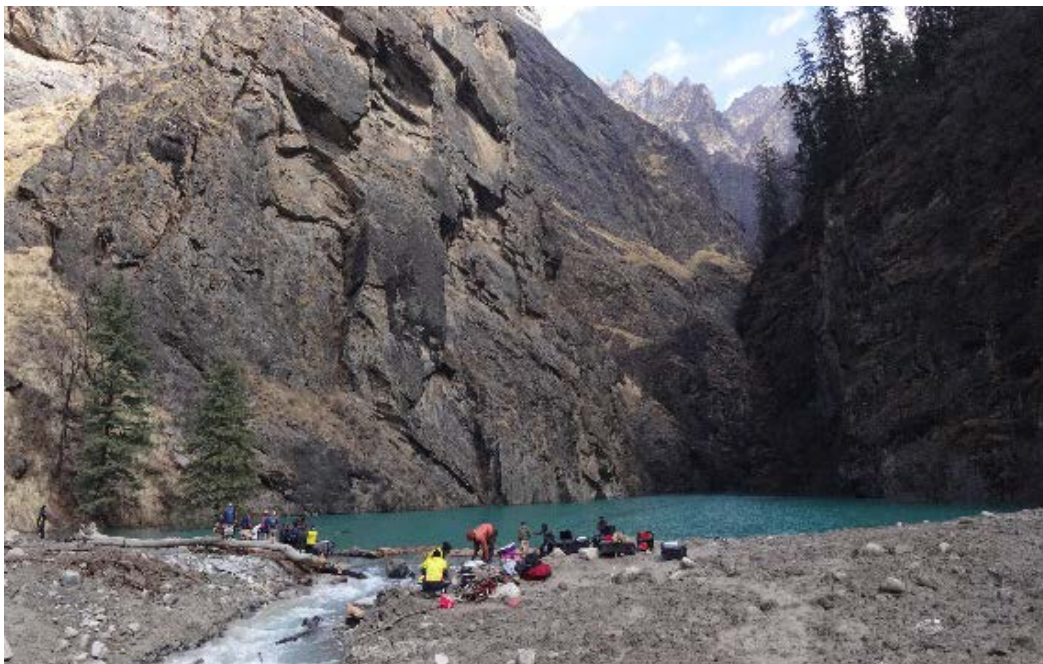
**Figure 8.** Personnel of ITBP and SDRF widen the channel and cleared of obstructions of logs

and SDRF, physically widen the channel and cleared of obstructions of logs (Figure 8). The channel was thus widened upto 20 m between February 22 and March 2, 2021 to ensure proper draining out water from the lake.

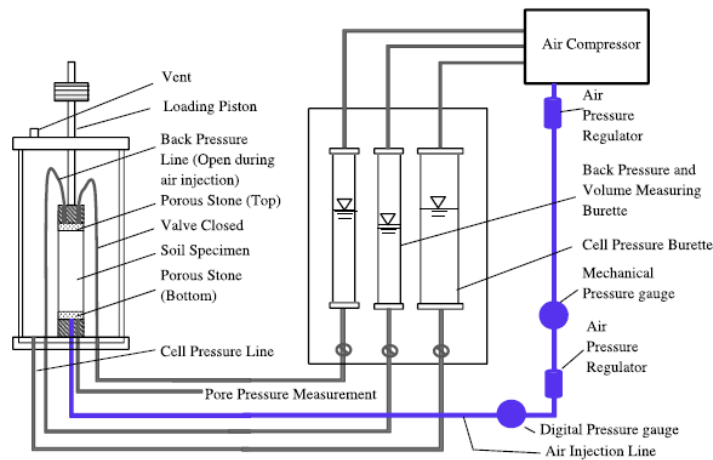
Şekil 2. Hava enjeksiyonu için modifiye edilmiş üç eksenli deney cihazı

Amanta ve Dasaka (2021) yaptıkları çalışmada, suya doygun granüler zeminin çevrimsel üç eksenli cihaz ile sıvılaşmasına karşı hava enjeksiyon yönteminin etkinliğini araştırmışlardır. Değişken olarak gerinim genliği, çevresel basınç ve hava enjeksiyon basınçları dikkate alınarak Hint standart kumu üzerinde gerinim kontrollü çevrimsel üç eksenli testler gerçekleştirilmiştir. Desatürasyon işlemi gerçekleştirebilmek ve hava enjeksiyon işlemi kolaylaştırmak için, Şekil 2'de gösterildiği gibi üç eksenli deney cihazı modifiye edilmiştir. Görsele mavi renkle vurgulanan hat ile numune tabanına hava kompresörü bağlanmıştır. Konsolide edilmiş suya doygun zemin numunelerine hava enjekte edilmiştir. Tamamen suya doygun ve hava enjeksiyonu uygulanmış zeminlerin dinamik özellikleri karşılaştırılmıştır. Zeminin hava enjeksiyon yöntemiyle desatürasyonunun zeminin sıvılaşma direncini önemli ölçüde iyileştirdiği belirlenmiştir. Farklı çevresel basınçların ulaşılabilecek nihai desatürasyon seviyesinde çok etkili olmadığı, hava enjeksiyonu durdurulduktan 30 gün sonra bile zemin içerisindeki havanın sistemi terk etmediği çalışmanın diğer bulguları arasındadır.
