CULTURAL HERITAGE AND SCIENCE

Cultural Heritage and Science (CUHES)

Exploring structural deterioration at historical buildings with UAV photogrammetry

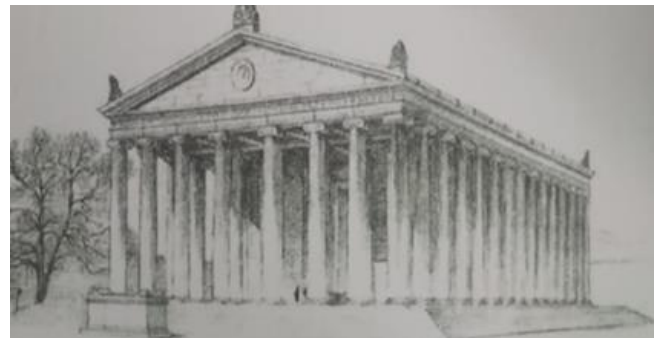
Figure 3. Reconstruction drawing of the temple [9]

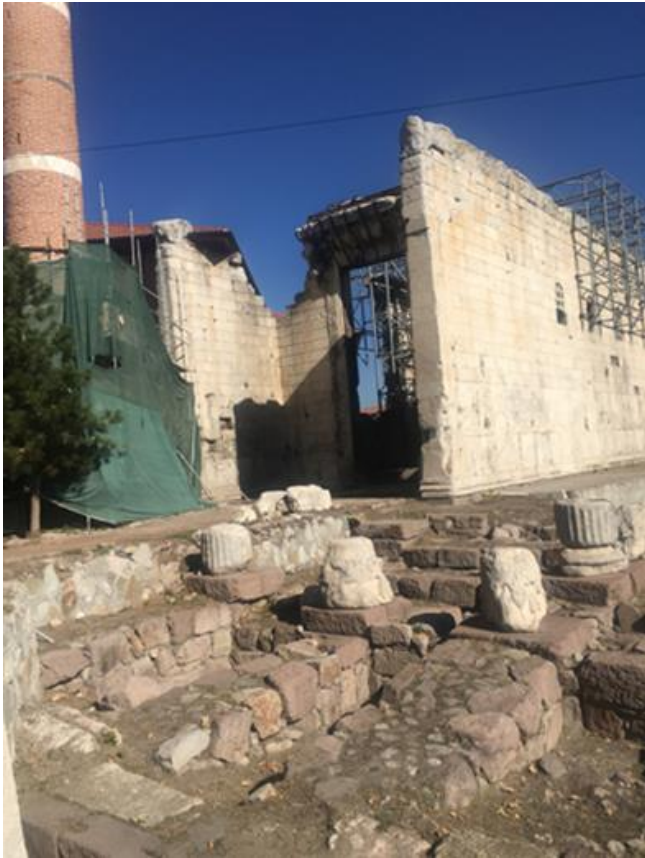
Figure 4. The Temple today

Original status: The marble temple has a pseudodipteral plan rising on a 2 meter platform over an area of 36mx54.82m. It is located in the south-west-northeast direction. It is decorated with 8 ionic columns on the short sides and 15 on the long sides, forming its peristyle. The interior complex (naos) consisted of three parts: 'pronaos' (inner area of the portico), 'cella' (central room) and 'opithodomos' (back porch). Between the extensions of the side walls, there were four Corinthian columns in the pronaos and two in the opisthodomos. The entrance to the cella is through the main door with an ornate lintel located at the rear end of the pronaos. The cella was the sanctuary of the temple, where only priests were allowed [10].

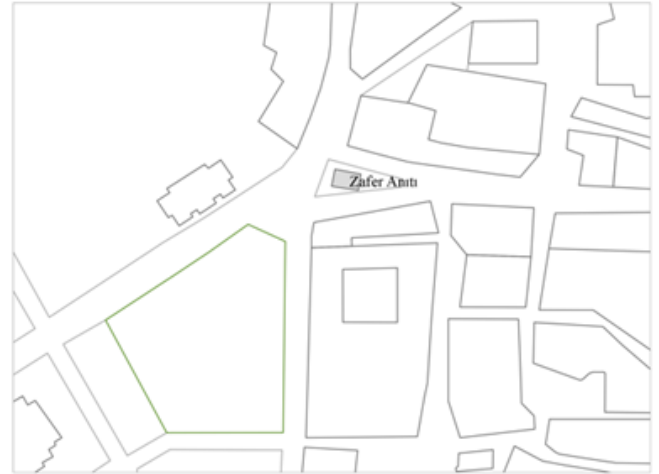
Figure 15. Schematic drawing of the first place of the Monument

Change: It was built in 1927 by the Austrian Sculptor Heinrich Krippel. In 1960, the location of the Monument was changed due to road widening works.

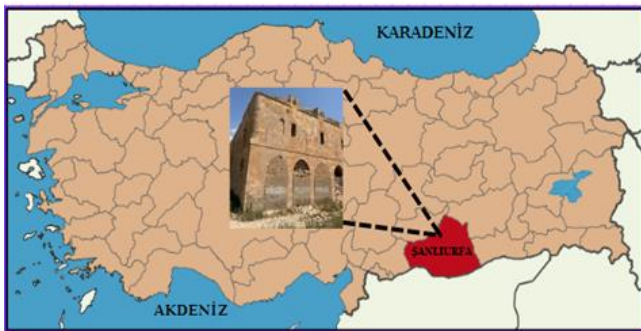
Figure 1. The study area

The selected study area, Germuş Church, is located in the Dagetegi near at the foothills of Germuş Mountain, which is situated 10 kilometers northeast of the city center of Sanliurfa. The historical church is positioned at coordinates 37°12'06.0" latitude and 38°51'04.2" longitude and is located 5 kilometers away from Göbekli Tepe, which is known as the "zero point" of history. The location information for the study area is depicted in Figure 1.

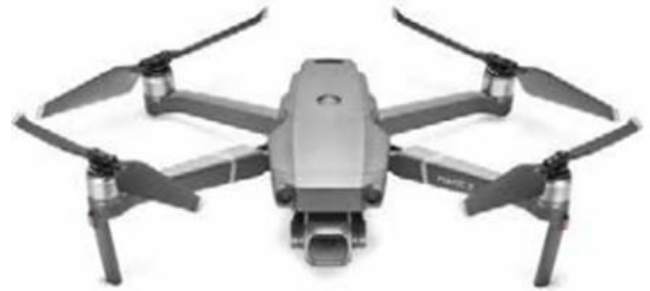
Figure 2. DJI Mavic 2 Pro UAV system used in the study

In this study, the DJI Mavic 2 Pro, a UAV system from the DJI brand, was used to generate a 3D model of the historical church. The DJI Mavic 2 Pro is a successful system with features such as an effective range of 8 km, a maximum flight time of 31 minutes, 4K recording with a Hasselblad camera, a 1" CMOS sensor, GPS sensor, 4-way obstacle sensing, automatic return to home, and a weight of approximately 1 kg [20]. The UAV used in the study is depicted in Figure 2.

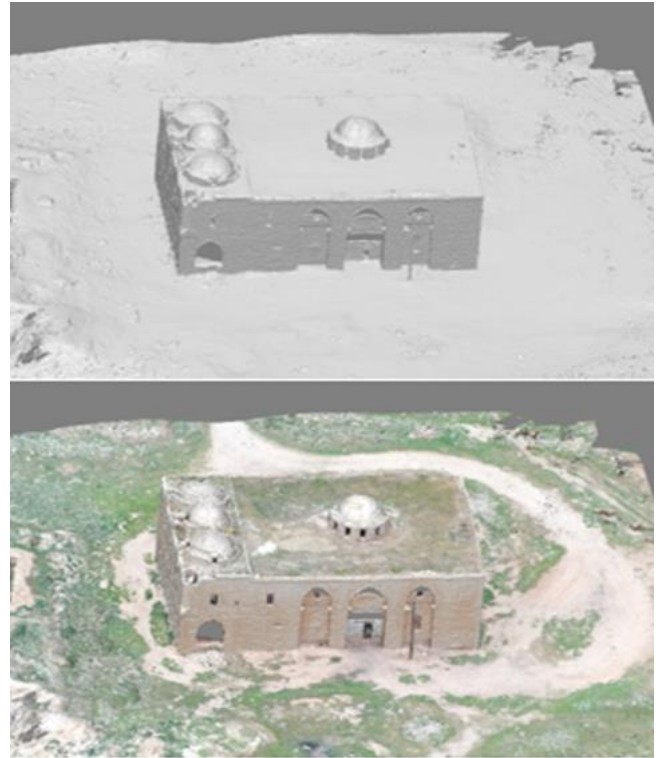
Figure 4. The generated point cloud

7,800,413 points. The colorless and colored form of the generated point cloud is given Figure 4.

The obtained point cloud allows us to obtain both 3D position and color information from all surfaces of the structure. Using this data, it is possible to produce a 3D solid model of the structure. Within the scope of the study, the 3D solid model of the Germuş church was produced both in colorless (Figure 5) and colored (Figure 6).

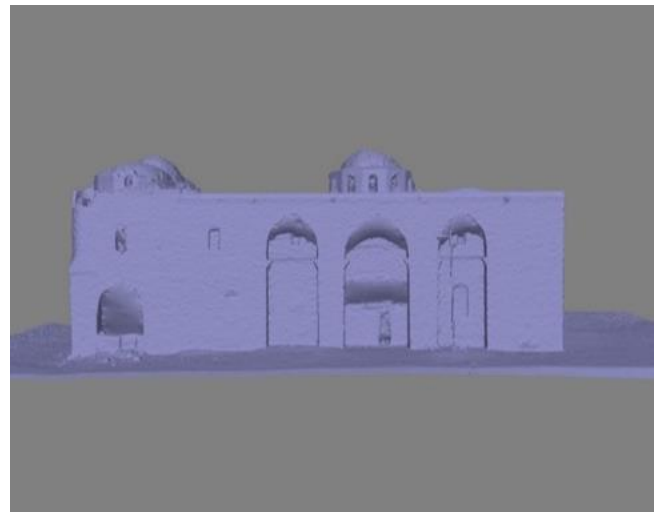
Figure 5. Colorless 3D solid model of Germuş Church

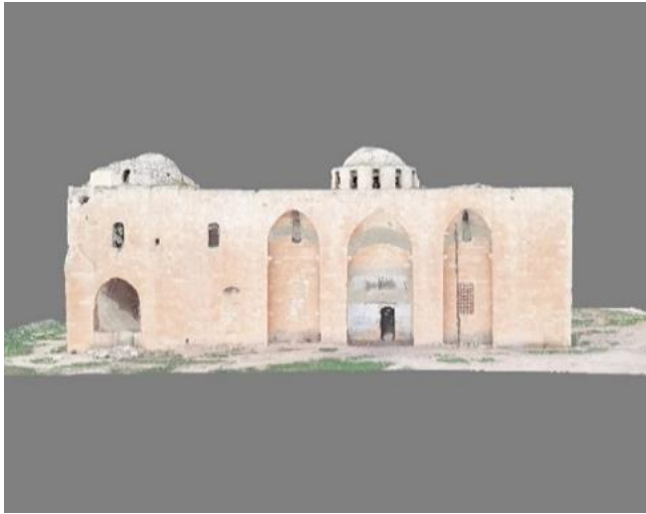
Figure 6. Colored 3D solid model of Germus Church

When evaluating the generated 3D model and the fieldwork, it is clearly visible that the domes of the historical church have collapsed and the side facades have suffered damage. The deformed parts of the historical church are indicated on the 3D model.

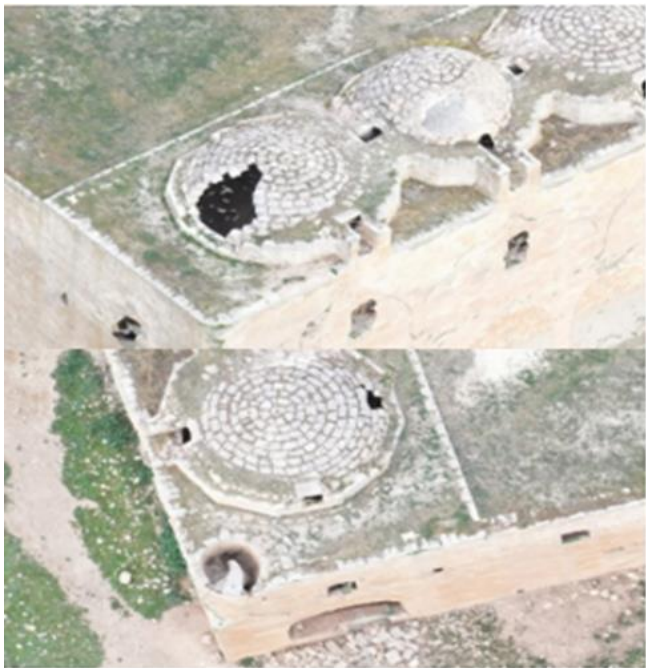
The damaged domes made of knitted stone pose a high risk due to falling stones. Figure 7 shows extensive damage to the dome, completely opening it up and causing stones to fall. The unstable structure increases the danger, as each dislodged stone increases the chance of further collapse. Urgent action is needed to stabilize the remaining sections, ensure safety, and restore the domes to their former glory.

Figure 7. The deformed dome.

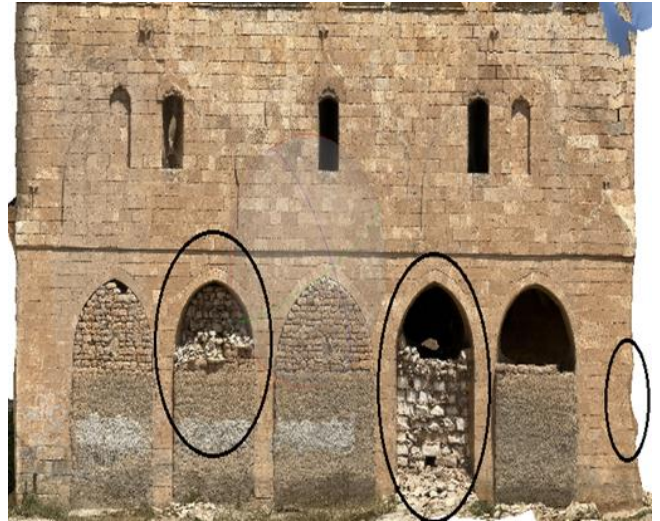
The building's exterior walls exhibit significant wear, a result of aging, decay, and human-induced damage. Over time, the elements have taken a toll, causing cracks

and faded paint. Additionally, poorly constructed masonry walls and graffiti further mar the surfaces. Figure 8 highlights some of these damages, emphasizing the need for restoration and preservation efforts.

Figure 8. The deformed walls

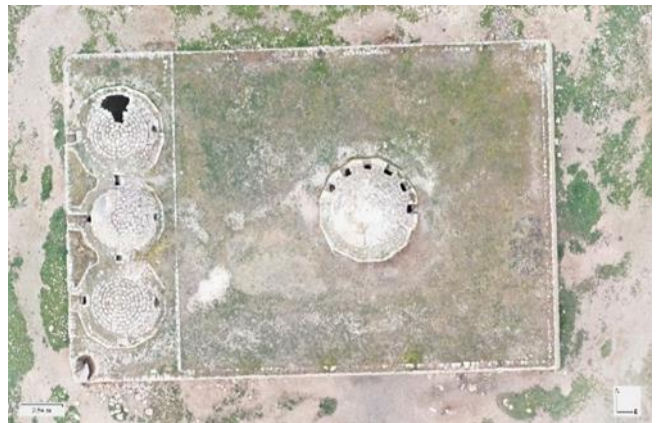
The presence of grass and weed plants on the building's roof, as shown in Figure 9 is a cause for concern alongside the structural damage. The accumulation of soil can lead to long-term structural issues. Over time, the roots of the plants can penetrate the roof's surface, compromising its integrity and creating pathways for water infiltration. The weight of the soil and vegetation can also strain the supporting elements, increasing the risk of collapse. To address these risks, regular maintenance and cleaning are necessary to remove the soil and vegetation, while implementing drainage systems and reinforcing the roof structure can help mitigate the effects of moisture and soil accumulation.

Figure 9. Soil accumulation and grass on the roof of the church

The accumulation of soil and growth of grass and weed plants on the building's roof pose potential risks. The roots can compromise the structure and lead to water infiltration, while the added weight can strain the supporting elements. Proper maintenance, including regular cleaning and drainage systems, along with reinforcing the roof structure, can help mitigate these risks and preserve the building's structural integrity.

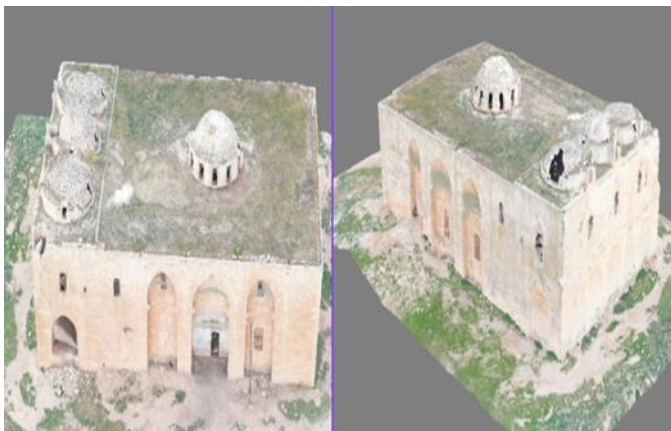
Figure 10. The 3D model of Germus Church

The final version of the 3D model of Germus Church is depicted in [Figure 10](#).

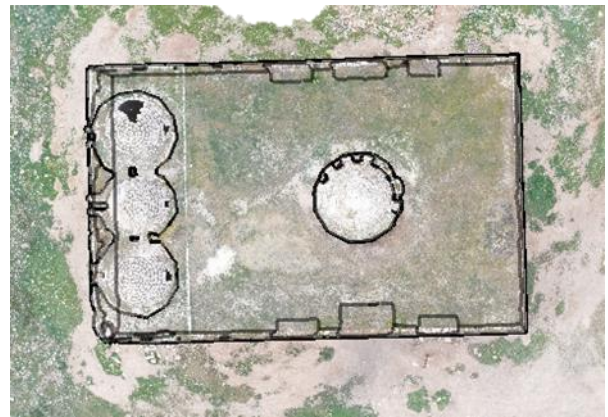
The provided [Figure 11](#) exemplifies the use of the 3D model for architectural survey drawings, showcasing the building's main outlines and highlighting specific damaged sections. This digital representation not only facilitates accurate documentation but also serves as an

Figure 11. An example of architectural drawings over 3D model

The 3D model generated from the site documentation serves as a valuable resource for creating architectural survey drawings. By utilizing the model, architects can accurately depict the building's main outlines and damaged sections, providing a comprehensive visual reference for analysis and preservation planning. The detailed representation of the model allows for in-depth examinations of the damage, aiding in the formulation of appropriate restoration strategies and ensuring the preservation of the building's original architectural intent.

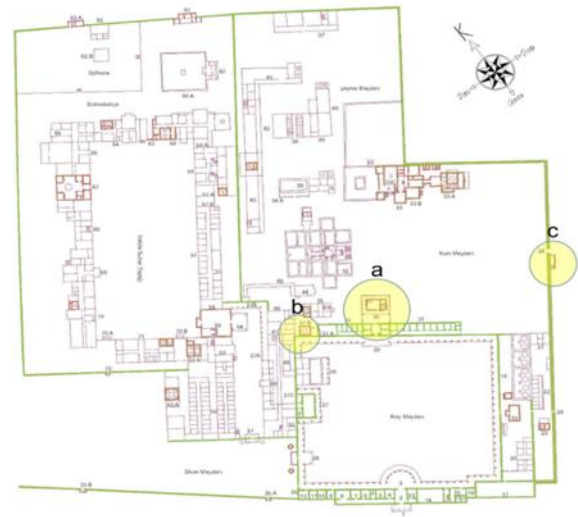
Figure 2. Areas where excavation works were carried out. a- Presentation Room b- East and north wall of the Alay Square c- Iron Gate, "Engraved from the map of the New Palace in Edirne made by Avadis Benliyan, an army journeyman"

Excavations took place in three areas: the Presentation Room, the Akağalar Wards, and the Iron Gate. The aim was for these three locations to complement each other and aid in understanding the site map. The goal was to find out where Sur-i Sultani separates the two courtyards (Alay Square and Kum Square) of the palace, following the protocol rules of the Edirne New Palace. This research aimed to create a strong foundation for planning the palace as a whole (Figure 2). Unfortunately, this is not easy to do because the New Palace has been mostly destroyed and restoration is difficult.

following the remnants of the eastern wall that borders the square and referring to Avadis Benliyan's sketches (Figure 2 - b). Geophysical studies were conducted on the northern wall of Alay Mansion to assist with future planning. Technical term abbreviations were explained upon first use. The text adheres to conventional academic structure, formal register, and clear, objective language.

The third point where the works were carried out was at Demirkapı, which opens to the Fatih Bridge, which provides access from the Kum Square to the Hasbahçe (Figure 2 - c). Demirkapı is located on the wall extending from the east of the Matbah-ı Amire parallel to the Tunca River and defining the eastern border of the Sand Square. A 19th century photograph of the gate, which is on the same axis as the entrance façade of the Cihannüma Pavilion, shows that the wall above the gate makes a curve and that there is a lead-covered, three-faceted

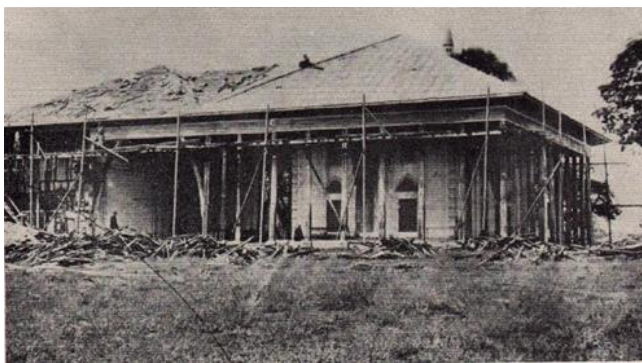
Figure 4. During the 1868 renovation, view of the Arz Chamber from the Kum Square (by Rifat Osman)

The Bâbüssaâde complex comprises the Presentation Room, a courtyard paved with marble, and four rooms allocated to the Kapı Ağası and the duty gatekeeper. These rooms are situated on either side of a small corridor accessible through a door from the courtyard, all supported by a lead-covered roof. The portico encompassing the Presentation Room on the opposite side of the Bâbüssaâde is upheld by 35 oak columns [1].

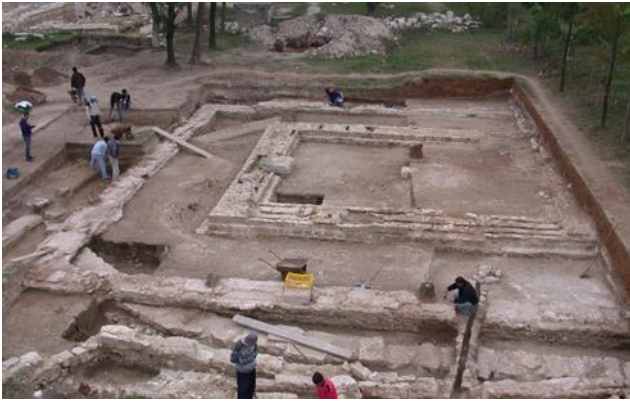
Figure 6. General view from the Presentation Room excavations. (by EYSK Archive)

As a result of the excavation in the area, we uncovered the walls that make up the Imperial Throne of the Presentation Room and the portico walls surrounding it. Figure 6 shows the walls uncovered during the excavation (Figure 6). The walls were discovered at the same height, leading us to believe that the land had been leveled and the building was subsequently removed, likely using machinery to shave it down. It is believed that the construction of the structure occurred during the building of the embankment on the south side, overlooking the sand square. The flood level of the Presentation Room was reached at the 37.67 elevation level, in the area descending down to 37.40 elevation level. Furthermore, during the drilling process, excavation of waste and clean water canalsthat belong to the palace, as part of a broader system were found at the 37.41 water level elevation [9] (Özer and Dündar 2019).

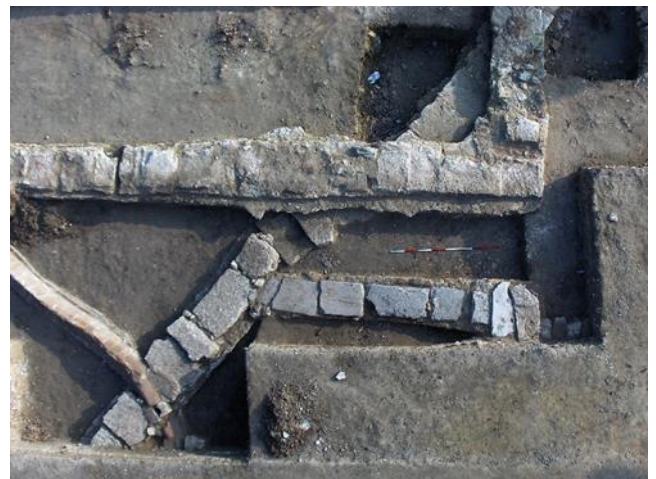
Figure 8. View from the water canals. (by EYSK Archive).

During the excavations in the area; besides the remains of the walls of the Presentation Room; water canals belonging to the palace were also encountered. There are two different types of canals; waste and clean water canals (Figure 8).

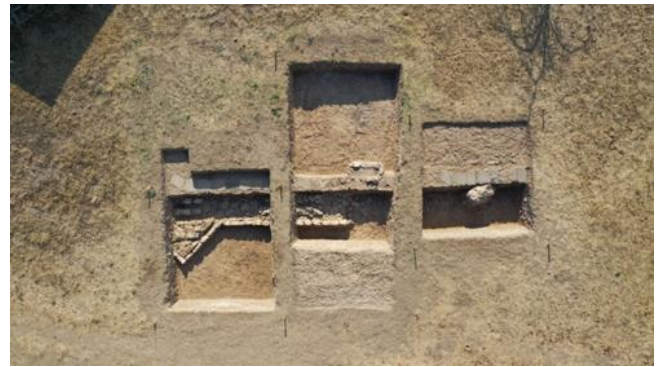
Figure 9. Alay square east wall (by EYSK Archive).

The sources were used as a basis for the study, which focused on the 5x5 m intersection of the eastern wall that separates Birun and Enderun from the northern wall. The study involved four trenches, each measuring 1.55 m. During the conducted studies, archaeologists uncovered the remnants of a wall running in an east-west direction that coincides with a wall extending from Bâbüssaâde (Figure 9).

The width of the wall, constructed with rubble stone, measures 95 cm. Additionally, three rows of foundation beam gaps, measuring 10x10 cm each, were discovered. Additionally, researchers have identified one of the triangular buttresses that extends parallel to the western wall of the eight-domed dining hall at Matbah-ı Amire, which was previously unearthed. A set of schist stones, the exact characteristics of which are not completely understood, have been found at the upper levels of the wall, resting against the section overlooking Alay Square. This finding suggests that soldiers during the Balkan Wars utilized rubble to fill the soil between walls as a temporary solution. Further data in later stages of the study may shed light on the nature of this finding.

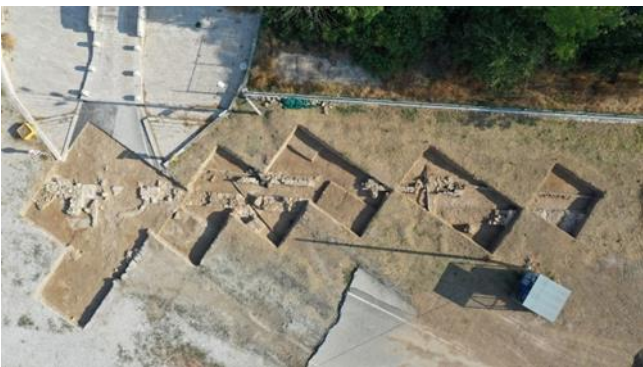
Figure 11. General view of Demirkapı and Sur-i Sultani excavation site. (by EYSK Archive)

In the first days of the works, the asphalt that was built to provide the connection between the stadium where Kirkpınar wrestling was held and Yeni İmaret Neighbourhood was dismantled. Then, at a point very close to the surface, the largely destroyed traces of Demirkapı were reached. However, no reliable plan of the remains of the gate, which was exposed to vehicular traffic for many years and pressurised during the asphaltting works, could be reached. On the other hand, one of the triangular buttresses, which can also be identified in the photograph, could be identified. In addition, the direction of the wall (Sur-i Sultani) on which the gate was placed, extending in the north-south direction parallel to the Tunca River and forming the eastern border of both Alay Square and Kum Square, could be identified (Figure 11).

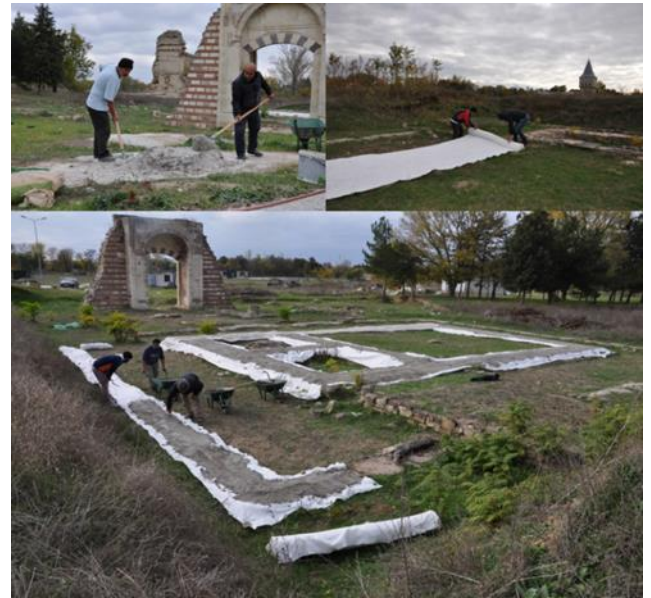
Figure 12. In-situ conservation practices (by EYSK Archive)

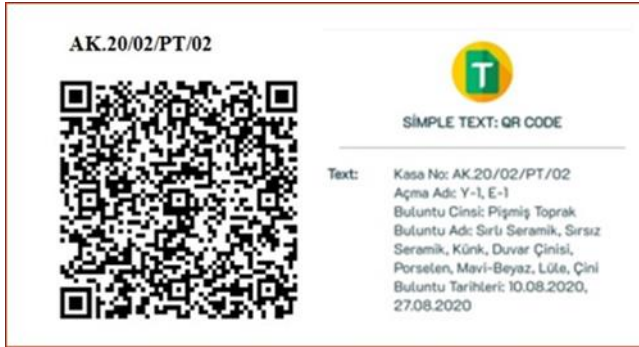
Figure 13. QR code system used in artefact storage.

system, a QR code system was introduced. In this system, the general information of the artefacts in the vault (find location, find type, find name, find dates) was transferred to the QR code via the computer. The barcodes were printed out and hung on the board. If these barcodes are scanned by downloading any QR Code programme from a mobile phone, the information about the type of finds in the vault will be accessed (Figure 13).

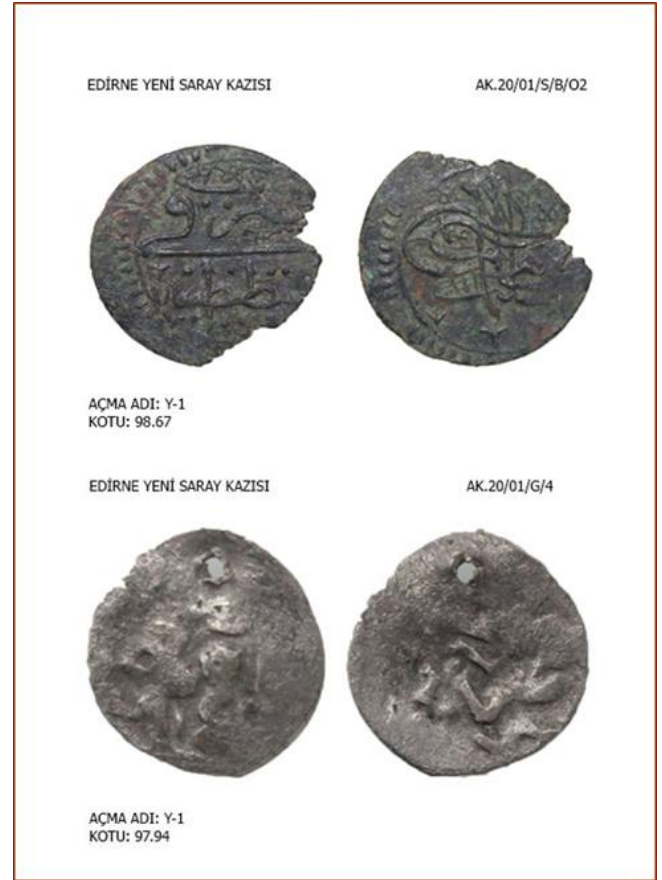
Figure 14. Examples of conserved coins (by EYSK Archive).

During the restoration and conservation works of the metal artefacts, they were firstly documented with photographs and then mechanically cleaned. With the help of small hand tools such as soft-tipped brushes, scalpels, cotton, bamboo sticks, active and passive corrosion layers on the metal surface were removed from the metal surface and the patina was preserved. The mechanically cleaned bronze finds were kept in a 3% solution of BTA (Benzotriazole) in Ethanol for 45 minutes to stabilize them against corrosion. Then they were purified in Ethanol-Distilled water solution. The surface of the mechanically and chemically cleaned metal artefacts was coated with Paraloid B72 prepared at 3% in Acetone with the help of a brush and the conservation works were finalized and stored under appropriate conditions.
