Ottoman Period of Commercial Urban Areas: Research of Manisa-Kula Conservation Area

OTTOMAN PERIOD OF COMMERCIAL URBAN AREAS: RESEARCH OF MANİSA-KULA CONSERVATION AREA¹

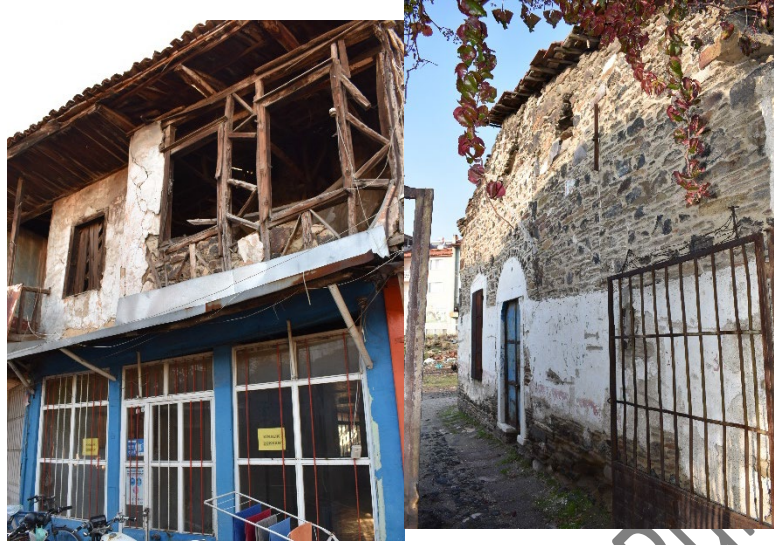
Figure 2. Veliöğlü Inn and Şapçı Inn (Personal archive)

Şapçı Inn is located on Hamdullah Street, within the urban conservation area. It is a single-storey building with a courtyard, built of masonry stone. Şapçı Inn plan scheme was shaped on a rectangular-trapezoidal form as a result of the land situation. Some of the spaces within the inn can be accessed from the street. The units in the main section are located around the courtyard. Some of these units are located back to back, while one is accessed from the street and the other from the courtyard.

Veliöğlu Inn is located within the urban conservation area, at the intersection of Hamdullah Street and 1st Street. It was built with a wooden frame construction system. While the lower floor is partially used, the upper floor is unusable due to structural problems. In the inscription of the building, it is written that it was built in H (1311) AD 1894. The building is a two-storey building with a gable roof and covered with Turkish style tiles. The lower floor of the surviving parts was built with rubble stone material. In the plan scheme, there is a courtyard in the middle and two-storey rooms around the courtyard. The single-storey shops attached to the inn are covered with vaults. It can be said that the plan of the building, which has two entrances, has changed significantly in the process.

It has been observed that Veliöğlü and Şapçı Inn, among the 1st Group cultural heritage buildings located in the Kula Urban Conservation Area, have survived to the present day. Ciğeroğlu and Zincirli Inns, whose existence is mentioned in the sources, have disappeared. According to the documents, the location of the Ciğeroğlu Inn, which has not survived to the present day, has been determined. Veliöğlü Inn was built in 1894 with a two-storey, reed-filled wooden frame technique. While some of the units on the ground floor of the inn are usable, the second floor is completely unusable.

Şapçı Inn, whose construction date is unknown, consists of single-storey shop units arranged around a courtyard in the masonry system. Most of Şapçı Inn's shops facing Hamdullah Street are in use. The shops overlooking the inner courtyard are unusable. Velioglu and Şapçı Inn, which have survived to the present day and are partially in ruins, face the threat of collapse day by day. With this; As a result of the studies carried out in the research area, 47 buildings should be preserved in their current state, 124 (80 historical buildings + 44 buildings from the republic period and after) should be preserved after simple repairs, 108 buildings should be used after major repairs, and 19 buildings should be completely demolished. It has also been concluded that the added illegal floors will be demolished.

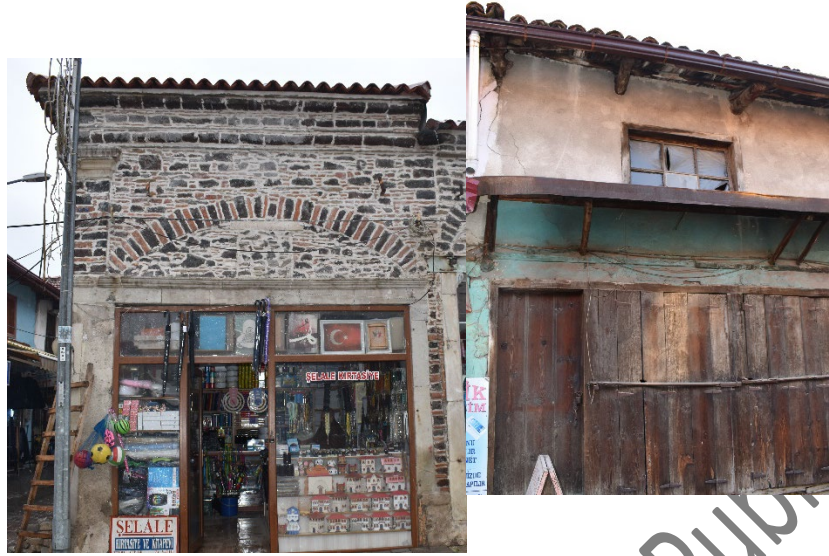
Figure 4. Masonry building example and wood frame structure example

Shops with masonry construction systems predominate in the area. There are many stone masonry walls built from volcanic "black stone" which is the local stone of the region, as well as stone/brick masonry alternating walls. Facade elements such as jambs around openings in masonry buildings, moldings at eaves or floor levels, and relief arches are also made of stone or brick.

Shops with wooden frame construction systems are generally shops whose front walls are made of carcass. The main walls adjacent to other shops must have been built with a masonry system to take precautions against fire, according to the regulations that came into force in the 19th century. The carcass walls in the area were made with post and pane filling, not lathing. It is understood from the spilled plaster parts that the inside of the load-bearing wooden frame was made of stone or brick filling. In shops with carcass walls, it is seen that the moldings around the opening, shutters, and moldings at the eaves or floor levels are also made of wood.

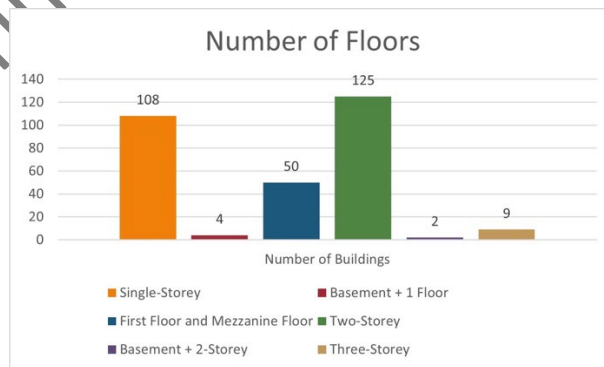
Table 1. Number of floors of buildings

When the floor numbers of 298 buildings within the boundaries of the study area were examined, the floor numbers were determined as follows:

- The number of single-storey buildings is 108,
- The number of buildings with basement + 1 floor is 4,
- The number of buildings with first floors and mezzanine floors is 50,
- The number of two-storey buildings is 125,
- The number of basement + 2-storey buildings is 2,
- The number of three-storey buildings is 9.

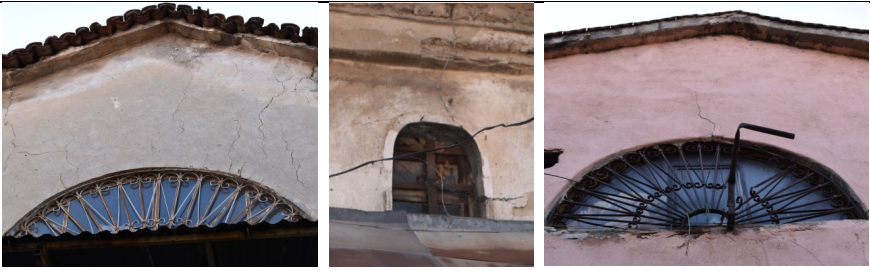
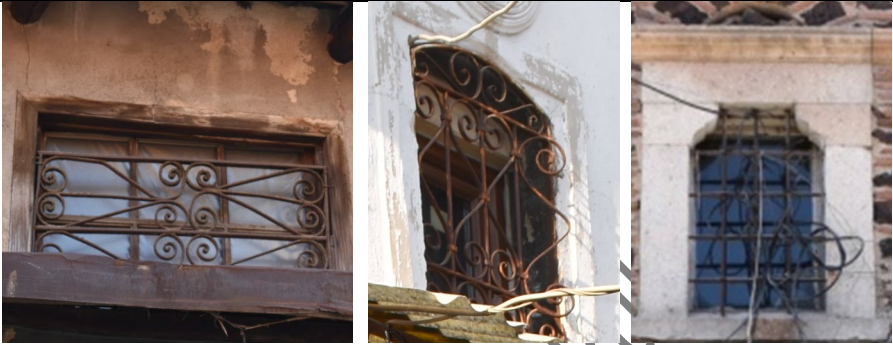
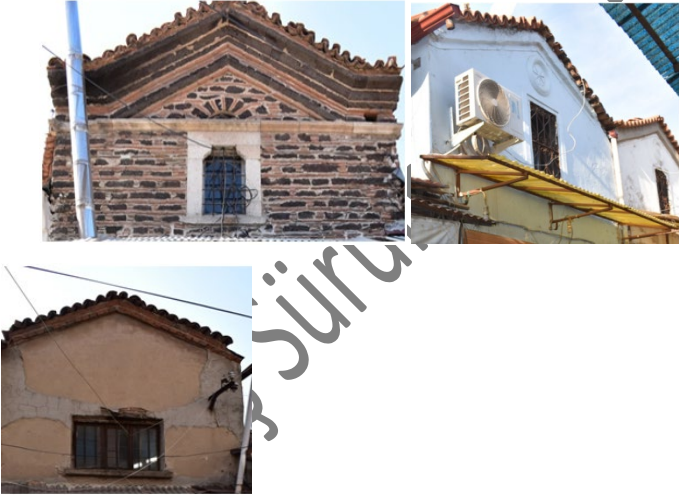
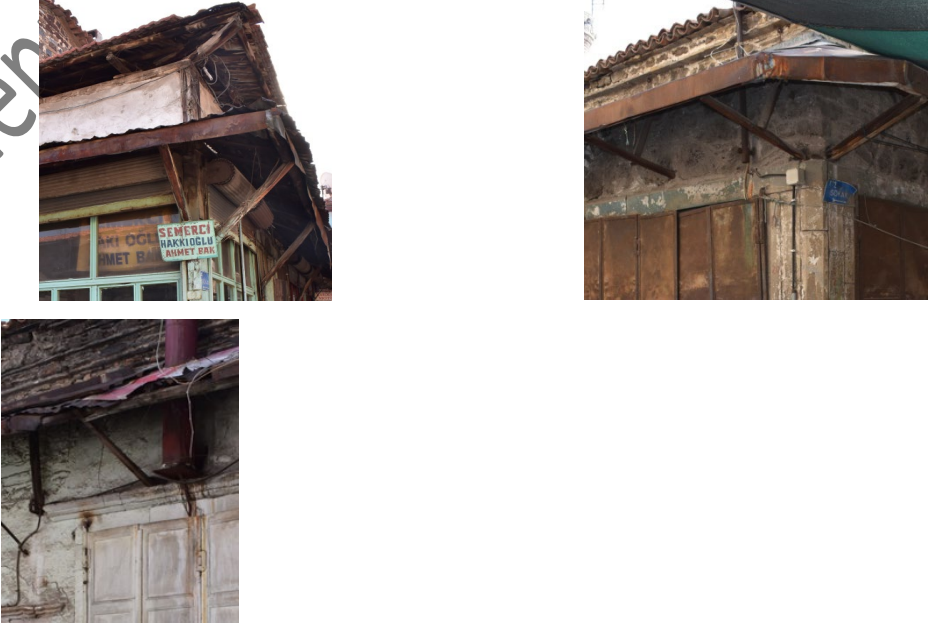
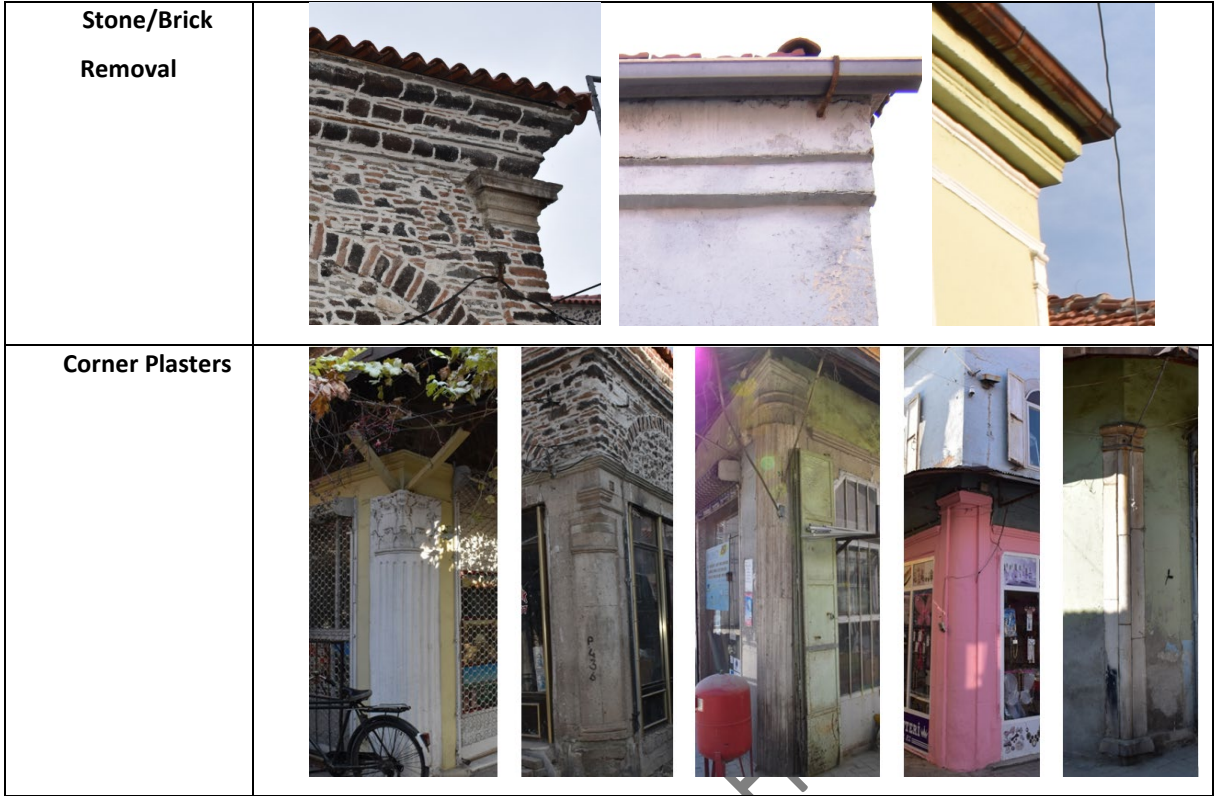
Tablo 2. Facade elements seen in shops in Kula traditional bazaar

The structural elements on the facades vary depending on the number of floors, typologies and construction systems of the shops. The shops in the Kula traditional trade area have a common architectural language. The elements that make up this common architectural language are: Wooden and metal shutters, doors and windows, triangular pediments, eye windows, iron railings, sheet metal covered wooden porches, stone/brick/wood moldings and corner plasters. Some shops are decorated with floral motifs or religious symbols such as flowers and leaves on corner placards. In addition to these facade elements, it has been observed that

iron and sheet metal doors and wooden joinery have largely survived to the present day in shops whose originality has been preserved.

Facade Elements	Photos
Metal Shutter	 
Wooden Shutter	 
Doors/Windows	 
Arched Doors/Windows

<p>Eye Window</p>

<p>Iron Fence</p>

<p>Triangle Pediment</p>

<p>Wooden Porch</p>

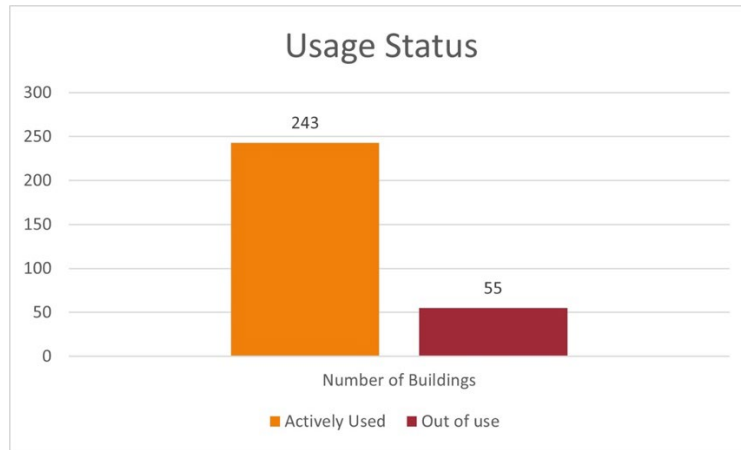
Table 4 . Usage Status of The Buildings

While the majority of the buildings in the Historical Trade Zone are actively used and continue their commercial activities, the remaining few are unused. When the usage status of 298 buildings in the study area was examined, it was determined that 243 buildings continued to be used and 55 buildings were no longer used.

When the usage status of the buildings is examined, the figures determined show that this commercial area is still actively used as a trade center. The ratio of the number of actively used commercial buildings to unused ones is approximately five times.

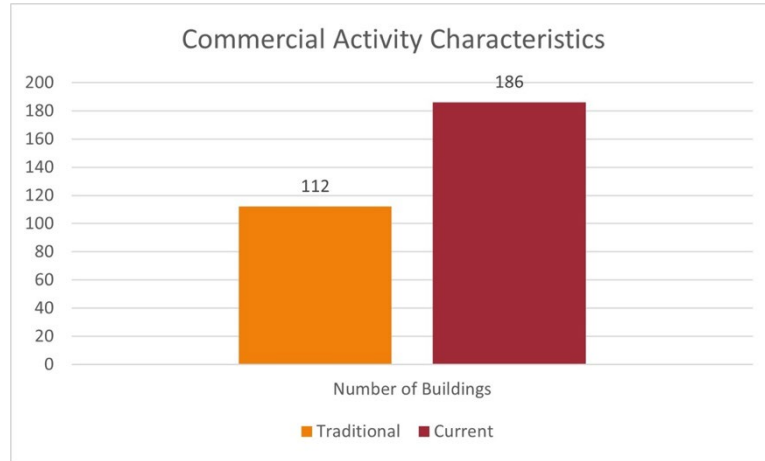
Table 6. Characteristics of commercial activities carried out in buildings

When the activity characteristics of 298 buildings within the boundaries of the study area were examined, it was determined that the number of buildings with traditional commercial activities was 112 and the number of buildings with current commercial activities was 186.

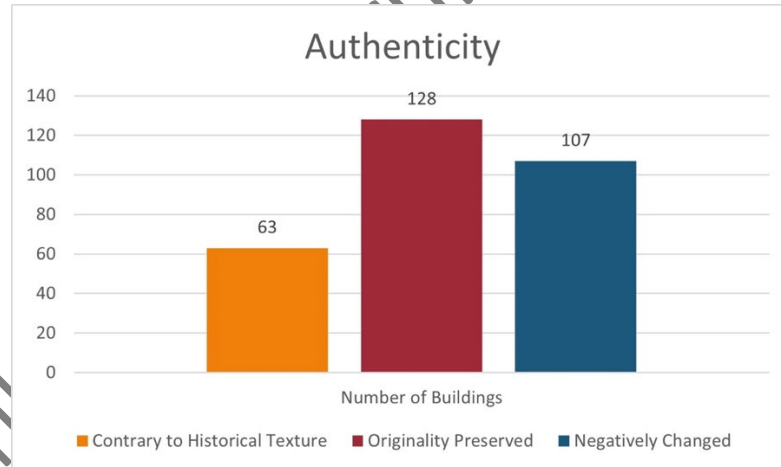
Table 8. Authenticity of buildings

Closing windows and doors or changing their dimensions, adding floors, interventions in the mass and material of the building that differ from its original state, changes in the plan and facade layout and similar interventions have caused the original architectural features of the buildings to deteriorate. Unlike these mentioned structures, there are also structures built in recent times within the boundaries of the study area. Since these buildings were built using today's construction techniques and materials, they are not suitable for other historical buildings in the historical texture, both in terms of construction techniques, use of contemporary materials, and number of floors. For this reason, three criteria were created to examine the authenticity of the structures in the study area regarding the conservation problems. These are "Contrary to Historical Texture, Originality Preserved, Negatively Changed".

When the originality status of 298 buildings in the study area was examined, the number of buildings contrary to the historical texture was determined as 63, the number of historical buildings with preserved originality was 128, and the number of qualified historical buildings that had undergone negative changes was 107.
