# Renovation Requirement for Dairy Cattle Barns and Two Renovation Models For Existing Dairy Barns in Bursa[*]

## Erkan Yaslioglu[1*] ,Ercan Şimşek[1], İsmet Arici[1]

**Abstract:** In this study, the needs for renovation of dairy cattle barns in Bursa, Turkey were discussed and selected two tie-stall barns were converted to free-stall barns. Renovation costs were calculated and compared with new barns in similar capacity and type. In dairy cattle farm number I and II, renovation costs for barns were calculated as $ 25.060 and $ 4.993 respectively . The overall renovation costs including milking facility were determined as $ 41.460 and $ 25.050 respectively. Renovation costs per cattle were $ 1.275 and $ 520 respectively. With the renovation working, housing conditions were improved; labor requirements and difficulties in labor using were decreased.

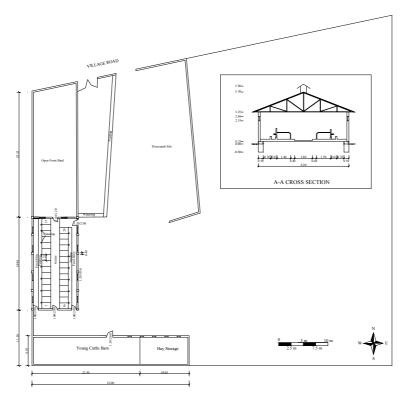
**Figure 2.** Existed Farmstead Layout for Enterprise I

Barn width, barn height and total windows area were insufficient windows were served as air inlet openings and its height was 2.35 m from the ground. Total windows area was 6,0 $m^2$ and window / floor area ratio as a natural lighting criterion was 5 %. Three chimneys with 0.60x0.40 m sizes located on the ridge were serving as air outlets. Ventilation capacity (2740 $m^3h^{-1}$) was lower than the minimum ventilation requirement (4644 $m^3h^{-1}$).

Feeding type and feed alley width (1.00 m) was not suitable for mechanical feed delivery equipment (Figure 2). Wheelbarrow was used for feed delivery. Manure was removed from the barn manually. Excessive labor use and hard working conditions were the most important problems. Time consumed for feed delivery, manure hauling and milking was two, two-half and three hours per day, respectively. Milking was performed two times per day with bucket milking systems. Figure 2. Existed Farmstead Layout for Enterprise I.

To provide a better indoor environment, efficient labor use and hygienic milking operation, existing tie-stall barn converted to two-row free-stall barn with 33 dairy cattle, which is suitable for adaptation of new technologies (Figure 3).

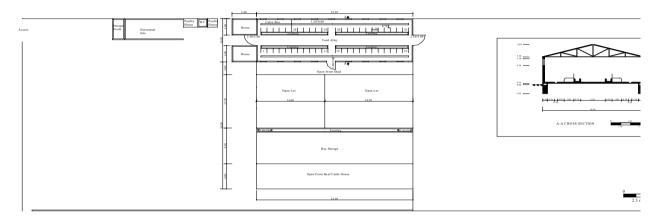
**Figure 4.** Existed Farmstead Layout for Operation II

Barn width, ridge height and total windows area were 10.30 m, 4.80 m and 16.32 $m^2$, respectively. Windows were serving as air inlet openings and the distance from the ground to the bottom of windows was 2.30 m. Total window / floor area ratio as a natural lighting criterion was 5 %. Continuous ridge opening with 0.30 m width were serving as air outlet. Ventilation capacity was calculated and it seemed to be sufficient. In winter, the barn windows closed by farmer for fear the cold weather would have an adverse effect on cattle.

Feed through and feed alleys were located in center of the barn. Feed alley width was 2.50 m. Feeding type is inappropriate for mechanical feed delivery. Position of the feed alley and use of bucket milking system made milking and manure hauling difficult and time consuming. The survey concluded that milking was performed two times per day and total time spending for milking, manure hauling and feed delivery were three hours, two hours and two hours, respectively. Calves and mature animals were sheltered in the same barn. There was no manure storage structure. Manure was stored on the ground in solid form.
