Post-Earthquake Forensic Examination of Two Unreinforced Masonry Buildings via Discontinuum-Based Analysis

Andrei FARCASIU[1]
Peter GRIESBACH[2]
Rhea WILSON[3]
Sinan ACIKGOZ[4]
Bora PULATSU[5]*

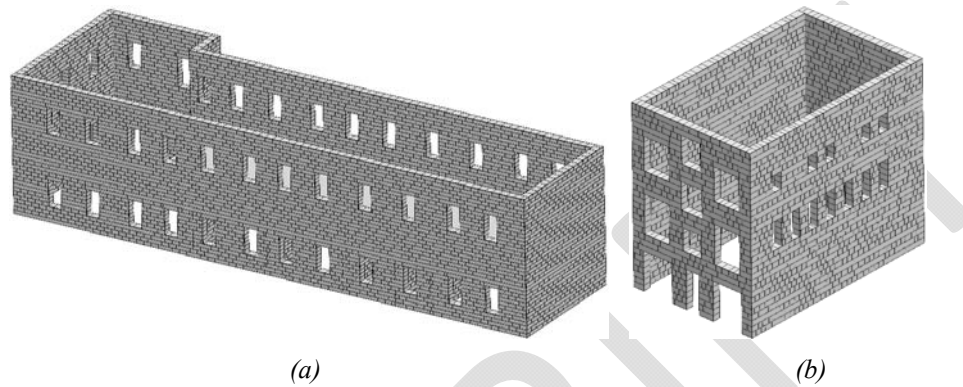
Discrete block models of the two case study buildings, Mithatpaşa and Liwan Hotel, are generated following the automatic generation procedures outlined in the previous section (see Figure 7a and b, respectively). A regular masonry pattern is adopted for the Mithatpaşa case study based on the available on-site information. In contrast, less information is available for the Liwan Hotel masonry pattern, leading to the generation of three different morphologies. Then, discrete block models are used to conduct nonlinear quasi-static (pushover) seismic analysis. Several analyses are applied to assess the influence of various aspects on the failure mechanisms of the buildings.

Figure 7 - Discrete block representation of analyzed buildings: (a) Mithatpaşa Primary School, (b) Liwan Boutique Hotel.

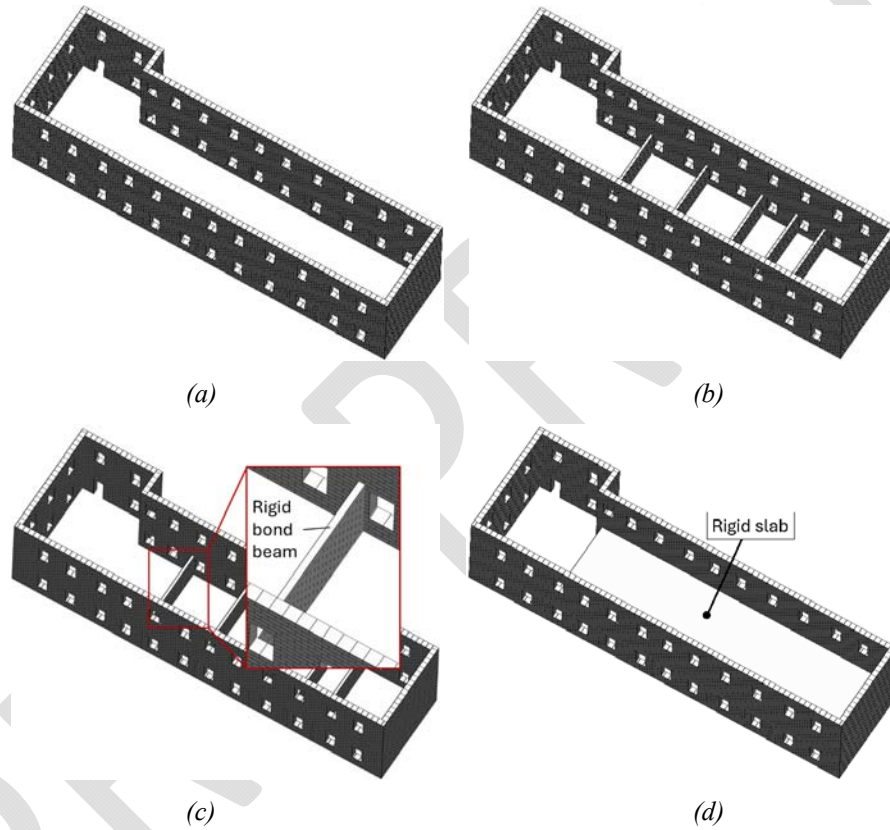
The failure mechanisms and the associated maximum accelerations are given in Figures 9 and 10, respectively. Results indicate a combined out-of-plane arching action with the overturning mechanism of the façade along the entire wall length when the interior walls are neglected (*Config#1*, Figure 9a). While this mechanism is likely to occur if there is no proper diaphragm action, the extruded portion of the building demonstrated almost no damage, as mentioned earlier. The lack of damage is attributed to the retrofitted stair and floor structure in this section of the building. Hence, the boundary conditions are updated, and in the second structural configuration, the extruded portion of the building is fixed in place, denoted as *Config#2*. The performed update yields a local overturning failure at the second storey, as shown in Figure 9b. The following iterations introduce five interior walls along the ground floor. Both simulations are executed without and with the extruded section fixed. The former

(*Config#3*) leads to a failure mechanism along the entire length of the second storey (Figure 9c), while the latter (*Config#4*) provides a better match compared to on-site observations (Figure 9d). Further adjustments are adopted by introducing rigid continuous beams (bond beams) along each partition wall, partially restricting the displacement of interior URM walls and providing limited diaphragm action (*Config#5*). Finally, a very similar collapse mechanism is noted when the bond beams are replaced with a rigid floor slab (*Config#6*), as shown in Figure 9e. The results indicate that the localized overturning mechanism at the upper storey can be attributed to a lack of orthogonal load-bearing walls or a roof structure that can provide diaphragm action in the second storey of the building.

*Figure 9 - Predicted collapse mechanism of Mithatpaşa building considering different structural configurations: (a) **Config#1**: No internal walls, (b) **Config#2**: No internal walls – extruded portion fixed, (c) **Config#3**: Addition of the internal walls, (d) **Config#4**: Internal walls – extruded portion fixed, (e) **Config#5**: Internal walls with rigid bond beam – extruded portion fixed and (f) **Config#6**: Internal walls with rigid slab - extruded portion fixed.*

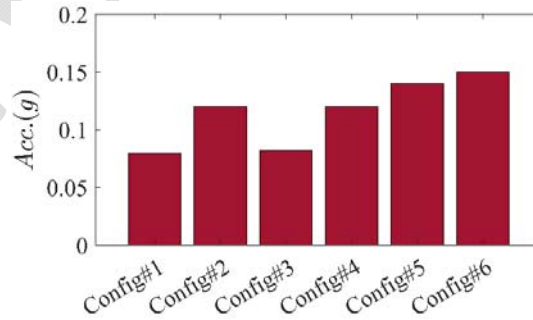
In Figure 10, the accelerations required to cause collapse according to the nonlinear quasi-static analyses are provided for each structural configuration. The results underline the positive influence of the adopted bond beams and slabs on the lateral load carrying capacity of the URM buildings, denoted in *Config#5* and *Config#6*, respectively. Interestingly, the interior orthogonals walls in *Config#4* also have a similar effect on the response.

Conversely, the lack of either a stiff diaphragm or orthogonal walls yields considerably lower capacity, as depicted in Figure 10 (*Config#1*). The remaining case studies (from *Config#2* to *Config#4*) provide seismic resistance bounded by *Config#1* and *Config#5*. According to Bozyigit et al. [28], the peak ground acceleration in the N-S direction of the nearest seismograph (3115) for the 6[th] of February Pazarcik earthquake was 0.33*g;* all the examined configurations would be expected to fail according to the analyses. However, the analyses provide more insight into how the failures may have occurred. If combined with detailed material characterization, they can produce more definitive estimates of collapse accelerations. This has not been attempted in this study, which is focused on developing more qualitative forensic understanding of behavior.

Figure 10 - Lateral acceleration required for collapse in different structural configurations.

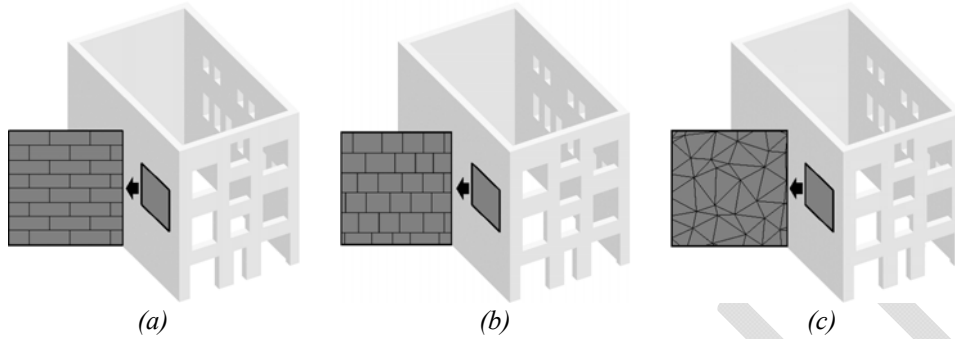
As shown in Figure 11, three wall morphologies are investigated. For the periodic pattern, two cases are considered: one with a vertical corner joint, offering no interlocking between the orthogonal walls (LH#1 and LH#1wR), and the other with a staggered joint linking the two walls (LH#1 and LH#1wR). For the nonperiodic morphologies, a staggered joint is always used. However, it can be visually observed from Figure 11 that the interlocking for the irregular masonry pattern with horizontal courses is likely to be better than the one without the horizontal courses (*e.g.*, the rubble morphology).

Figure 11 - The investigated URM construction morphologies: (a) periodic, (b) nonperiodic with horizontal courses and (c) nonperiodic without horizontal courses (rubble).

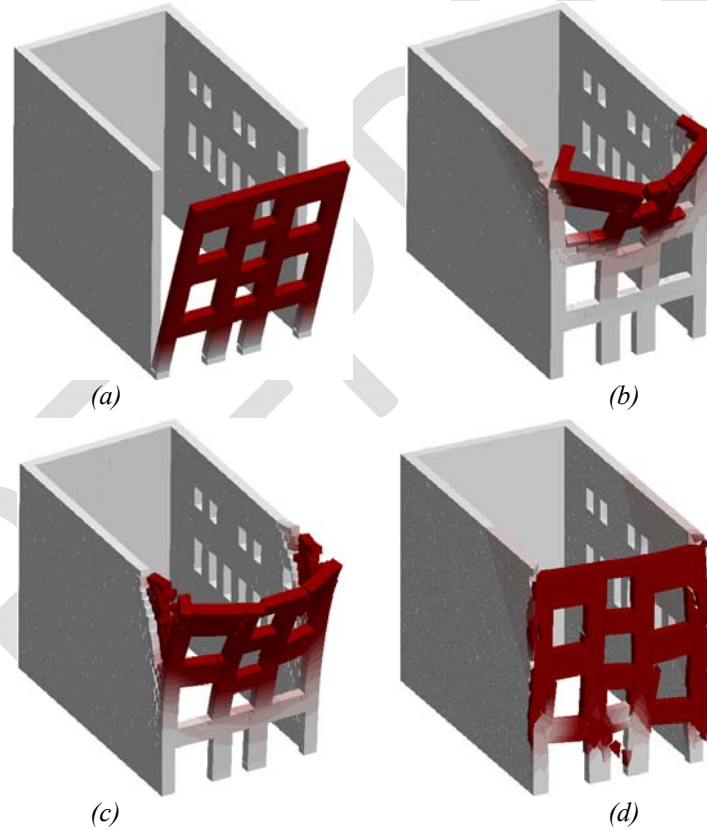
Figure 12 - Predicted collapse mechanisms considering different construction morphologies without any horizontal diaphragm: (a) periodic masonry, vertical joint between front façade and orthogonal walls (LH#1), (b) periodic masonry, staggered joint between front façade and orthogonal walls (LH#2), (c) nonperiodic masonry walls (LH#3) and (d) rubble masonry walls (LH#4).

The predicted collapse mechanisms are shown in Figure 12 and Figure 13, for buildings without and with a rigid roof diaphragm, respectively. Given the detachment of the façade from the roof in Figure 1b, the roof is not considered at first. In Figure 12a, the failure mechanism of (LH#1) is presented where only the front façade overturns. In comparison, the same running bond construction with the addition of staggered joints at the intersection of the orthogonal walls (LH#2) demonstrates a partial façade collapse mechanism localized at the upper floors of the building (Figure 12b). Figure 12c and Figure 12d show the results of nonperiodic constructions: (LH#3) describes a building with horizontal courses, and (LH#4) a rubble construction without horizontal courses. The results show that LH#3 involves a failure mechanism involving the longitudinal walls, with diffuse joint openings. In contrast, the rubble morphology in LH#4 fails by masonry disaggregation prior to the formation of a local failure mechanism.

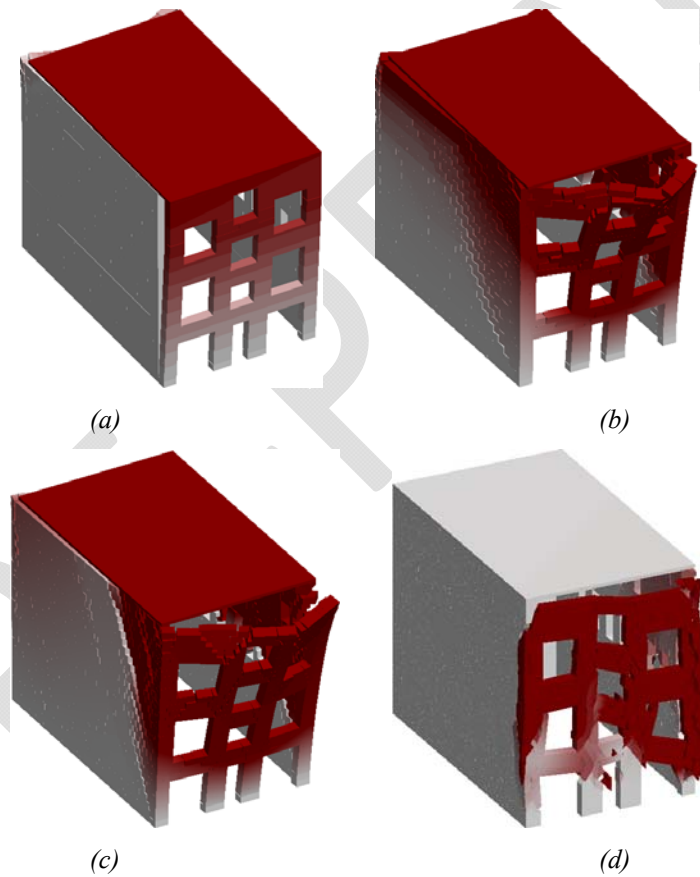
Figure 13 - Predicted collapse mechanisms considering different construction morphologies and considering a rigid roof diaphragm: (a) periodic masonry, vertical joint between front façade and orthogonal walls (LH#1), (b) periodic masonry, staggered joint between front façade and orthogonal walls (LH#2), (c) nonperiodic masonry walls (LH#3) and (d) rubble masonry walls (LH#4).

Only frictional resistance is considered in the computational model to replicate the poor bonding between the roof and the supporting walls. In this case LH1wR (Figure 13a) yields a one-way bending behavior with a total separation of the front façade from the rest of the building due to the partial dead load of the roof. This does not match the partially collapsed state of the building in Figure 1b, where the failure mechanism also involves the side walls. LH#2wR considers good connections between orthogonal walls and extends the failure mechanism to the longitudinal walls (Figure 13b). The results highlight the critical influence of connection details. However, this still does not capture the failure mode observed in the building. The nonperiodic masonry cases (LH#3wR and LH#4wR) are also investigated. The results show that LH#3wR experiences significant in-plane deformations near the centre of the western façade (indicating increased participation of the orthogonal wall in the collapse mechanism with respect to Figure 12c), similar to LH#2wR, while the rubble masonry texture again fails by disaggregation, as shown in Figure 13d. The disaggregation response is not significantly influenced by the additional frictional restraints provided by the roof structure; the poor construction quality dictates the disaggregation failure prior to the formation of any other local response mechanisms.

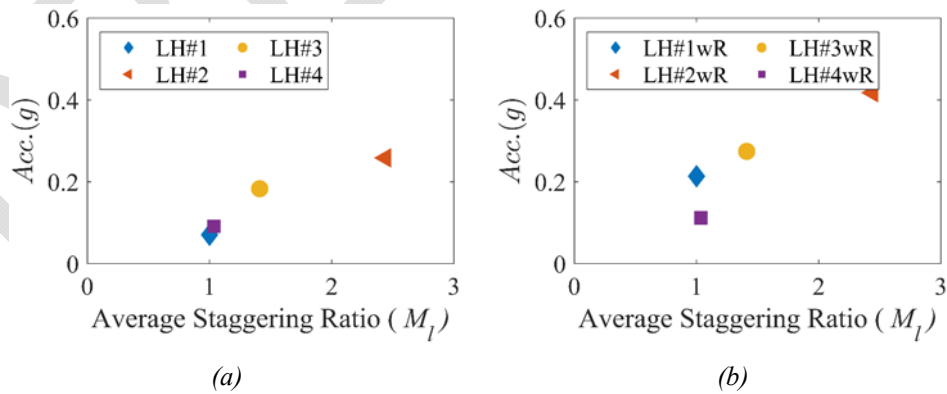
Finally, Figure 14 shows the lateral collapse acceleration obtained from the nonlinear quasi-static analysis for each wall configuration and their associated corner average staggering ratio (M_l). Note that this ratio is computed at the intersection between the front façade and perpendicular walls since the failure is governed by the detachment of the front façade and, eventually, the vertical overturning mechanism. The results indicate that the lowest seismic multiplier is obtained for the rubble masonry building (LH#4 and LH#4wR), which has experienced a wall disaggregation failure. A slight increase in accelerations is noticed for the failure of the structure where no connection is present between the front façade and side walls (LH#1 and LH#1wR). However, both configurations underline the vulnerability of the buildings to poor corner detailing. The highest seismic capacity is obtained for the running bond pattern with and without roof diaphragm (LH#2 and LH#2wR), demonstrating the positive influence of construction morphology. Nonperiodic wall constructions with horizontal courses (LH#3 and LH#3wR) indicate an intermediate seismic capacity. The positive influence of the roof diaphragm can be associated with notable increases in seismic capacity for all cases except LH#4 and LH#4wR.

Figure 14 - Lateral accelerations associated with predicted collapse mechanism and masonry construction morphology: (a) without a rigid roof and (b) including a rigid roof.

According to Bozyigit et al. [28], the peak ground acceleration in the E-W direction of the nearest seismograph (3132) for the 6[th] of February Pazarcik earthquake was 0.54g; all the examined configurations would be expected to fail according to the analyses. However, like the case study before, the analyses provide more insight into how the failures may have occurred.
