Çiğdem Ceylan
İnönü University, cigdem.ceylan@inonu.edu.tr, Malatya-Turkey
Mehmet Önal
İnönü University, mehmet.onal@inonu.edu.tr, Malatya-Turkey

INVESTIGATION OF THE EFFECTS OF DETONATIONS NEAR THE BATTALGAZİ CAMPUS OF İNÖNÜ UNIVERSITY, MALATYA, TURKEY ON SOIL SHALLOW-DEPTH

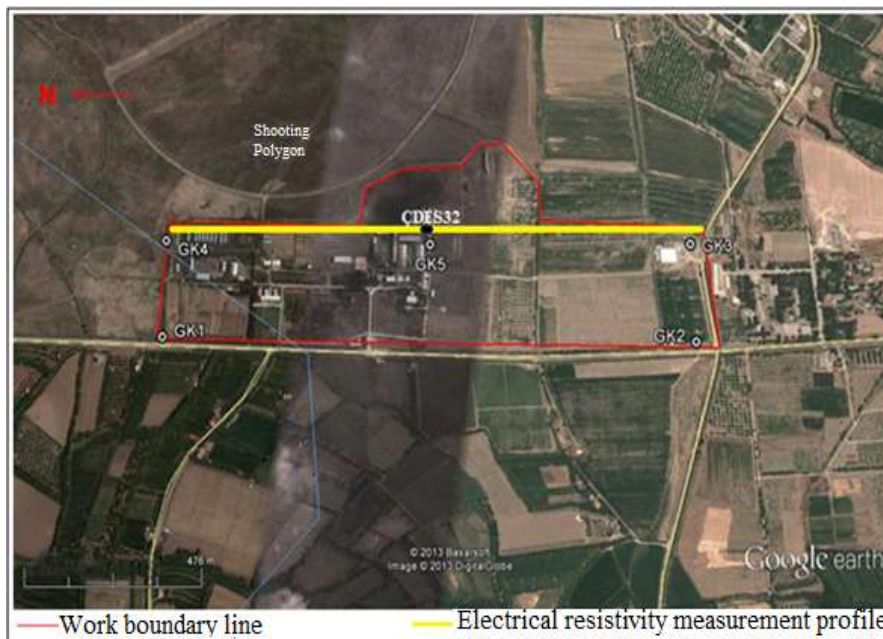
Figure 3. Observation wells used to measure the ground water levels in the study area

Soil classification was performed in accordance with the data and the Unified Soil Classification System (USCS). To determine the annual change in ground water levels, five of the soil drill wells were used as observation (OW) wells (Figure 3). For every month in one year, ground water levels (GW) were measured and recorded (Table 1). In the study, data obtained from the tests performed on samples collected from observation wells was used. Ground water level in the study area varied between 2.29m and 6.42m. Table 1 reveals that the lowest ground water level was observed in March. In the region, which is mostly an agricultural region and in which seasonal precipitation is low, with the initiation of the irrigation season due to increasing temperatures, ground water levels increased after April. From the three 50 m-deep wells drilled for irrigation purposes in the campus site, an average of 50 l/s water is obtained. This indicates that the study area is groundwater-rich.

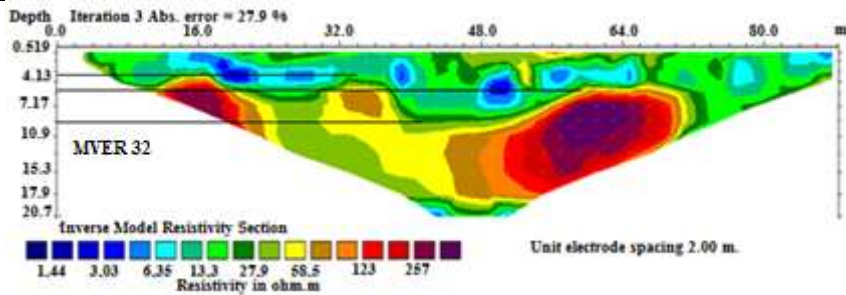
a. Pre-detonation (September, 2013)

Figure 4. Results of the multielectrode vertical electrical
resistivity measurements at the NS direction
a)Before detonation; b)After detonation

The change from light to dark indicates that the relevant unit thickens from light to dark. The comparison of the pre-detonation and post-detonation figures in Figure 4 clearly reveals that, at the 16.0 and 80.0 points, the silt unit above the sand-intercalated gravel unit was pushed towards the surface. In the study carried out at the NS direction, according to the measurements taken at the direction no. MVER 32 from north to south, at point no. 32, silt and clay-intercalated sand unit and the silt unit were pushed to 7m, while they were previously 4 m-deep; at point no. 56, they were pushed to 9.5m, while they were previously 6.5 m-deep. Again, at points no. 16 and 80, the silt unit above the sand-intercalated gravel unit was pushed towards the surface. The differences between pre-detonation and post-detonation measurements reveal that the detonations carried out in the military area had affected the shallow soil. To clearly observe the unit, a test pit was drilled at approximately 150 m east of the MVER 32 direction and well no. OW5, near the shooting range (Figure 5). In the 10m-long, 4m-deep and 1m-wide pit, a 2.5m-thick clay unit was observed towards the surface and a dense silt unit was observed towards the lower levels. The units in the study area are generally in a horizontal position. However, as can be seen in Figure 5, there are deviations from the horizontal position in between the silt and clay units. This change in form is attributable to the impact of detonations on the loose and near-surface unit. Ground water in the study area is quite close to the surface. The data on drinking water and irrigation water in the region shows that these wells have high

- In Figure 4, according to the measurements taken at the direction no. MVER 32 from north to south, at point no. 32, silt and clay-intercalated sand unit and the silt unit were pushed to 7m, while they were previously 4m-deep; at point no. 56, they were pushed to 9.5m, while they were previously 6.5m-deep.

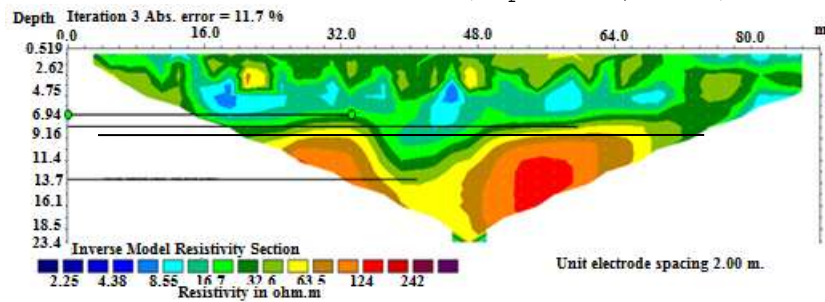
b. Post-detonation (December, 2013)

Again, at points no. 16 and 80, the silt unit above the sand-intercalated gravel unit was pushed towards the surface. The differences between pre-detonation and post-detonation measurements reveal that the detonations carried out in the military area had affected the shallow soil. Similar deformation traces are also observed in figure 5. According to these deformations, it can be said that detonations are effective in the shallow soil depth.

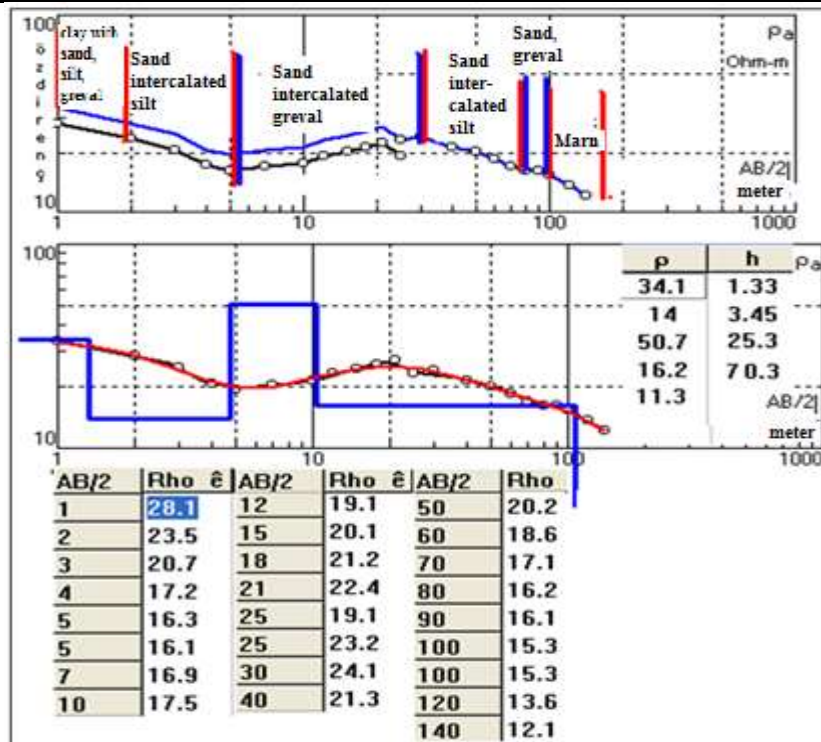
Figure 6. Electrical resistivity values of the MVER 32 measurement
points

This can be attributed to the plastic properties of clay. Resistivity values of silt, silted-sand, sandy and silted-clay units were similar to each other. Resistivity values increased with increasing sand ratios in the units. The high resistivity values of graveled-sand units indicate that the units were firm within themselves. According to the measurements, the units from the surface to bottom layer were: between 0-1.3m, silt-intercalated sand; between 1.3-5m, gravel and silt-intercalated sand; between 5-30m sand-intercalated gravel; between 30-100m silt-intercalated sand; between 100-140m, marl unit.
