# Fracture Analysis of a Case-Hardened Kingpin

<sup>1</sup>Totomak A.Ş., İzmir, Turkey

<sup>2</sup>İzmir Katip Çelebi University, Dept. of Materials Science and Engineering, İzmir, Turkey

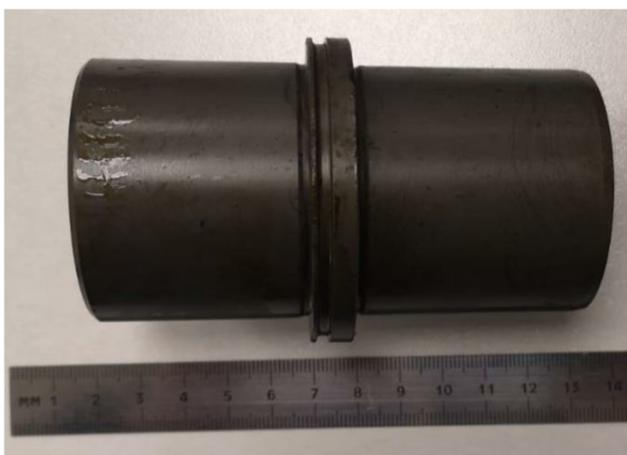
**Figure 1.** Images of the (a)original, and (b)broken kingpin part

The spectral analysis, metallography and fractography studies, SEM analysis and hardness tests were carried out for the 16MnCr5 steel parts, respectively. The image of the kingpin part broken in assembly lines is shown in Figure 1. The chemical composition of the analyzed 16MnCr5 steel is shown in Table 1, and the mechanical properties are given in Table 2.

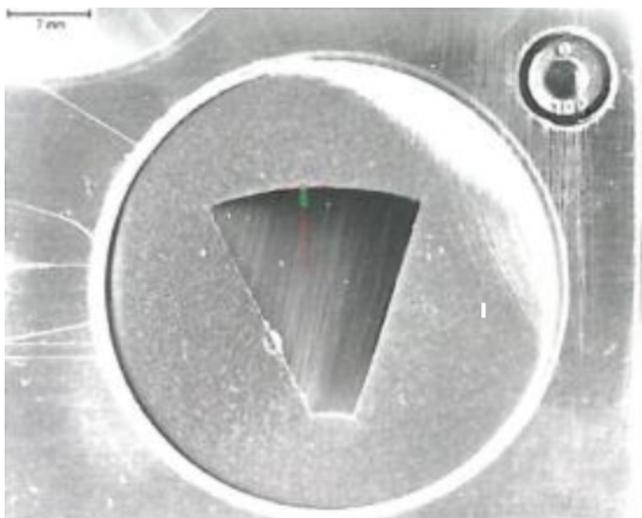
Figure 9. Prepared hardness test sample from the radius area

The polished cross section prepared from the radius area of the part is shown in Figure 9, and the hardness test results are given in Table 3 and Figure 10. It is known that Bainite phase is formed at slower cooling rates more than that for martensite formation and faster than that for ferrite and pearlite microstructure and martensite is formed when the cooling rate from austenitic microstructure is sufficiently fast. So, these hardness results confirm the microstructural analysis mostly.

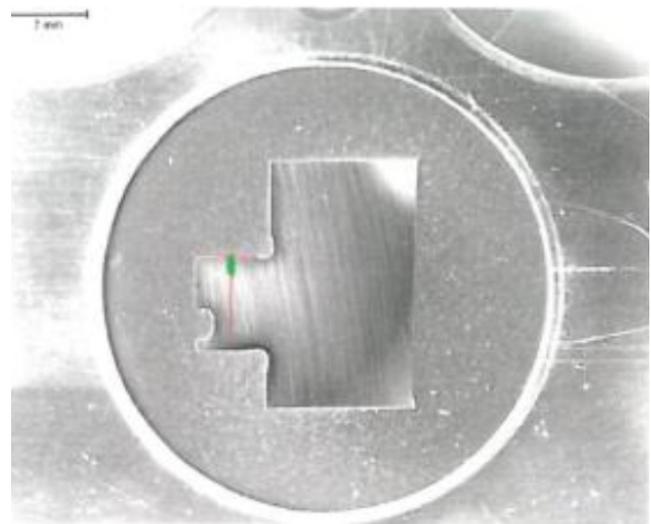
Figure 11. Prepared hardness test sample from the fracture area

The polished cross section prepared from the fracture area of the part is shown in Figure 11, and the hardness test results are given in Table 4 and Figure 12.
