Restoration Project of Central Cedit Mosque in Erzurum

Kevser ÇELTİK ŞAHLAN^{1,*}

Abstract

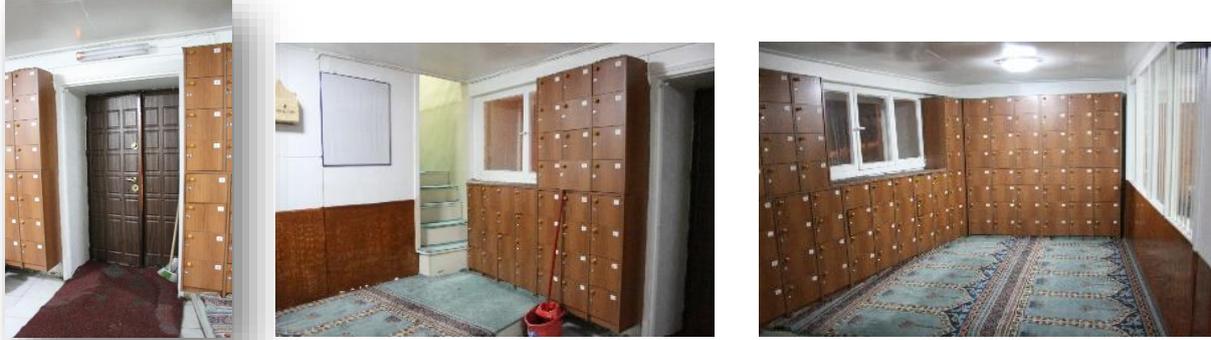
Figure 4. The last prayer hall

Access to the women's praying place is via the "L" shaped wooden staircase in the northwest corner of the last prayer hall. Shoe lockers are located on the east and south walls of this section. To the north is a rectangular, double-leaf wooden door that forms the entrance to the prayer hall in the centre. On both sides of the door, four rectangular glass elements separated the prayer room and the last prayer hall. The last praying section, has a flat wooden ceiling and a tiled floor in the middle and is slightly raised on both sides (Figure 4)

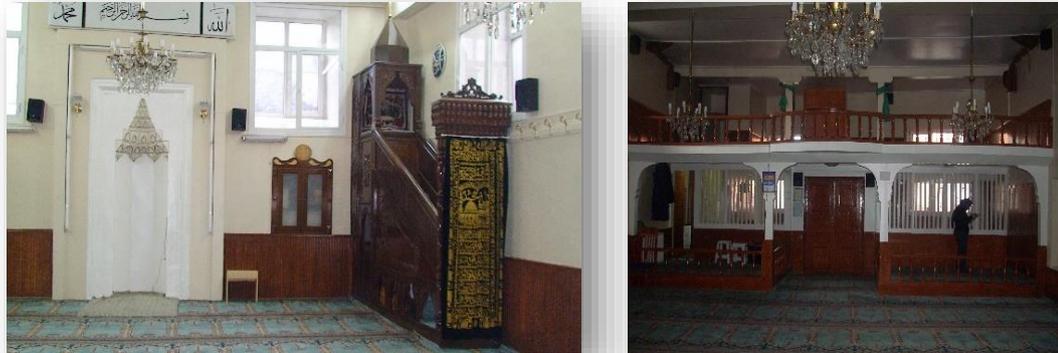
Figure 5. Praying hall - mihrab - minbar - Women's praying place

The mihrab in the centre of the south facade of the praying hall is made of cut stone. The mihrab niche is five-sided. The niche consists of six rows of muqarnas. The wooden minbar, which was placed parallel to the southwestern wall, has no historical and aesthetic features. It is believed to have been erected in the late period.

Worn and mechanically weakened wood materials should be strengthened to extend their lives. Even if no severe physical damage to the minbar is observed, it is necessary to provide it with a suitable surface protection to prevent possible deterioration. For this purpose, an acrylic resin can be used as a suitable surface protection agent. The prepared solution is applied to the surfaces with a brush.

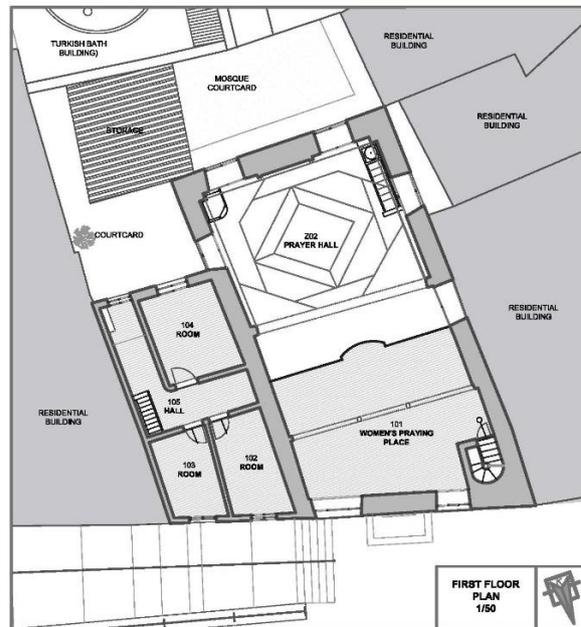
Figure 6. Plan of the Women's praying place

The women's praying place in the north of the building is supported by four wooden posts, two of which rest against the wall. The wooden posts are connected by three arches (Figure 6). The terraces raised on either side of the entrance door to the praying hall in the lower part of the women's praying place are bordered by wooden railings. The upper floor of the women's praying place is opened to the second floor of the last congregation place with a beam thrown in the east-west direction, supported by two wooden posts. The upper floor of the mahfil projects into the praying hall with an arched balcony in the centre. The staircase that provides access to the second floor of the women's praying place, open to the mahfil with a door that is rectangular shape at the top. The ceiling of the women's praying place is made of flat wood. On the second floor of the women's praying place two vertical rectangular windows on the north side are made of plastic and have iron railings from the outside. The walls of the women's praying place are also covered with wooden cladding up to a height of 90 cm above the floor.

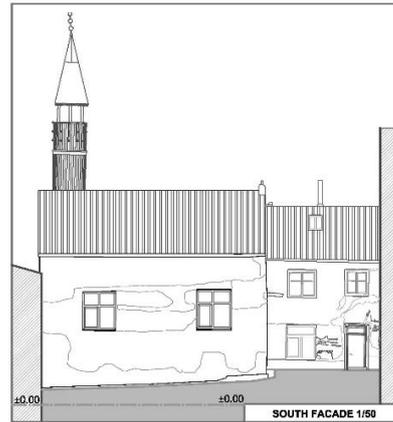
Figure 8. South facade

Since the building is contiguous, it has very few facades to the east and west. The building was plastered with cement mortar on the east, west and south facades, and there are two windows on the east facade and one on the west facade. (Figure 8). The 16.30 m high minaret, located in the northwest corner of the mosque, has a wooden frame covered with sheet metal. The roof of the building is a hipped roof and covered with sheet metal.
