## Thermal image analysis for fault detection of PV systems in Ankara/Turkey

Hale Bakır<sup>1\*</sup>,

(1st International Conference on Engineering and Applied Natural Sciences ICAENS 2022, May 10-13, 2022)

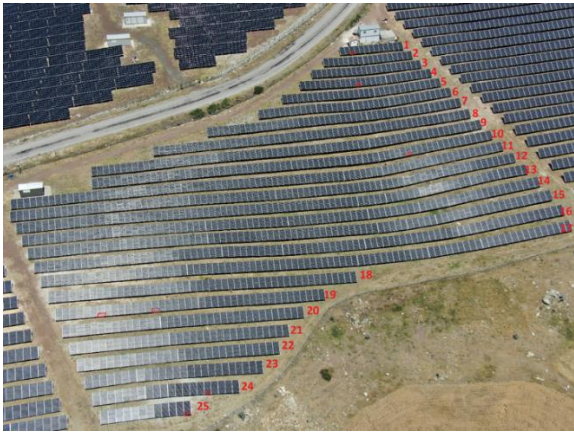
Fig. 3 2.7 MW solar power plant captured by drone

In this study, fault analysis and detection were carried out in a 2.7 MW solar power plant using a thermal drone in the field. The image taken by the drone of the power plant is given in Figure 3. Table 1 gives the drone flight information used while testing the 2.7 MW solar power plant.
