Detection of micro-cracks in PV system using electroluminescence (EL) testing

Hale Bakır^{1,*}

¹ Department of Electronics and Automation, Sivas Cumhuriyet University, Sivas, Türkiye

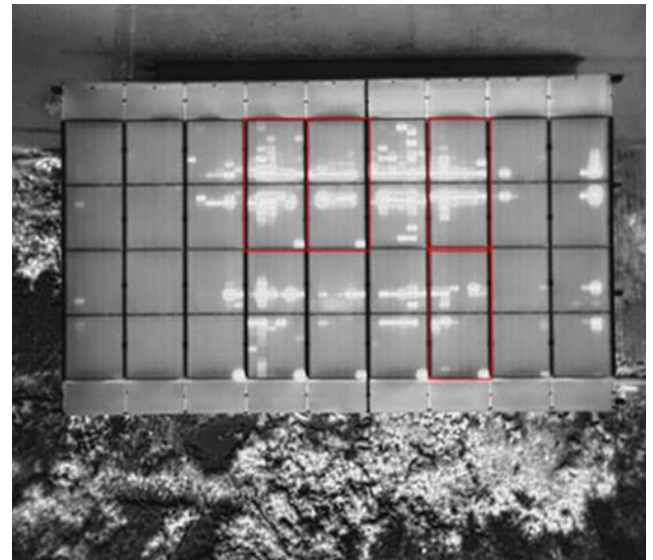
Figure 3. Solar power plant

Panels tested by EL camera are shown in Figure 3. EL images taken with an electroluminescence test device are shown in Fig. 4-5. In Figure 4(a), the broken cells are seen in the darkest black areas with the EL test. In total, 8 broken cells were detected, as can be seen in Figure 4 (a-d). The problem cell is shown in Figure 5(a) with the EL test. In total, 3 problematic cells were identified, as can be seen in Figure 5 (a-c). With the EL test method, fast and precise resolution of failures is achieved. Cracks and breakages are visible. However, the type of failure occurring in the problematic cells is determined and energy losses are prevented by on-site intervention. Micro-cracks are cracks that occur on the panels and are difficult to see with the naked eye. Micro-cracks of the panel; may occur during production, transportation and installation phases. Although these cracks do not show their effect during the first installation and electricity generation, they may cause a decrease in the efficiency of the panel with the increase in the size of the cracks in the following periods. Any defects in solar cells, such as cracks, poorly soldered connections, and mismatches, cause higher resistance and become hot spots in the long run. A typical EL imaging setup is shown Figure 6. As a result, in this study, the number of samples displayed is 4, the number of cells displayed is 576, the number of damaged (broken / cracked / possible problem etc.) cell is 11. It is observed that the fractures/cracks detected in the panels have similar characteristics. This situation is not due to manufacturing defect, but rather transportation or assembly. It seems that the pressure applied to the panels during the process was created by impact. This should be compared and confirmed with their current condition by requesting the panel manufacturer's ex-factory electroluminescence images and IV measurements of the panels. Although it is thought that the detected "Possible Faulty" cells are not of the type that will affect the production at the moment, they are checked periodically. It is recommended to follow their development/progress.
