Lost Tangible Cultural Heritage: A Traditional Tokat House Restoration Project

Dilara Gökçen PAÇ^{1,*}

3. RESTORATION PROJECT OF A TRADITIONAL TOKAT HOUSE

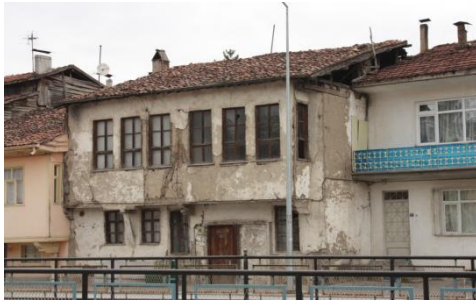
Figure 4. *Images of the House in 2012 (Author's Archive)*

The subject of the study is a wooden house located on Behzad Boulevard, Mahmutpaşa Neighborhood, Tokat Province (Figure 4). The drawings of the house were completed in 2012, and in 2013, it was demolished, and apartment blocks were built in its place (Figure 5). The structure is situated within a designated conservation area. Being in an area where the traditional house cluster is concentrated, the building has many unique features that reflect the characteristics of its period. Considering both the studied structure and the overall street and settlement, there are no significant structural issues, but there is a need for repair and maintenance.

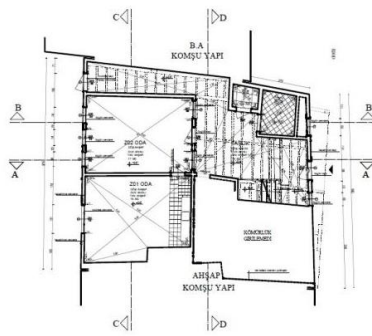
Figure 6. Ground Floor Survey Plan Drawing (Author's Drawing)

The house features two rooms, Z01 and Z02, on the ground floor, accessible from the stone-paved area (Figure 6). Wooden beams are visible on the ceiling of the stone-paved section. Both Z01 and Z02 rooms have wooden paneling on their ceilings. There is a corridor connecting the stone-paved area to the garden, adjacent to the Z02 room. The garden door is in a deteriorated state. Additionally, a non-original bathroom and toilet have been added to the stone-paved area (Figure 7). The ceiling height of the bathroom and toilet is half that of the stone-paved area and Z01-Z02 rooms (Figure 8). These additions are constructed using reinforced concrete. The original entrance door and the windows in the stone-paved area are authentic and in harmony with the overall architectural style of the building. To access the stone-paved area, Z01, and Z02 rooms on the ground floor, one descends two steps from the entrance door. There is also a coal storage room on the ground floor.

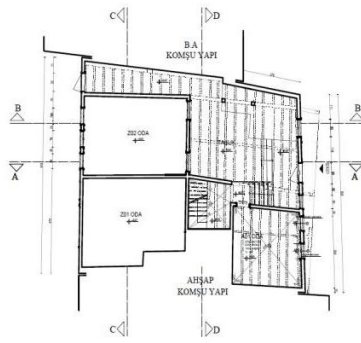
Figure 9. Mezzanine Floor Survey Plan Drawing (Author's Drawing)

There is a room on the mezzanine level (Figure 9). Access to the room on the mezzanine level, often used for storing provisions, is provided via a wooden staircase from the stone-paved area (Figure 10). The flooring is made of concrete, and the wooden construction of the house can be seen on the ceiling. The room covers an area of 11 square meters and has no door. It has two windows. The windowpanes are missing, and some areas are covered with linoleum. The windows are original and share similarities with the windows in many other rooms of the house. The walls of the room are damaged (Figure 11). Paint on the walls has partly disappeared, revealing wooden posts beneath.

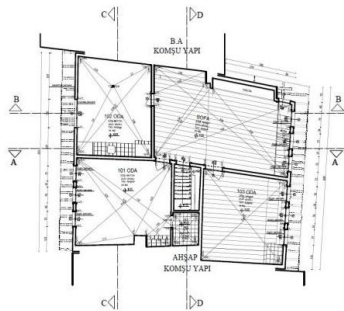
Figure 12. 1st Floor Plan Drawing (Author's Drawing)

Access to the first floor is provided through a wooden staircase from the mezzanine level (Figure 12). There is a wooden door leading from the staircase to the living area (Figure 13). The first floor features a room configuration centered around the living area. The windows of the living area face the front facade. On this floor, there are three rooms: Room 101, Room 102, and Room 103. The living area includes a wooden bench and storage area (Figure 14). Room 101 and Room 102 face the rear facade. Room 101 also has a small kitchen, and it has been observed that the chimney passes through this room. The doors and windows of the room are original. The ceiling and flooring are made of wood. Room 102 has a kitchen counter. It is generally the most damaged room compared to the first floor. Plywood on the ceiling has fallen in some places. The door and window of this room are not original. Room 103 faces the front facade. Its door and windows are original. The flooring and ceiling are made of wood. There is a tiled area in one corner of the room.

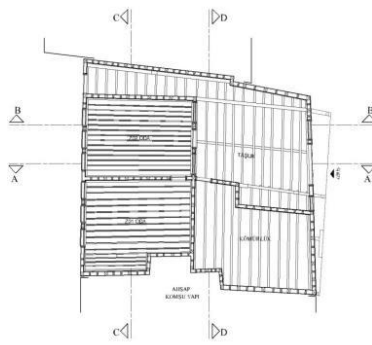
Figure 21. Ground Floor Restitution Plan Drawing (Author's Drawing)

The windows of room Z01 on the ground floor have been modified by closing them and installing smaller windows (as evident from the records of the garden facade) (Figure 21). The windows of this room have been restored to their original state based on the existing wooden traces on the facade and in comparison with the windows of room Z02. The non-original kitchen elements and partial mosaic tile flooring in this room have been removed, and the removed flooring has been replaced with wood. The non-original door of the room has been replaced according to original examples. The windows, door, flooring, and ceiling elements of room Z02 are original and have been retained. On the ground floor, there is a hall leading to the garden from the stone-paved area. The original garden door accessed from this hall has been stabilized and retained. Non-original additions, including a bathroom and toilet, which were added to the stone-paved area, have been removed. The entrance door of the single-winged residence has been modified based on the existing traces on the facade. The windows in the stone-paved area are original. The coal storage unit on the ground floor has been rearranged, dividing it into a bathroom and toilet unit. The door under the staircase leading to the coal storage has been closed.

The windows of Room Z01 will be replaced with the original ones (Figure 28). Room Z01 will be stripped of non-quality kitchen elements, partial mosaic tile flooring, and recent additions. Skimming will be applied to all flooring coverings, and wooden coverings will be treated and polished. The entire electrical system will be placed beneath the plaster. The ceiling covering and wooden beams' damaged sections will be completed using original materials, while existing sections (treated and painted) will be preserved. The garden door will be stripped of recent additions and reinforced. Any added bathroom and toilet units in the stone part will be removed. The wall adjacent to the concrete building in the stone part will be plastered. There is a non-original bathroom and toilet unit added later in the stone part, which will be removed. All doors, except for the single-wing entrance door of the building, will be turned into double-wing doors to restore the original state. All doors will be stripped of worn-out paint and putty, and maintenance will be performed on door handles and lock systems. The coal room unit on the ground

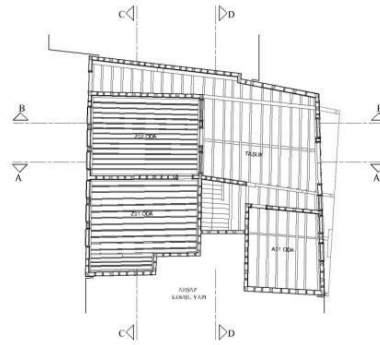
Figure 22. Mezzanine Floor Restitution Plan Drawing (Author's Drawing)

The mezzanine floor contains a room (Figure 22), typically used for storing provisions, and this room is accessed from the stone-paved area via a wooden staircase. This unit has been reimagined as the kitchen

in the restitution project. The flooring has been changed to mosaic tiles, and kitchen elements have been added. An original door has been installed for the room without a door, based on original examples. The windows of the room are original.

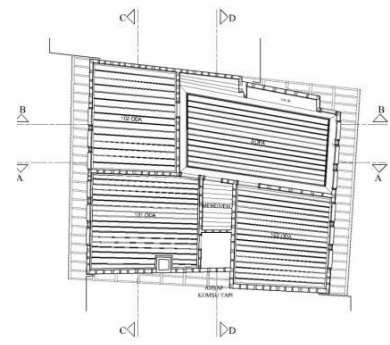
Figure 23. 1st Floor Restitution Plan Drawing (Author's Drawing)

The 1st floor is accessed from the mezzanine via a wooden staircase. This original staircase has been stabilized (Figure 23). An original wooden door leading from the staircase to the living room has been retained. Non-original additions along the staircase have been removed. The windows, doors (except for 102), sedir (raised platform with cushions), and yüklük (built-in storage cabinet) in the living room are original. The kitchen elements and non-original additions in room 101 have been removed. The room's original door and windows have been retained. The ceiling and flooring are of high-quality wood. Room 102 has a kitchen counter. The kitchen elements in the room have been removed. The ceiling of the room, which had suffered damage, has been reconstructed using original ceiling profiles. The room's non-original windows and door have been replaced with original window designs, based on the traces on the facade, and a new original-style door has been constructed. Room 103 faces the front facade and its original door, windows, ceiling, and flooring have been retained, while the non-original tiled niche has been removed.

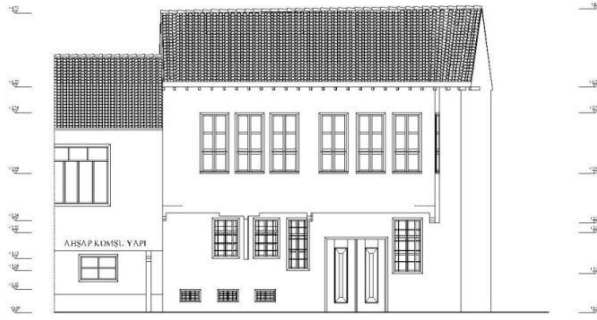
Figure 24. Front Facade Restitution Drawing
(Author's Drawing)

On the Street Facade, apart from the single leaf of the entrance door, the general facade features have been preserved in their original state. The structural system of the residence can also be inferred from the deteriorations in the existing plaster on the facade (Figure 25). The entrance door is positioned approximately 15 cm below the road level. Due to the road elevation above the facade, in the restitution, the door has been restored to its original state. The single leaf wooden entrance door is not damaged and is original; however, based on the wooden traces on the facade, it is evident that it was originally a double leaf door. The missing leaf has been added to the door according to its original design (Figure 24). The original wooden window, which was covered by a poorly constructed bathroom addition on the facade, has been reopened. The metal railings of the facade windows are original and have been renewed.

The facade facing the street has largely retained its originality (Figure 31). The facade will be restored in accordance with the facade restoration project. If deemed necessary, the walls of the entrance facade will be reinforced and the plaster will be redone with the original material after all existing plaster is removed. All metal elements on the facade (such as metal wrought iron, metal forgings) will be cleaned and treated with chemicals to prevent corrosion and oxidation. The original wooden components on the projection (dormer) will be carefully examined and repaired, preserving the original details of any deteriorated parts. Existing parts will be treated, treated with wood preservatives, and repainted. The entrance door, which is located 15 cm below the street level, will be restored to its original state due to the street elevation. The single-wing wooden door will be transformed into a double-wing door and restored to its original state. The original wooden window covered by the uncharacteristic bathroom

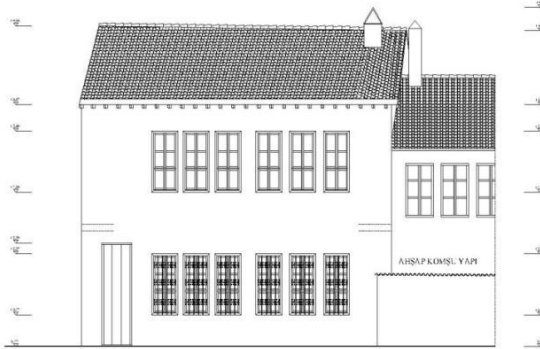
Figure 26. Rear Facade Restitution Drawing
(Author's Drawing)

On the Rear Garden Facade, the plaster has partially fallen off in some areas, revealing the underlying wooden construction (Figure 27). In certain places, mud mortar can be seen beneath the removed plaster. The window of Room Z01 on the rear facade is not original; a portion of it has been closed and altered to an older state (as indicated by the wooden traces) and has been changed according to the original design (Figure 26). The window of Room 102 on the first floor is also not original and has been altered compared to the other original windows on the facade. The concrete mass rising from the ground level on the facade has been removed.

extension on the facade will be revealed. Metal railings on the facade windows will be replaced. For the garden facade, after removing all the existing plaster, if necessary, the walls will be reinforced and the plaster will be redone with the original material (Figure 32). All metal elements on the facade (such as metal wrought iron, metal forgings) will be cleaned and treated with chemicals to prevent corrosion and oxidation. The metal railings on the windows of the facade will be renewed. The window of ZO1 room, which is not original, will be replaced according to original examples. The window of room 102 on the 1st floor, which is not original, will be replaced according to the other original windows on the facade. The concrete mass rising from the ground level on the facade will be removed. Landscaping of the garden will be carried out, and seating areas will be created under a pergola. Roof tiles will be renewed, and the roof structure will be reconstructed. The chimney on the roof will be plastered, and a cap will be added to the chimney. A rain gutter will be added to the roof.
