INVESTIGATION OF DEFECTS OCCURRING IN THE CASTING SHOP PROCESS OF CERAMIC SANITARYWARE ON THE FINAL PRODUCT

Nihal Derin COSKUN^{1*}, Eray CASIN², Cumhur Eren ISIK³

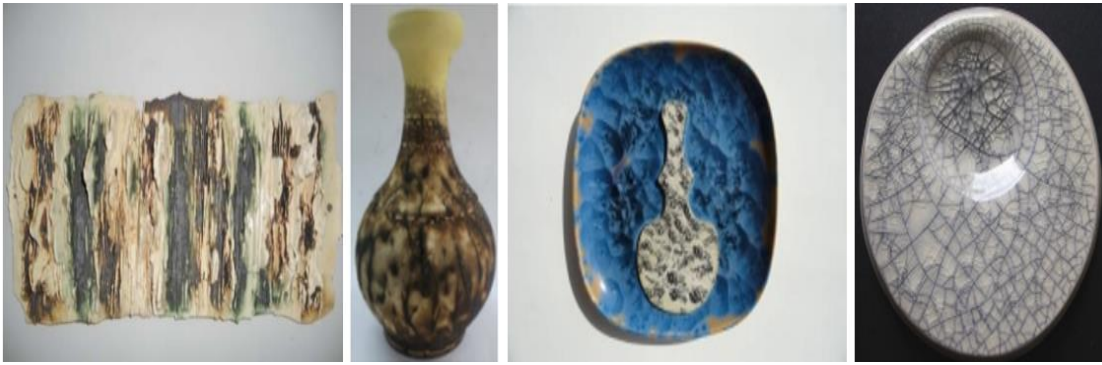
Figure 1. Some glaze defects used as artistic effects in artistic ceramic products (Berberoğlu, 2015; Genç ve ark., 2018; Genç, 2010; Taşkın, 2009).

As seen in Figure 1, different textures and impurities provide artistic effects in artistic ceramic production.

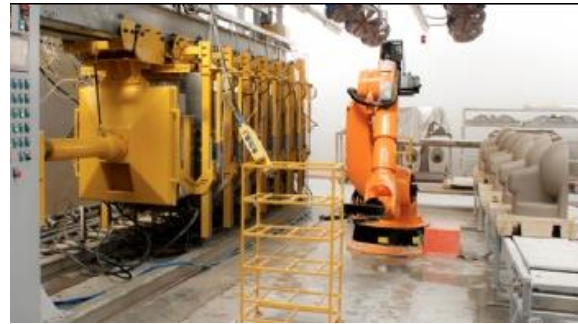
Figure 6. Vitrified die casting machine from Ece Banyo.

Many sanitaryware products such as sinks and toilet bowls are produced on the pressure casting benches as seen in Figure 6. However, while the molds are being opened, especially in products such as large-sized toilet bowls or similar shower trays, metallic parts that are

poured from the upper part of the counter due to friction cannot be detected because they are taken into the system by robots without human touch. These types of defects also appear as stain faults at the exit of the kiln.
