Utilization of unmanned aerial vehicles for the detection and localization of deteriorations in historical structures: a case study of Ishak Pasha Palace

Emirhan Özdemir*¹, Rüştü Çallı¹, Selim Kartal¹

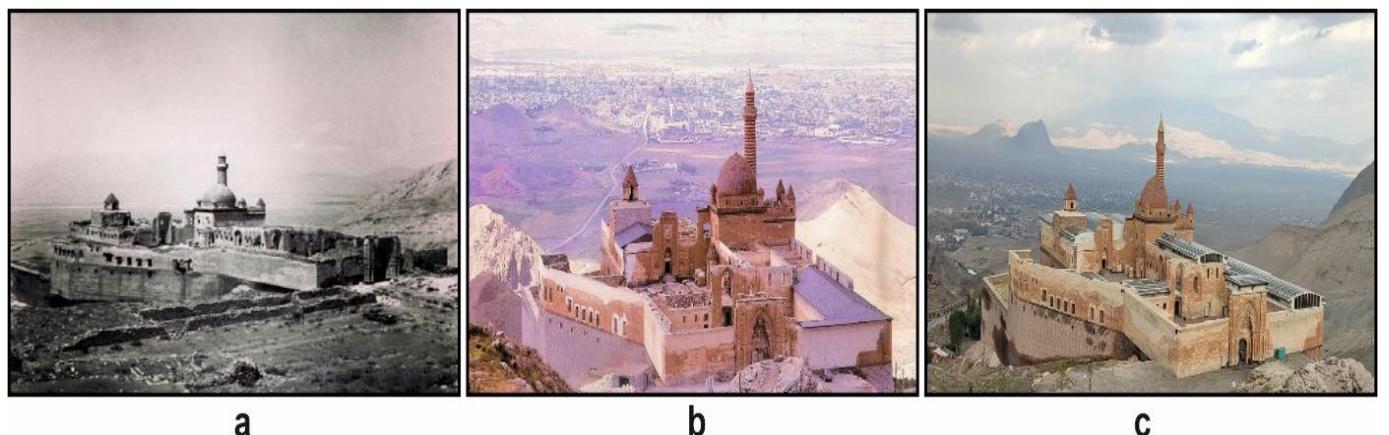
Figure 2. Ishak Pasha Palace from past to present; a) before 1993, b) between 1993-1996 and c) after 2006

Ishak Pasha Palace has been able to survive to the present day through various repairs since the 1950s. The repairs carried out on the structure can be categorized into periods before 1993, between 1993 and 1996, and after 2006 (Figure 2). The post-restoration condition of this historical structure has been selected as the focus area for the preservation of the structure and for the detection of potential damage that may occur in future periods due to renovations or deteriorations, along with the measures to be taken.
