THE DOCUMENTATION AND RESTORATION PROPOSAL FOR USAKIZADE RIFAT EFENDI MANSION IN KUTAHYA PROVINCE CENTRAL DISTRICT

Uşakizade Rifat Efendi mansion, located in the central district of Kütahya province, is one of the examples of civil architecture that preserves its unique features and embodies the plan, construction system and building elements of traditional Kütahya houses. Gözüm Seyh Sultan "tekke", located in the same courtyard with the mansion, is similar to traditional buildings in the region with its architectural features and construction techniques. The documentation of these buildings, which was studied for the master's thesis by the writers in 2020, carries utmost importance due to deterioration in the structures. Within the scope of this article, visual and vectoral documentation studies, analysis of deteriorations, corruptions and restitution are summarized, interventions for restoration and new function proposal are presented.

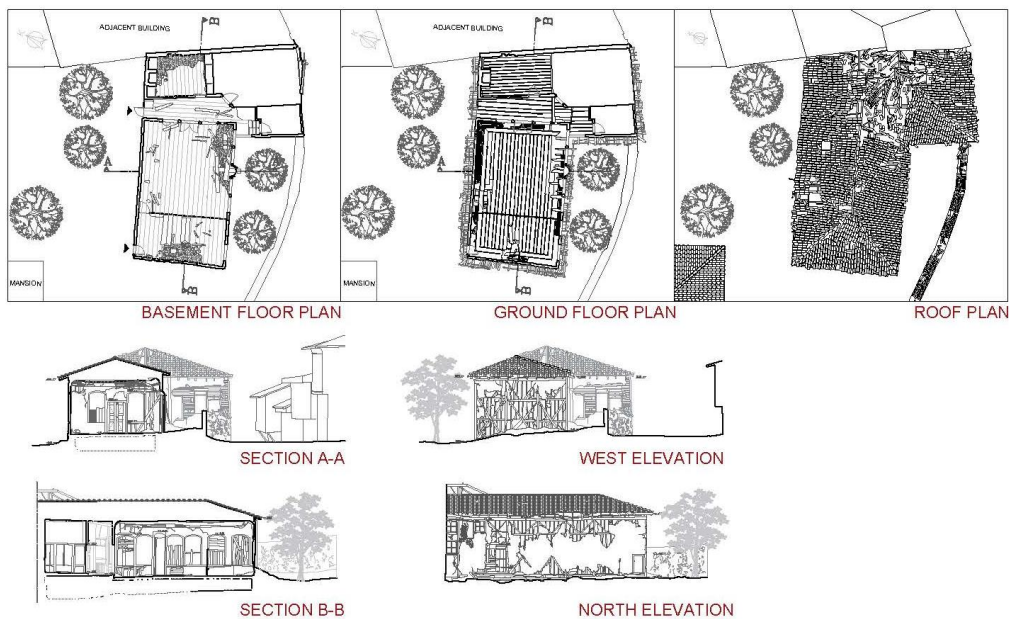
Figure 3. Measured drawing of Gözüm Seyh Sultan “tekke” (lodge)

The “tekke” consists of outbuilding area and an area that includes of the tomb and the worship place called masjid (Figure 3). L shaped building has 265.4 m² closed area and it was consisting of two floors which are basement floor and ground floor. It has three entrances that two of them from the courtyard and the other entrance is directly from the street on the south facade.

When entering the tomb from the courtyard, it is seen that there are two wooden sarcophagi right across the entrance door (Figure 2-v). In the area surrounded by stones under the sarcophagi , it is thought that there are graves of a male and a female, named Gözüm Seyh and Valide Sultan [8]. The tomb was separated from the masjid with a wooden lattice divider (Figure 2-u). The masjid has a mihrab in the south direction (Figure 2-t). There are 6 window openings without casements on the both side of the mihrab. Structure of the space has serious problems such as decay, material loss, change in colour are observed.

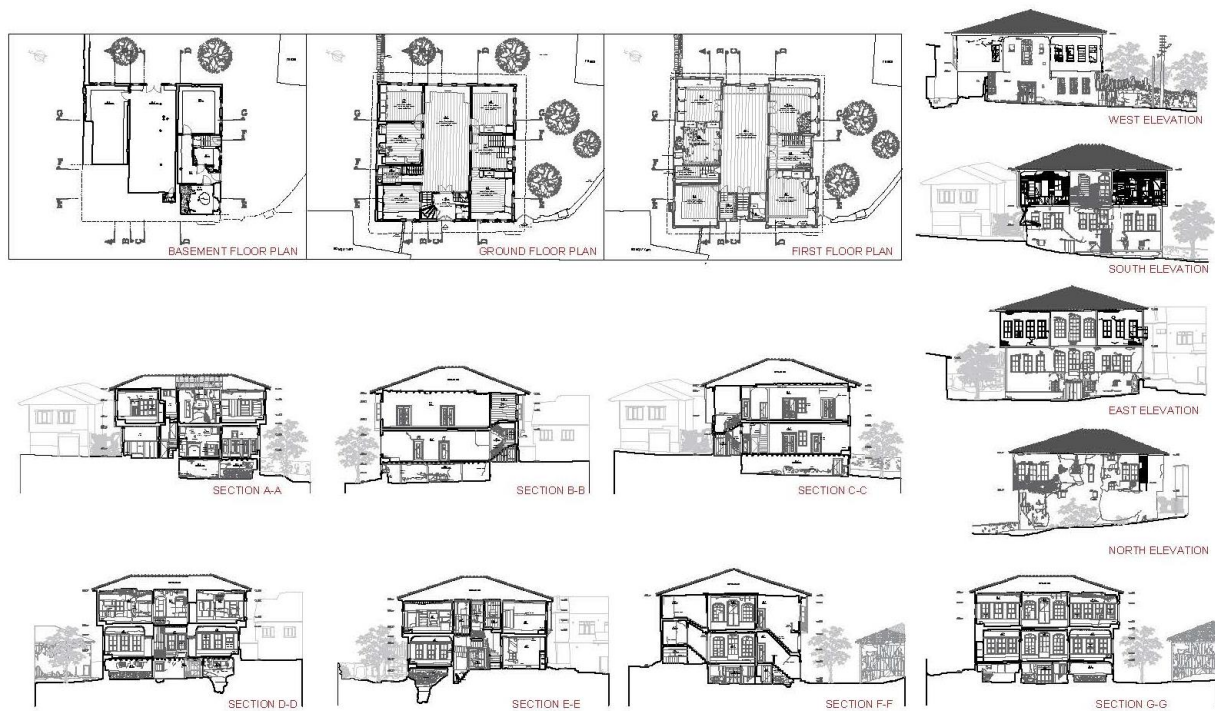
Figure 5. Measured drawing of Uşakizade Rıfat Edendi Mansion (2020)

Relation between the construction and topography has been solved with different number of floor in facades. The building covers an area of 15.34 x 15.22 m² and was consist of three floors which basement floor, ground floor and first floor (Figure 5). The building has 672.2 m² closed area which on basement floor is 180.2 m², on the ground floor is 235.4 m² and on the first floor is 256.6 m². There are three entrances; the main entrance to the residence with no 2 is through the west facade located near the garden entrance and the other entrances are from the south and east facades in the courtyard (Figure 4-d).

The basement floor consists of two parts; spaces which are used as barn and woodhouse, are accessed through the double winged wooden door on the east facade (Figure 4-f). The other part of the basement floor, consists of three storages and a hall is entered from the south facade (Figure 4-h). There is no transition between these two parts. In the middle of the basement spaces, there are 4 wooden columns that were placed to support the ceiling (Figure 4-e). The ceiling of the place was left uncovered and the floor is compacted soil. The walls were built as stone masonry and timber frame construction systems and plastered from the inside (Figure 4-g). The plaster of the walls is flaking away and there are some cracks on the surface.
