EVALUATION OF THE RESTORATION STUDIES DONE IN THE WOOD STRUCTURES OF HISTORICAL BUILDINGS: KEBAN YUSUF ZIYA PASHA MOSQUE

Mehmet Vefa HAN^{1*}, İmran DÖNGEL², Cevdet SÖĞÜTLÜ¹

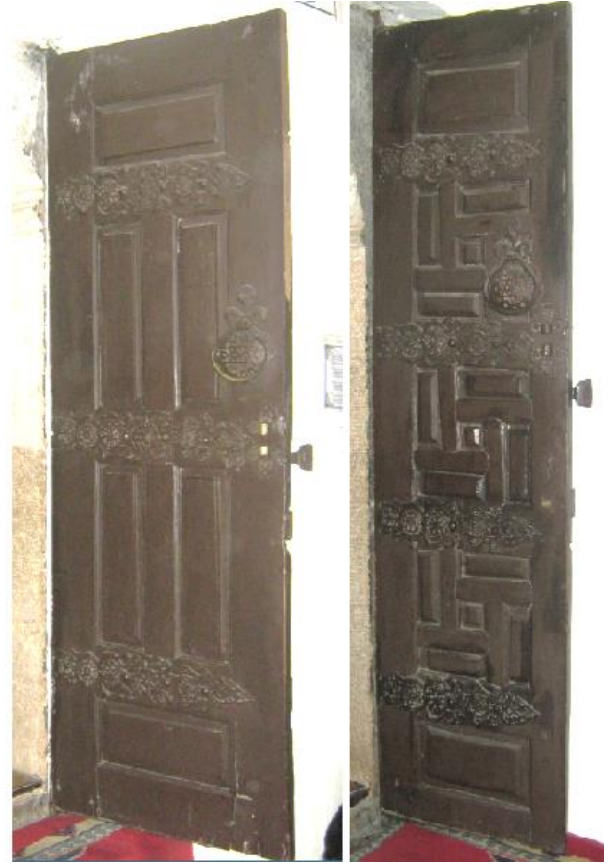
Doors of the courtyard are double-wing gates and are produced with driving technique (Figure 3, 4). Large and small knuckles serving as the decoration of doors are nailed to the wall. In addition, the door handle is made in the shape of a half bun and metal badges were put at each door's corner.

Figure 3. The entrance to the mosque's doors.

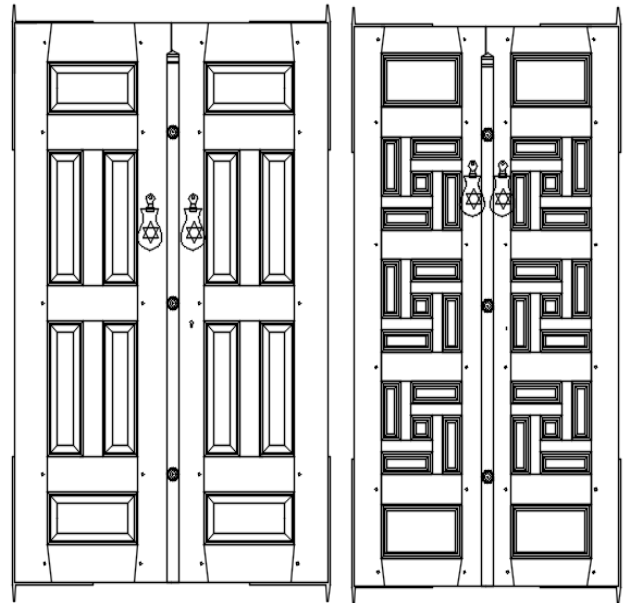
Figure 4. The entrance to the mosque's doors technical drawing.

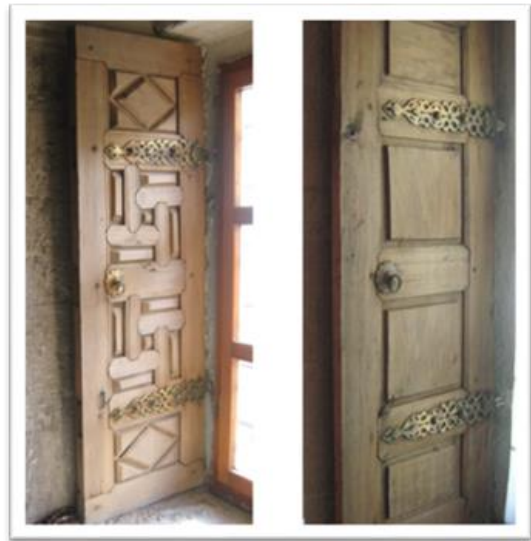
The interior window shuttle on the right of the mihrap was made with the künde-kari technique while others were made the tablaruka technique (Figure 9, 10). Rails of window shutters were combined as open mortise with the real künde-kari technique, as others were combined as concealed mortise. Wooden dowels were used in order to anchor mortises. Metal strips, which are decorated with geometric designs, are located on the top and bottom rails of window shutters.

Figure 9. Window shutters made with tablaruka and künde-kari techniques.

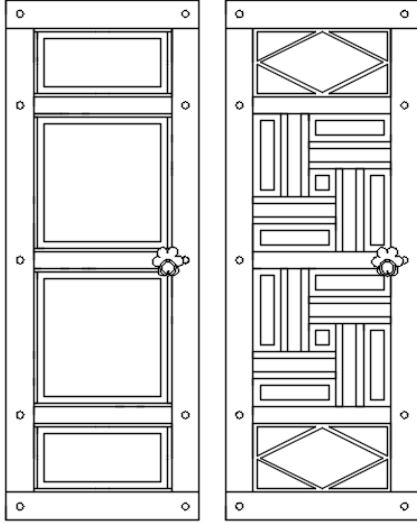
Figure 10. Window shutters technical drawing.
