FAILURE ANALYSIS OF AN UPPER BENDING CYLINDER BUSHING IN A PLATE MILL

Premature failure of a bending cylinder bushing in a plate mill was investigated in this study. Visual, chemical and microscopic analyses were performed to detect the possible reasons of this failure and possible measures to be taken were mentioned not to be encountered for this type of failures in the future. No traces of welding were observed in the performed studies. Intensive elongated MnS inclusions, fatigue striations and splits from the grain boundaries were detected in the microstructural investigations. It was also proved that the base of the bushing was worked without chamfering. The importance of the removing hydrogen from the structure by annealing to decrease the hydrogen brittleness risk which would occur after the chromium coating process, and the chamfering of the bushing base to decrease the crack susceptibility was stressed.

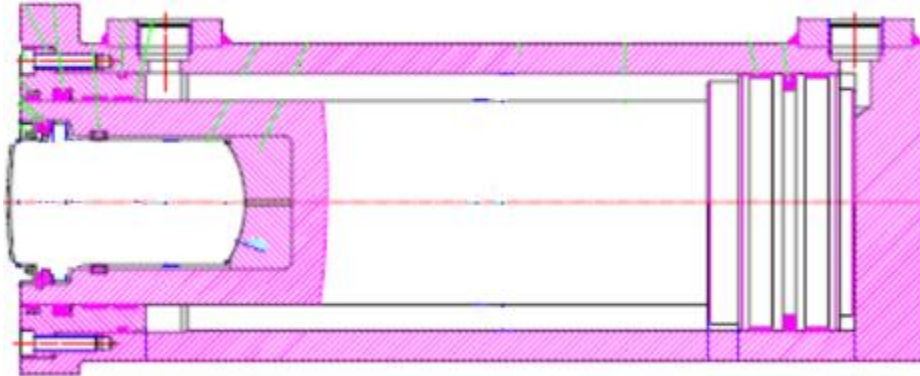
Figure 2. Technical schematic drawing of the bending cylinder system

Technical schematic drawing of bending cylinder system is seen in Figure 2. Piston rod moves inside the cylinder by means of the fluid.
