Urfa Pazar (Hodja Ahmet) Mosque Repair and Conservation Practices

Emine EKİNCİ DAĞTEKİN ^{1*}

Citation: Ekinci Dağtekin, E. (2024). Urfa Pazar (Hodja Ahmet) Mosque repair and conservation practices. *Journal of Architectural Sciences and Applications*, 9 (1), 249-263.

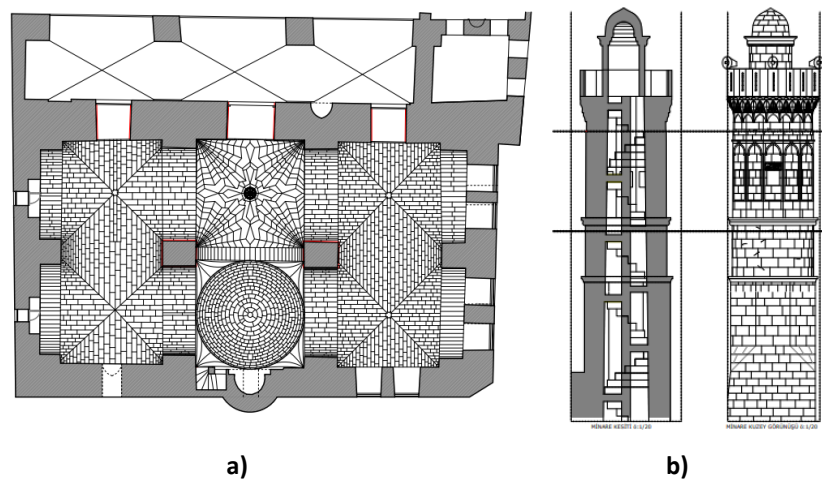
Figure 3. a) Interior view of covering system b) Minaret construction system (Dağtekin Archive, 2023)

The main load bearer of the building is rubble and rough masonry stone walls. It is built in the stone masonry technique. The structure is constructed with ashlar stones on the sides. The area for the religious services has been separated into six sections with two naves in a parallel line with the altar (mihrab). The front of the altar (mihrab) has a dome and the sides are cross vaulted. On the continuation of the altar (mihrab), there is a star vault in the middle on the second nave. In terms of the technique and artistic considerations, this star vault is the only example in Urfa with a central section decorated with intersecting geometric shapes (Kürkçüoğlu, 1993a, p.42). The portico (son cemaat yeri) is cross vaulted and sits on four stone pillars in two rows in the centre. On the Northeast corner of the courtyard, the minaret is built using ashlar stones and sits on a square pedestal. The body of the minaret with a single balcony, has been divided into four sections with three mouldings. The first, third and fourth sections have a dodecagon plan whereas the second section is decorated on every surface with sharp arched niches. Four rectangular windows were opened in the niches facing the main directions (Figure 3).

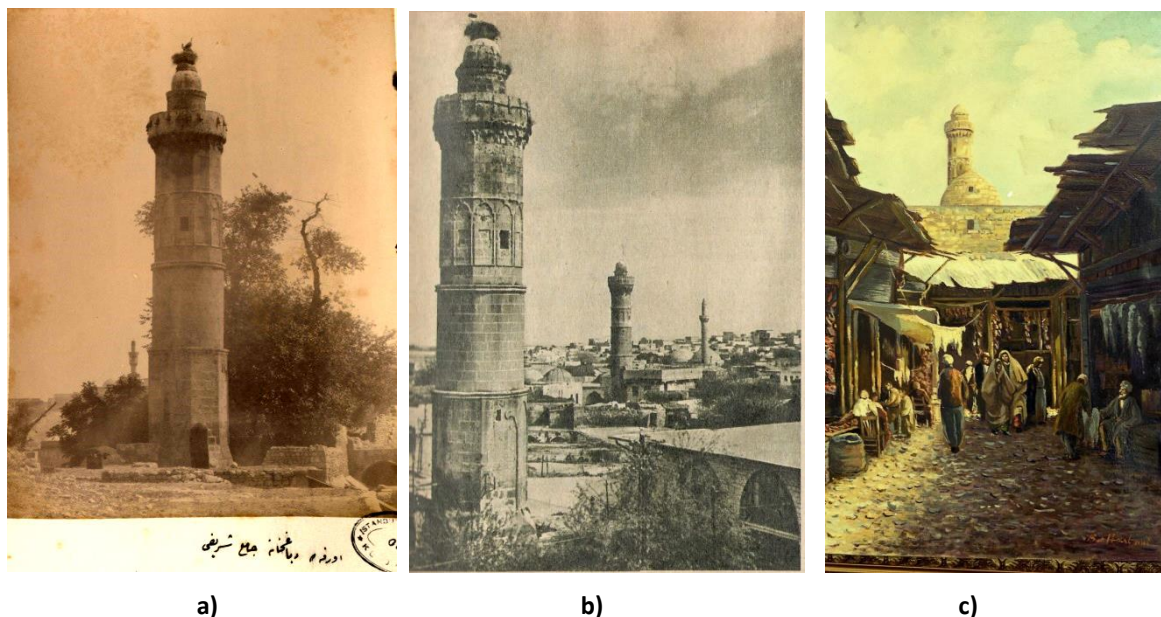
Figure 4. a) The minaret of Pazar Mosque (Kürkçüoğlu, 2009, p.53) b) The minaret of Pazar Mosque in the year 1963 (Kürkçüoğlu, 2011, p.356) c) Pazar Mosque from the Kovacılar Arcade (Kürkçüoğlu, 2011, p.236)

The years between 1880-1890: The very first visual information regarding the building is found in the “Sultan Second Abdülhamit’s Yıldız Photography Album” where the minaret was pictured. The tall trees around, the minaret and the arch space of the portico with three sections on the courtyard could be observed in the picture. The area where the minaret is seated is where the ablution room is placed today on the entrance gate on the North wing of the mosque. The irregular stones around the pedestal of the minaret makes us think that there had been an intervention for the repair of the structure (Figure 4a).

The year 1963: The second photograph in respect of the building is taken from the book by Kürkçüoğlu published in 2011 with the title “Once upon a Time Urfa with Photographs”. In this photograph, we observe that the arches that were originally open in the portico had been closed from the point of the joist hanger. On the East of the courtyard of the mosque, the roof of a structure on a lower elevation and trees within the courtyard could be seen.

The third undated photograph of the building comes from Kürkçüoğlu’s personal archive and is a hand drawing of the mosque from the Rag Pickers’ Bazaar. The mosque’s masonry walls, dome and minaret appear to be structurally sound (Figure 4).

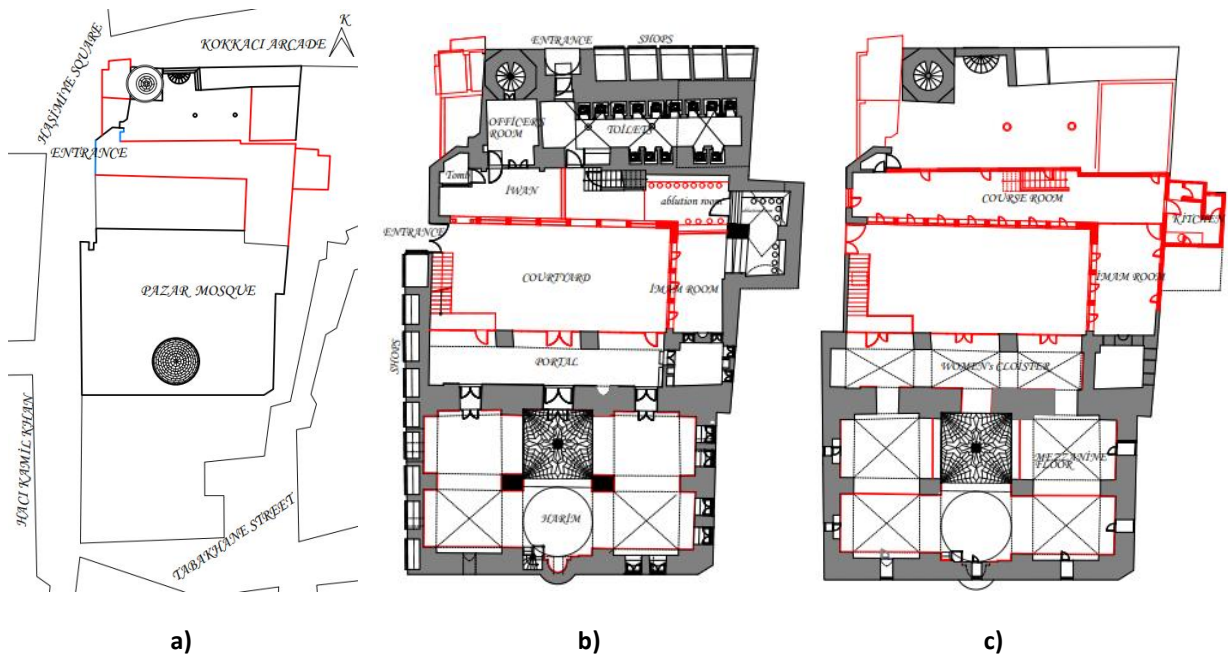
Figure 11. a. The layout plan (the year 2012) b. Ground floor plan c. First floor plan (Dağtekin Archive, 2023)

The year 2012: The survey carried out during this period provided detailed documentation by identifying the additions and alterations made to the mosque harim area and courtyard since the 1960s, as well as the physical interventions that disturbed the originality of the building. It was observed that the ablution room in the east of the courtyard was removed, the toilet rooms in the north direction were changed, new two storey buildings were built on both wings, the western and northern entrance doors of the courtyard were surrounded by shops etc. from outside and inside, and a mezzanine floor was created with a reinforced concrete deck to create a women's mahfil in harim and a portico (Figure 11). In the restoration project of the building approved in 2012, the new structures in the courtyard were not intervened due a lack of administrative budget.

Between the years 2017-and 2019:-During this period, the restoration project of 2012 was revised due to the demands for the removal of all additions inside and outside the mosque and the reorganisation of the courtyard. The revised restoration project proposed the removal of new structures added to the courtyard, reinforced concrete mezzanines, metal closures and wooden wainscots added to the mosque's worship and portico, cleaning and joint repair of painted stone surfaces, and expropriation of shops on the exterior façade to reduce density.
