A Historical Building Functioned As A Museum; Bursa Umurbey Bath

The Umurbey Turkish Bath, located in the present Sericulture district, one of the most important Silk production centers of Bursa in the past, was built in 1430. It is important because the bath reflects its architectural characteristics. The Turkish Baths are divided into two groups: "Single Baths" where men and women benefit separately, or "Double Baths", where separate hammams adjacent to each other for men and women are constructed together. The Umurbey Hammam is the "Single" Hammam. The change seen in the societies changes the needs of the people as well as changing the structures because of the places that are shaped by the time they belong. Structures that can't carry their function from past to today are provided with a secondary function to continue their lives. The Umurbey Bath was given a function as a museum. In this study, the daily change of the Umurbey Baths from the past, survey drawings, survey reports, restoration projects, restoration reports and photographs before and after the restoration were included.

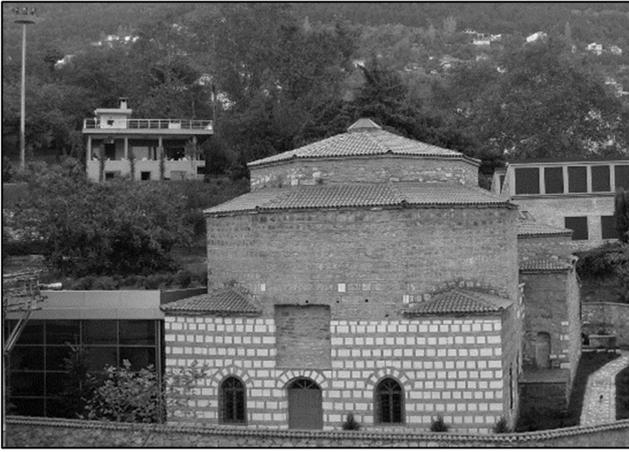
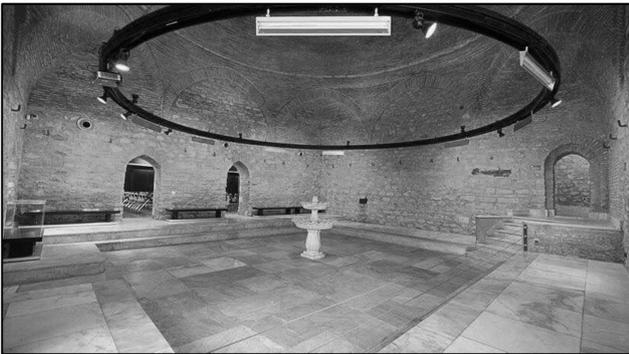
Fig. 9 Interior and exterior images of hammam (Sevcan Türe n.d.)

The exterior of the hammam; the worn out pieces of cut stone, rubble stone and blend bricks were replaced with new ones and a joint mortar was made between them. In addition, the interior walls of the hammam were scraped to reveal the masonry system and a joint mortar was made between them.

The main entrance door of the hammam was repaired. The damaged arched windows have been restored. The arch above the entrance door of the bath was unearthed. Additional steps that were added to the coldness part have been removed. The windows that were closed with bricks were opened. In order to establish a connection between the foyer and the hammam, the window in the coldness part was converted into the door. The difference in elevation between the foyer and the hammam was solved by the ramp.

The fountain in the coldness part was repaired and the missing parts were completed. The missing marble basins have been completed. The missing

mirrors were made in accordance with the original, and the broken ones were repaired. Most of the marbles found at the site of all the rooms have been restored. In the region that has collapsed in the middle of the hot part; it is covered with marble, sloping to the sides to prevent water from accumulating in the middle. The doors that were not in place, were not made again because no information about their original state could be reached.

The metal parts of the lights above all the spaces are renewed and completely covered with glass to protect from external influences. The inside of the boiler was cleaned and the chimney was repaired. The top of the water reservoir is covered with khorasan (brick dust mortar) bricks as it was before. The roof coverings were removed and the insulation was applied to the roof's bottom and then covered with roof tiles. Landscaping of the garden was done.
