# The Documentation and Restoration Proposal for Zaimzade Kamil Efendi Mansion Located in Eskişehir Province Sivrihisar District

Özlem YILMAZ<sup>1, \*</sup>, Özlem SAĞIROĞLU<sup>2</sup>

Zaimzade Kamil Efendi mansion located in Eskişehir province, Sivrihisar district is one of the examples of civil architecture which considerably preserves its unique features within historical environment and embodies authentic construction technique, original space formation and architectural elements of traditional Sivrihisar houses. The mansion, settled in by the groups prone to vandalism, has entered into a fast deterioration process as it is open to atmospheric effects. Within the scope of this article, the formation of the mansion, authentic architectural elements and construction system is defined; the current situation is documented with the problems, dated, recommendations given in connection with restitution and restoration recommendations have been presented in both graphic and vectorial with their stages

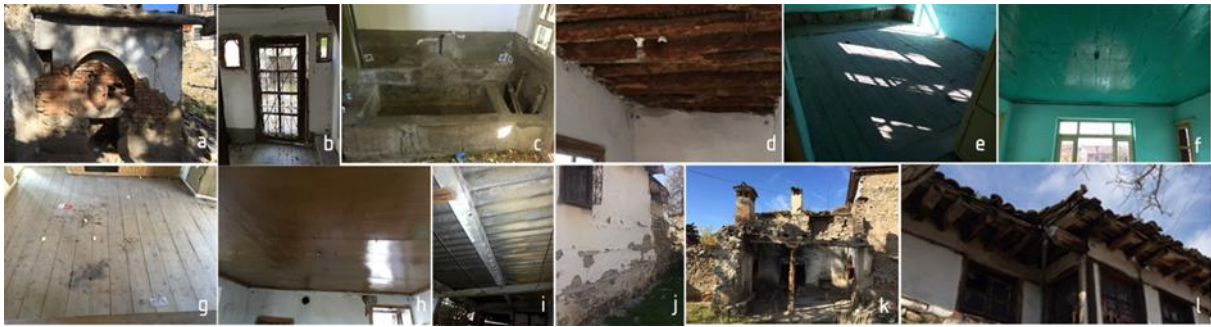
The Zaimzade Kamil Efendi Mansion is similar to the other mansions which consist of a closed outer hall, a gable roof which is covered with over and under tiles and dual saw type projection. The partition walls and courtyard facing exterior walls of the structure were built as mud filled timber frame construction, and the other walls are built as masonry rubble stone wall. At the same time; the north and south facades of basement walls function as garden walls. All the walls except the garden walls on the north are plastered and painted.

**Figure 4.** The photographs showing the construction system

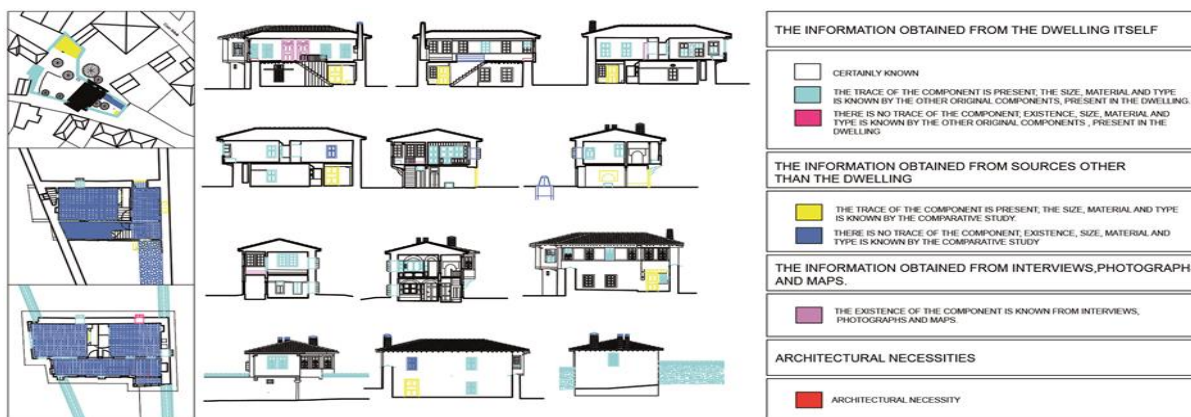
Figure 6. Using sources in restitution

1. First degree reliable sources: Authentic and existing space, surface and elements and data obtained from old photographs have been evaluated in this context. Preservation is proposed by strengthening and reconstruction in accordance with the information obtained. Among the elements completed within this context are; "mamrak", some parts of the windows, "harçevi" and some parts of "tandirevi", sofas, the ornamentation of cupboards and "kalemişi" boards.

2. Second degree reliable sources: Sources that have or have not traces in the building but all their features are known as a result of comparative study have been evaluated in this context. Authentic materials, completion with form and details have been recommended for them. Among the elements completed within this context are; doors, windows, cupboard shutters, floor and ceiling coverings.

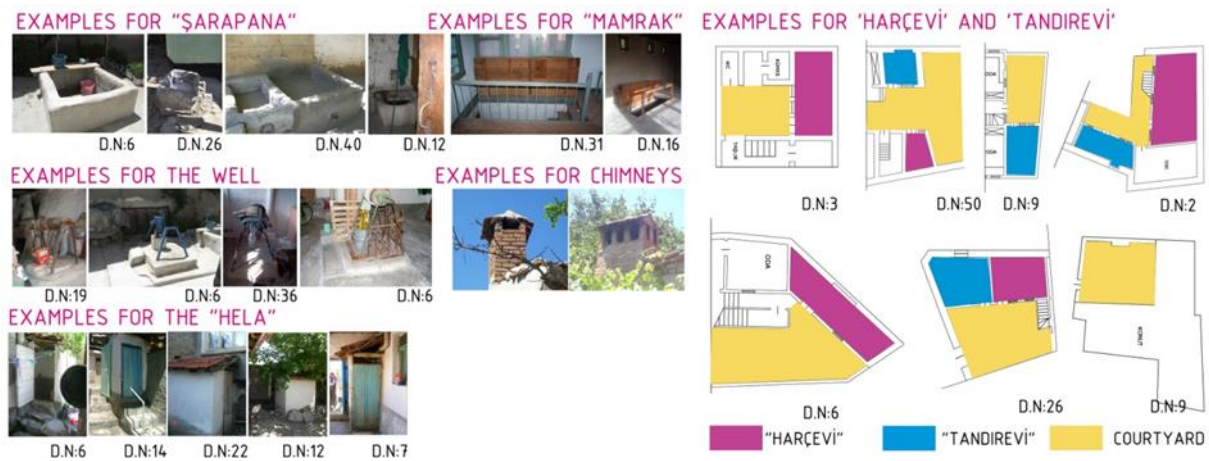
Within the context of comparative study to have a source for restitution study, historical mansions located in Sivrihisar have been studied; the suitable ones based on sofa typology and construction period have been evaluated. Furthermore for the architectural spaces and elements such as "harçevi", "tandirevi", toilet, fountain, "şarapana", "mamrak", well and chimneys; additional study have been carried out (Fig.7).

Figure 7. Comparative Study chart (D.N=Door Number)

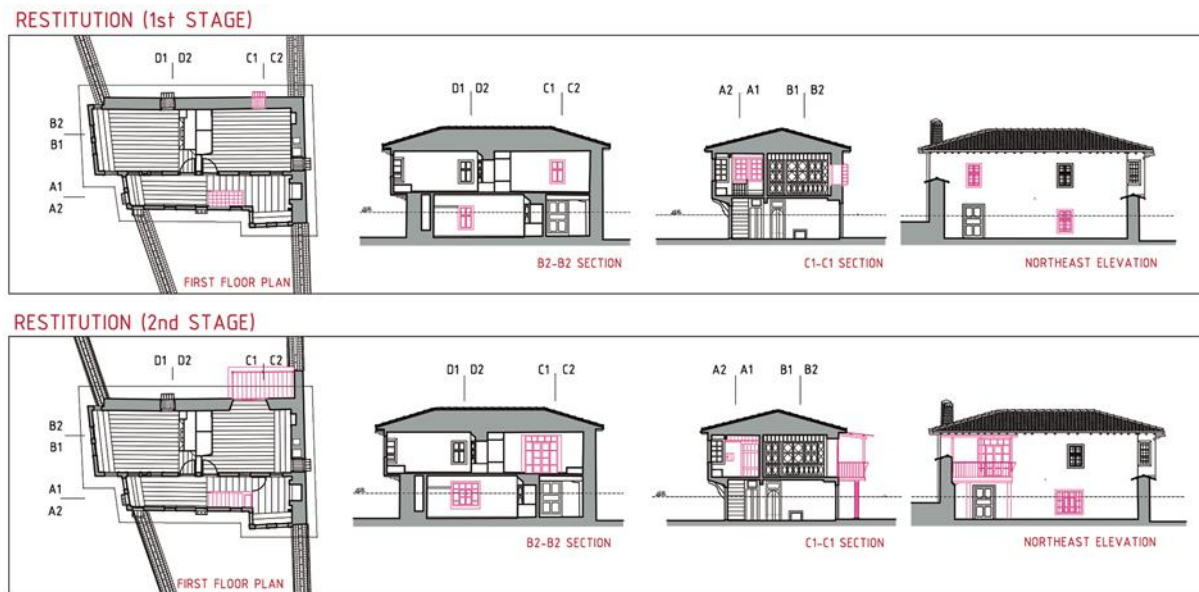
treatments have been done carelessly with unqualified materials recently. Within this context are; iron safety rails around the balcony, addition of metal plate as a top covering on balcony, adding toilet and adding a hall to the entrance and side with briquette and brick piling. There is no written, visual or oral information regarding period of the changes and transformations the building has undergone. However, changes done with qualified material and craftsmanship; by studying the deformations in the wood, it has been decided that was carried out long time ago and considered to be worth protection and evaluated under the 2nd term restitution study (Fig.8).

**Figure 8.** The partial comparison of the restitution periods
