# Measuring of Core Split Line Defect on Pillar Type Vented Brake Disc and Investigation of Crack Occurrence Potential on the Disc Caused by Its Geometric Deviation

<sup>1</sup> TOFAŞ Turk Automobile Company, R&D Center.  
\*recep.akyuz@tofas.com.tr

## Abstract

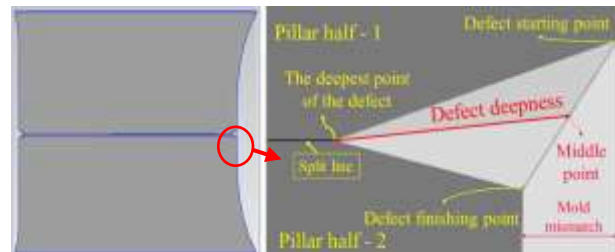
Detection and measurement processes of the defect were done according to the flow shown in the Figure 2-3, considering the mold mismatch. One of the important criteria is to consider the saw thickness which was used to cut the disc for defect detection. The thickness of the saw should not be thicker than 2 mm to provide the measurement accuracy. Thicker saws can cause material loss on the defect area.

**Figure 2.** Measuring method of the core split line irregularity under microscope.

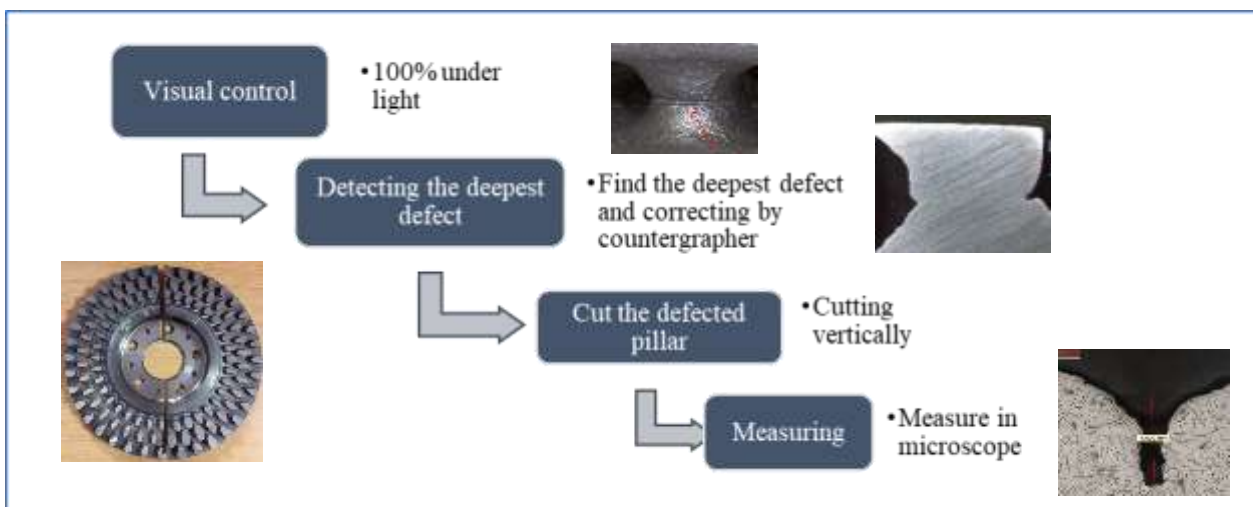
**Figure 3.** Measuring systematic of the core split line irregularity

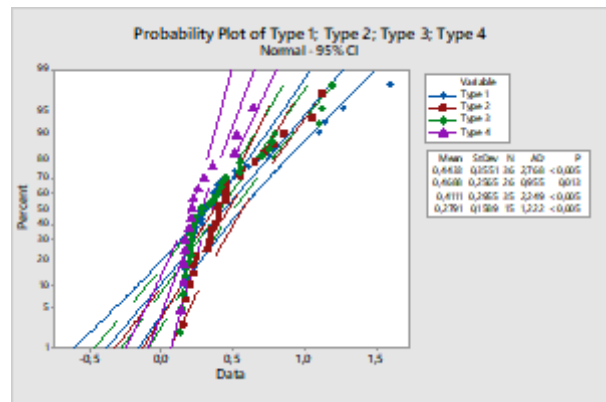
Before testing, 4 different types of vented brake disc were examined with above specified method in terms of 10 samples which were selected from each type of those brake discs were measured by contour measuring [20] and reported in Figure 4. According to analysis results, the defect characterizations were similar in Type 1 and Type 3. But standard deviation of the defects was bigger in Type 1 (See Figure 5). Also, it is seen that the depth of defects in Type 1 were distributed in a larger range compared to other types. (see Figure 6). After evaluation of the outputs, it was decided to carry out the tests with Type 1.

**Figure 5.** Defect distribution and standard deviation for 4 types.

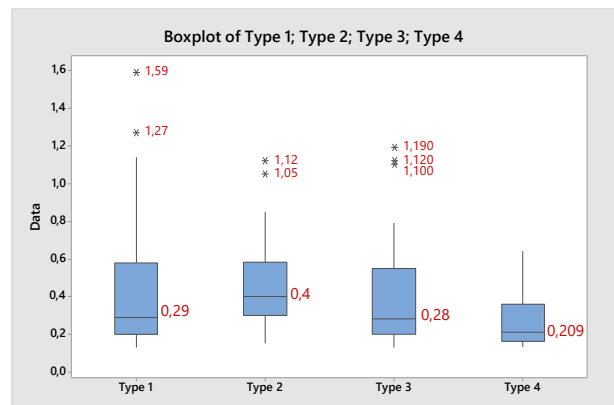
**Figure 6.** Distribution of the defect for each brake disc type.

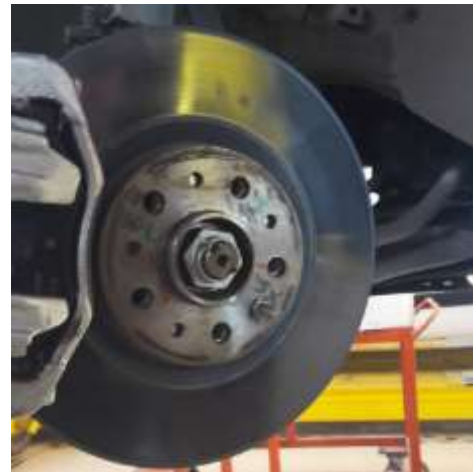
**Figure 10.** Assembled brake disc on vehicle after thermal shocked crack test on vehicle.

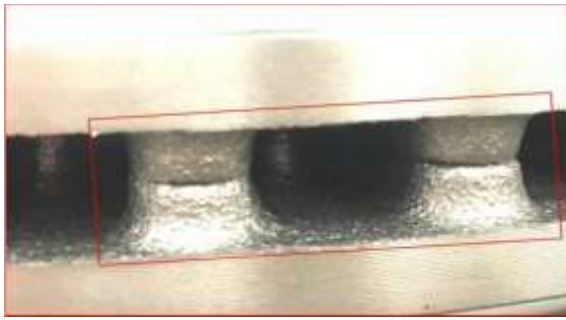
Four rotors that have visually higher defect depth out of 30 rotors which have core split line defect were tested to analyze their crack occurrence. Maximum defect depth and occurrence of cracks on defects' base upon rotors, which cut with fret saw, were analyzed via defined methodology after crack test (Figures 11, 12a, 12b, 13a and 10b) and the results are shown on Table 2.

**Figure 11.** Selected brake disc for the test.
