Failure Analysis of Distributor Gear

Abstract

Keywords: Failure Analysis, Distributor Gear, Finite Element Method, Fatigue

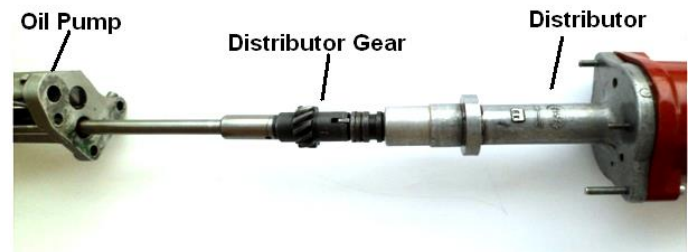
Fig. 1. Oil pump and distributor gear mechanism

Coil, distributor shafts, spark plugs and cables are some of the main parts of the ignition system. The task of distributors is to send the high electric voltage that takes place in the ignition coil, to the spark plug in the cylinder in the correct firing order. Distributor shafts need to be driven regularly to fulfill this task. Since this drive is, in different ways, dependent on the design of the engines, the distributor shafts are either driven directly by a camshaft or by a gear on the camshaft. In some vehicles, the distributor shaft may also drive the oil pump. The gear in question is of such a vehicle (Fig 1).

The first visual control of the gear revealed that one tooth was completely broken and the other one was partly fractured. Gears can fail in many different ways [1-3], incorporate fatigue [4,5], wear, impact fracture and stress rupture [6]. Some of the studies on failure analysis are as follows; Among these, Heyes (1998) have shown that the parts that most often fail are in the engine, and its components make up 41% of automotive failures. This is followed by transmission failures (26%). Studies on power train investigated the axle shaft and shaft shank. They determined that the damage to the axle shaft was caused by heat treatment, while the damage to the shaft shank was caused by some defect in the design [8, 9].
