Formation and Failure of Natural Dams in Uttarakhand Himalaya: An Observation from Lwarkha, Chamba Tahsil of Tehri Garhwal District, India

5. Case Study of Lwarkha, Chamba Tahsil of Tehri Garhwal district

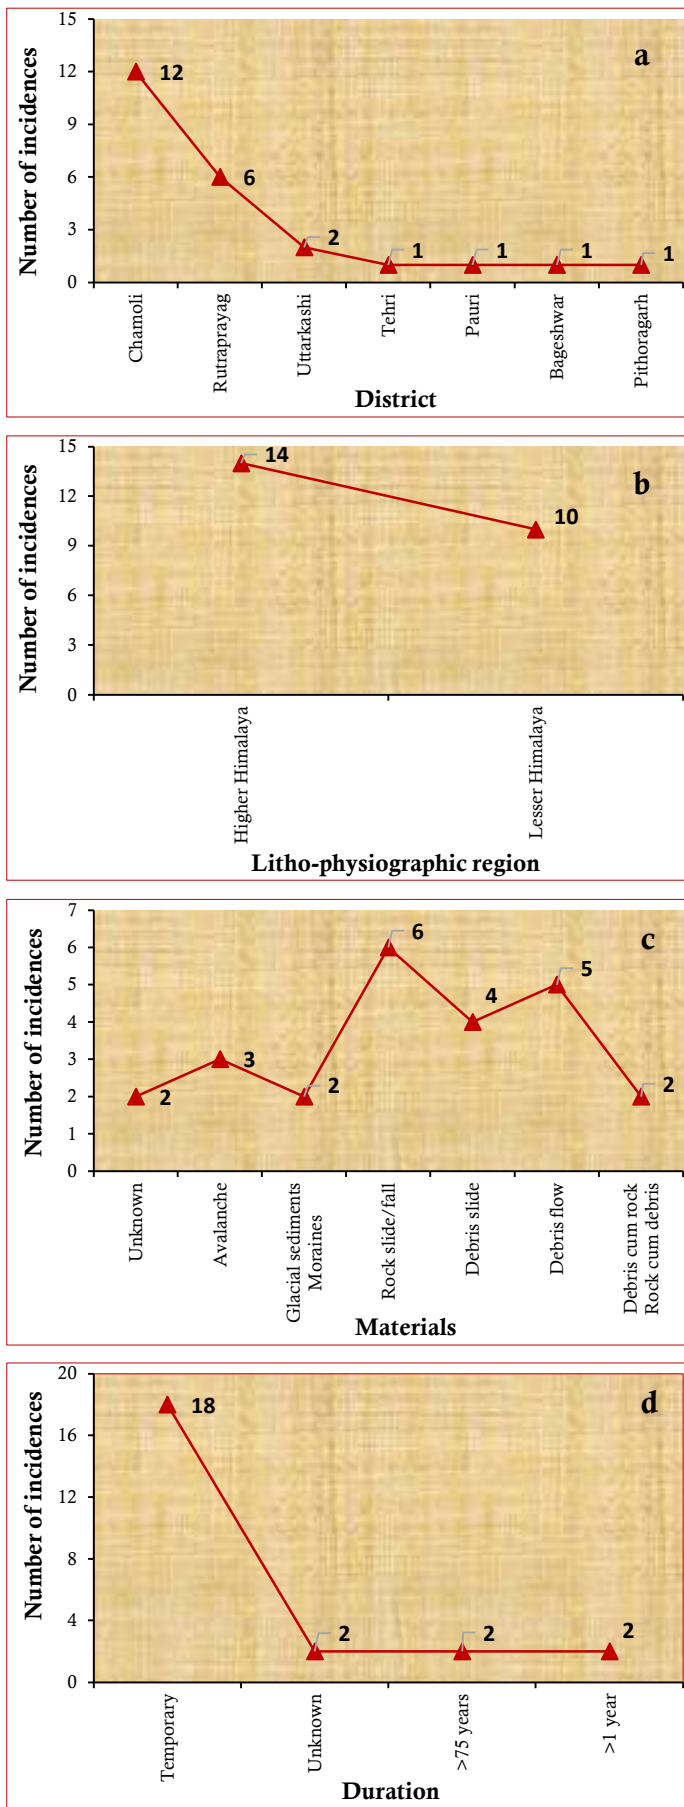
Of total natural dams documented from all around the Uttarakhand, about 14 natural dams is to be observed in Higher Himalaya while 10 numbers in Lesser Himalaya (Fig. 4b). The data indicate that majority (58 percent) is to be observed in Higher Himalayan region while 42 percent in the Lesser Himalayan region. Of total, about 6, 5, 4, 3, numbers respectively formed by rock slides/falls, debris flows, debris slides, avalanches and each 2 numbers by rock cum debris/debris cum rocks, glacial sediments/moraines while the remaining 2 numbers incidences details of which could not be conformed (Fig. 4c). Largely (25 percent) natural dams are observed to be formed by rock slides/falls while 21 percent by debris flows. Apart from, relatively less about 17 percent and 13 percent respectively by debris slides and avalanches. Only, each 8 percent damming of streams is to be observed by glacial sediments/moraines and debris cum rock/rock cum debris slide. Out of total, 18 numbers natural dams are to be observed temporary and each 2 numbers are observed >1 year and >75 years while the remaining 2 numbers incidences details of which could not be conformed (Fig. 4d). The data indicate that largely (63 percent) of the natural dams is observed to be formed temporary while each 8 percent is observed to be >1 year and >75 years.

Fig. 4. Distribution of formation and failure of natural dams in Uttarakhand Hiamalaya; (a) district wise, (b) litho-physiographic region wise and (c) materials wise and (d) durations wise
