The 2009 L'Aquila earthquake (Italy): Its characteristics and implications for earthquake science and earthquake engineering

¹Ömer AYDAN, ²Halil KUMSAR, ³Selçuk TOPRAK

ABSTRACT

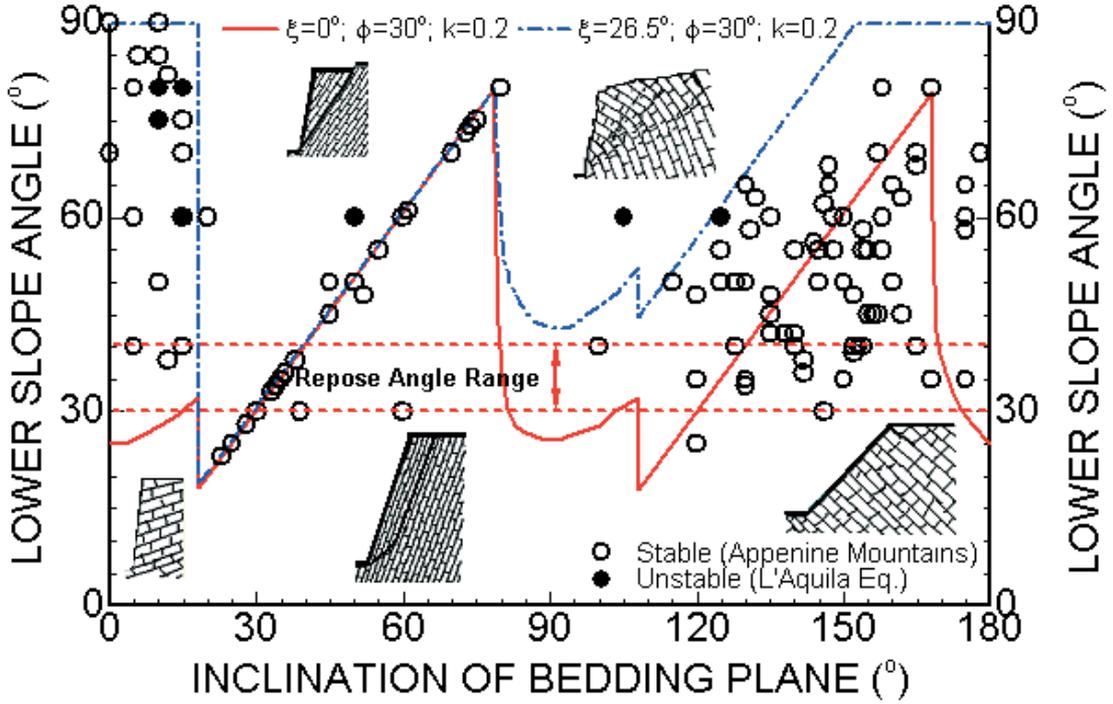
and Kumsar (2009) presented some methods that can be used to analyze the various modes of failure of rock slopes. Figure 14 compares computational results with observational data from stable and unstable slopes. The data compiled by Aydan et al. (1989) from the

natural rock slopes of the Apennine Mountains are also plotted together, as the mountains of the region belong to the Apennine mountain ridge. The Apennines are composed of mainly limestone and other calcareous rocks of different geologic ages. As a result, their stability is influenced by the orientation of bedding planes as well as normal faults. During the compilation of data, it was noted that when layers are thin, it seems that the slope angle for stability under natural conditions is drastically reduced. Furthermore, when layers dip into a slope, the natural stable slope angle tends to be almost equal to that of the bedding plane. As for layers dipping into the mountainside, the stable slope angle is almost equal to, or greater than, the normal angle of the bedding planes. When it is greater than the normal angle of bedding plane, its value ranges from 5° to 35° . When the slope becomes higher, the stable slope angle tends to converge to that of the norm of the bedding plane. The repose angle of slope debris ranges between 30° and 40° . Figure 14 is considered as a guideline for local engineers when selecting the slope-cutting angle in the actual restoration of the failed slopes.

Figure 14. Comparison of observational data with computational results from previous studies (ξ : intermittency angle; k : horizontal seismic coefficient; ϕ : friction angle).

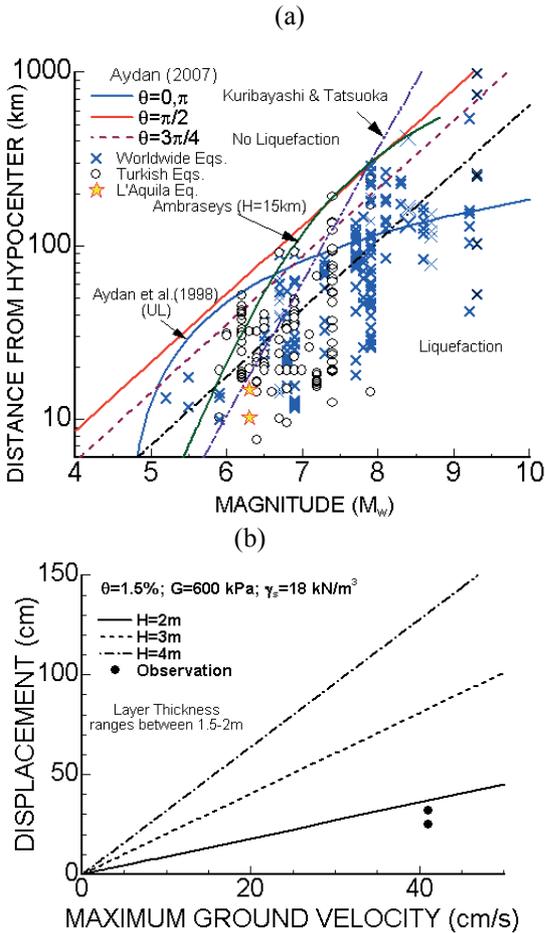
Figure 16a compares the authors' observations with the empirical bounds proposed by several researchers (Aydan et al., 1998; Aydan, 2007; Ambraseys, 1988; Kuribayashi and Tatsuoka, 1979) for the limit of ground liquefaction. The observations are within the limits of liquefiable ground. Since the data is quite limited now, new data may give more accurate results. An attempt was made to obtain data concerning

the ground deformation due to liquefaction-induced lateral spreading, using several methods. Aydan et al. (2008) proposed a new method based on the maximum ground velocity obtained from the strong motion records. Figure 16b compares the estimation of ground deformation for different layer thicknesses. The comparison with the observational data implies that the thickness of liquefied ground in the Martini district should range between 1.5 and 2 m. Additional comparison is based on the use of ground motion data in the close vicinity of the liquefaction site in the Martini district.

Figure 16. Comparison of observations with estimations from the method proposed by Aydan et al. (2008) based on maximum ground velocity.
