An analysis on the corrosion of a cultural heritage

Ömer Bozdoğan¹, Aydan Yaman^{*2}, Hacı Murat Yılmaz²

²Aksaray University, Engineering Faculty, Department of Geomatics Engineering, Aksaray, Turkey

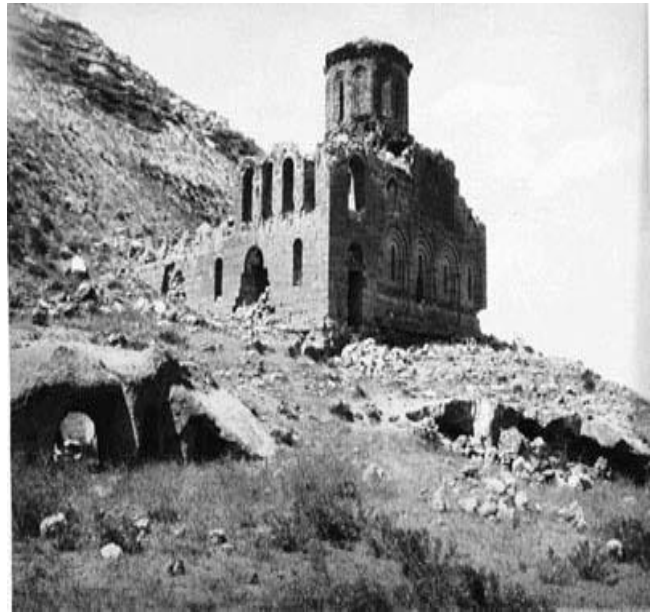
Figure 2. The situation of Çanlı Church in 1981

The bell, that the church was named after, could not be seen in the photograph, since it was stolen in ancient times. As seen in the picture, this historical building is

about to be destroyed due to the neglect. In addition to the local people looking for treasure, it is also thought that weather conditions have destroyed the structure.

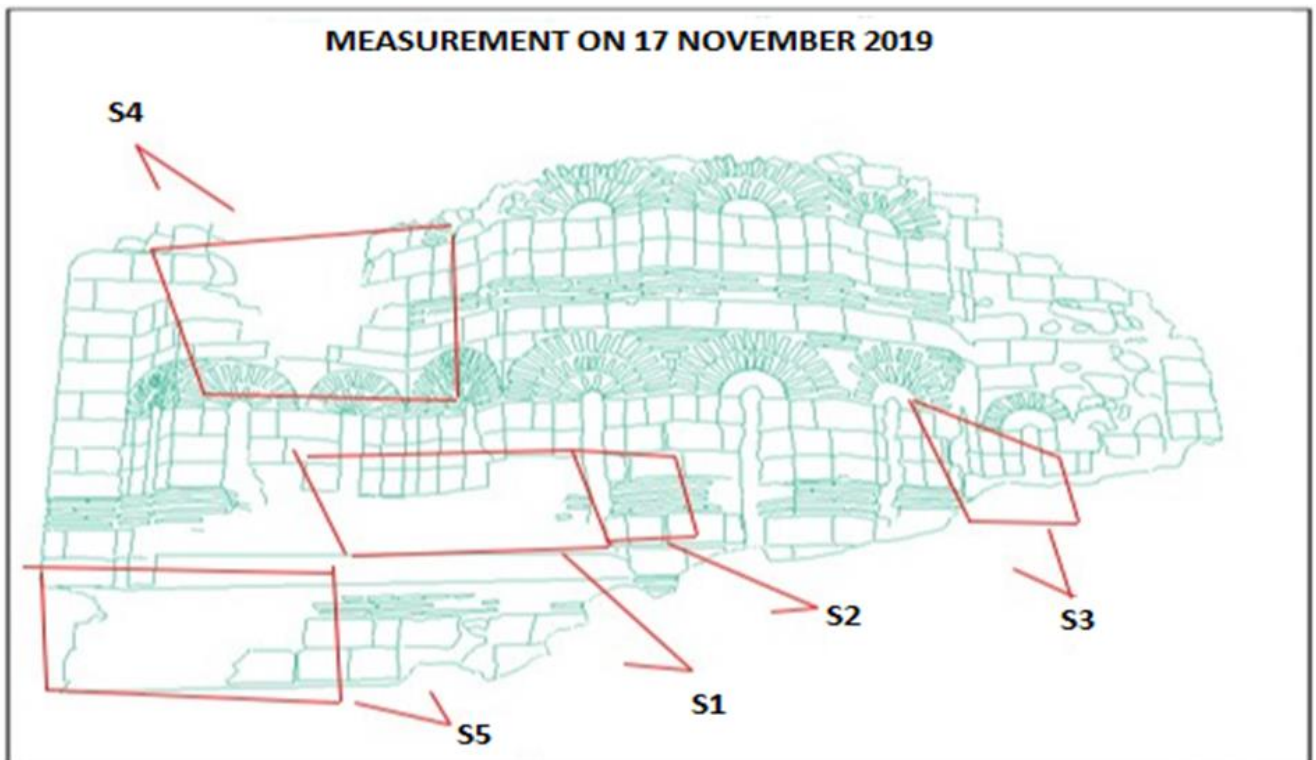
Figure 18. Measurement of Çanlı Church's south facade for 2019

When Table 1 was examined, the north facade area was calculated as 4.251.891,00 m², the west facade area was 3.860.913,00 m² and the south facade area was 7.629.097,00 m², in the studies conducted in 2006 and in comparison, with the areas in 2019, it is seen that the highest corrosion is on the South facade with 13%.
