Investigation of structural problems on the ground and walls of Diyarbakir Historical Behram Pasha Mosque by the georadar (GPR) method

Diyarbakir, Behram Pasha Mosque,
Georadar(GPR), structural problem

ABSTRACT

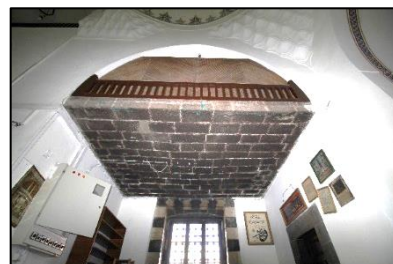
Figure 11. Flat floor made with interlocking stones under the mahfil (2021)

There are three iwan-shaped niches on the east and west sides of the harim. The vaulted iwans are arranged as two for each direction due to the crown door and the mihrab in the entrance region. The bottom of the mahfil region on the north wall is a flat slab paved with interlocking stones. In the original form of this floor, no binding material was used. However, in the restorations made over time, the spaces between the stones were partially filled with mortar, as can be seen in Figure 11.

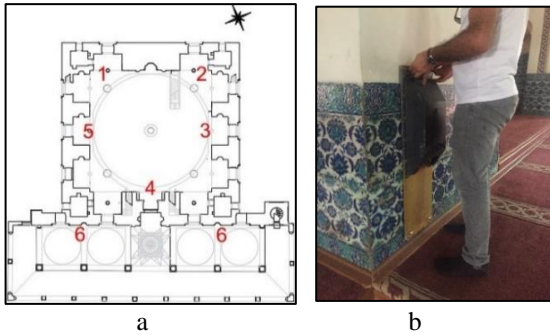
Figure 29. Locations and applications of GPR scans done on the mosque walls

In the Behram Paşa Mosque, GPRscans were made on the walls in the harim (Figure 29 a and b). In the scans made on the walls, the profile dimensions were taken as variable and the depth of the survey was chosen as 4.00 m. In some of the walls in the harim region, gap deformations due to cracks and fractures were detected.
