## Structural Analysis and Reinforcement of XVI Century Building in the Center of Naples, Italy

## 1. INTRODUCTION

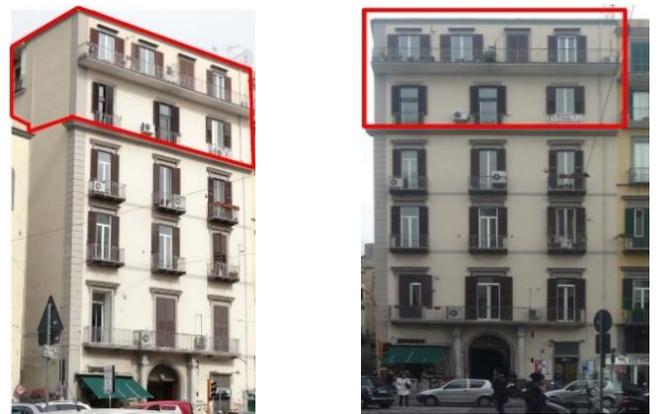
**Figure 8.** The facade of the building. In red the two floors probably added during the last two centuries

In the figures we can see that the decoration of frames in the window from the first floor up to the third floor are the same frames and finished with stucco decoration on the third floor. On the other hand, on the fourth floor in the very simple window without frames, it means that this floor was built at a different time from the floor below, perhaps in the year 1900 because of the construction technician of this floor still in masonry. After that, the top floor is recently built, because it is built in reinforced concrete.

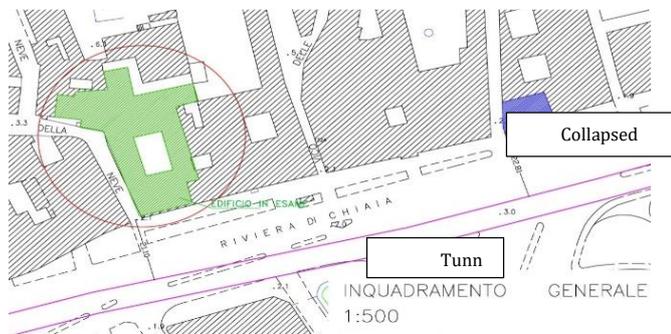
**Figure 9.** Map of the building, the tunnel line in construction and the collapsed building.

Among the anthropic damaging activity, we can remind the construction (2000-2015) of a new subway tunnel 15m in distance from the building and 20m in depth. On block more to the east, the “Guevara di Bovino” building (17th century) partially collapsed on March 4, 2013. “Fig. 9”.

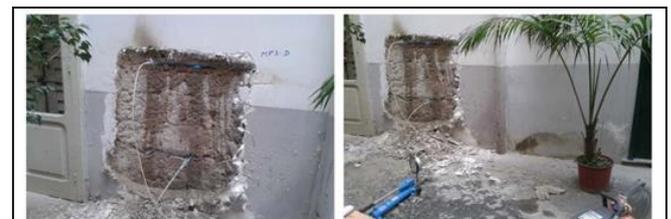
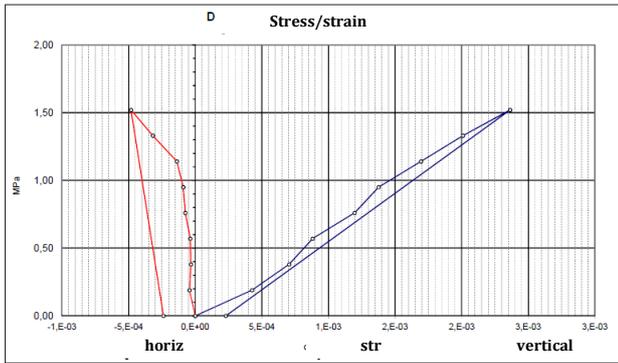
**Figure 11.** Flat jack test on the ground floor wall

Single jacks and double tests, carried out on the first floor and ground floor walls, gave an evaluation of the maximum stress of the masonry due to the vertical loads.

Analyzed interval	Pressure MPa	Vertical deformation	Vertical Elastic Modulus MPa
3-2	0.19	2.79E-04	681,76
4-2	0.38	4.56E-04	833,81

Figure 12. Test with flat jacks carried out on the ground floor wall

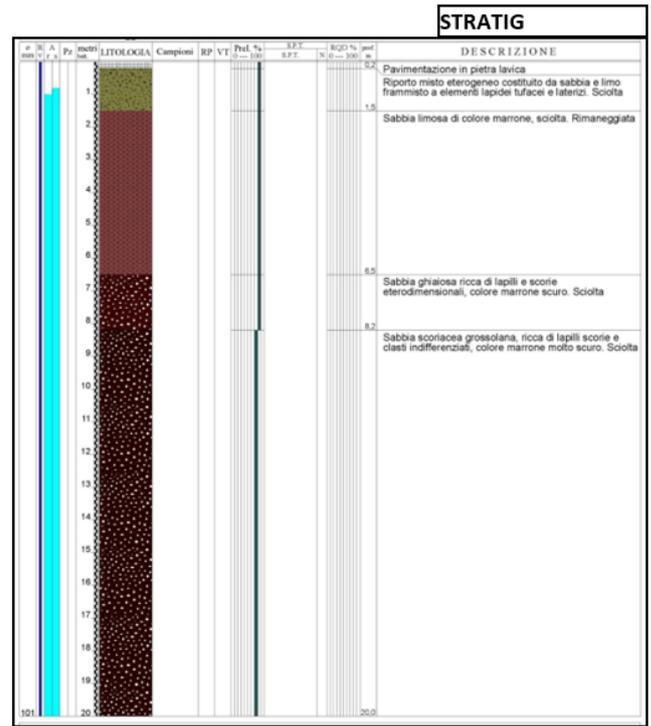
Figure 14. Stratigraphic column at the borehole S3

Stratigraphic column S3 (in the hole subsequently used for the inclinometer). It is evident the presence, expected, of sands and silts up to a depth of about 6.5 m from the ground level.

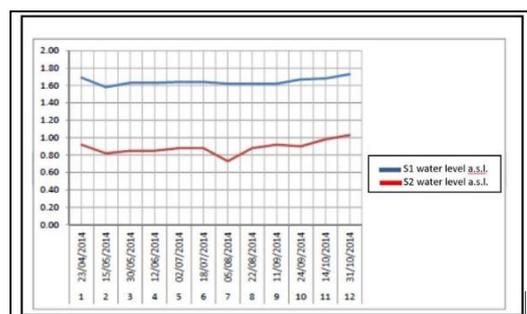
Figure 15. Piezometric control of the water table

The surveys were carried out for six months, during which an alternating behavior of the groundwater is plausible, for instance in conjunction with weather events, but also correspondence with any effects of, albeit modest, tides, and finally thermal variations. The hypothesis of a silty-clayey sub-layer, susceptible of short or medium-term response to changes in the water table, is confirmed. This means that the building, like many other buildings overlooking the Riviera di Chiaia, is subject to slow movements in the foundation which also affect the structure of the building itself. It is also true that the age of the building (hundreds of years) should have reduced this effect, and therefore the most recent movements can not be entirely correlated to this condition of variation of the groundwater table “Fig.15”.

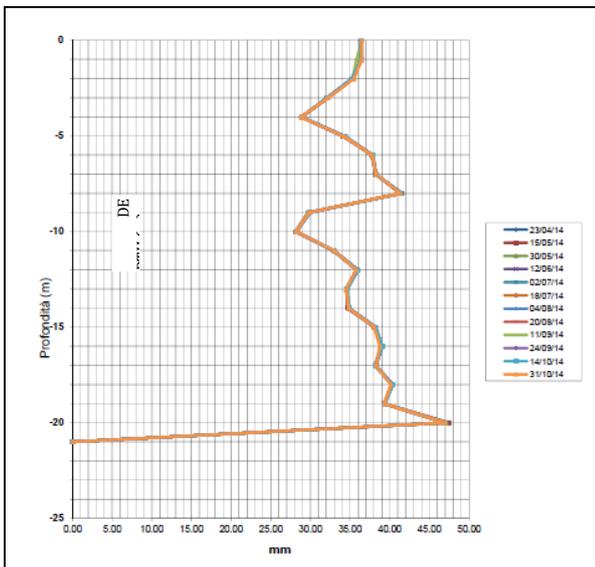
**Figure 16.** Horizontal displacement of soil borehole according to the inclinometer

- a. a deformation of the drilled pipe out of the lead of about 285 mm;
- b. a deformation trend represented by the graphs shown below;

Indeed the analysis of the data collected in the observation period studied, after an initial evolutionary trend in even minimal movement, corresponding to a settling of the measuring system, especially in the most superficial portion of the tube, it has not undergone further movements except within the range of less than 1.5 mm, which can be classified as part of the instrumental error.

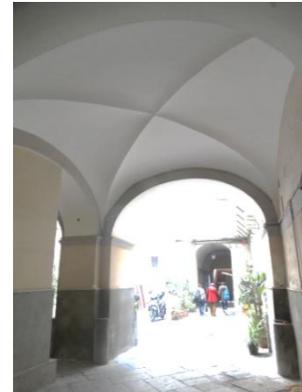
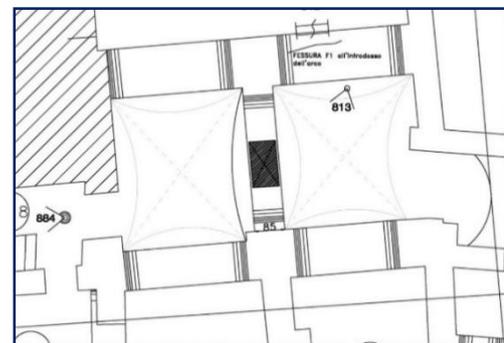
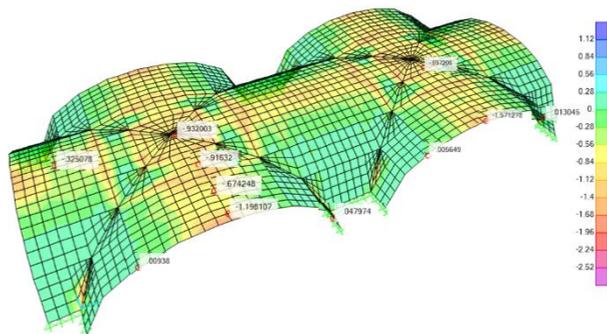
**Figure 22.** The cross vault on the ground floor, in the hall

The results of the non-linear analysis give an ultimate load of 650 kN, while the operating load is about 583 kN. Then the safety factor is as follows:

$$\eta = 650 \text{ kN} / 583 \text{ kN} = 1.12 > 1$$

We can conclude that the cross vault twin has a very limited structure safety factor, and probably some horizontal chain will help much to improve the resistance of the vault.

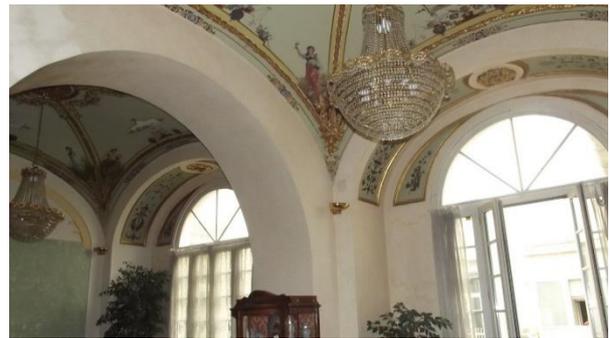
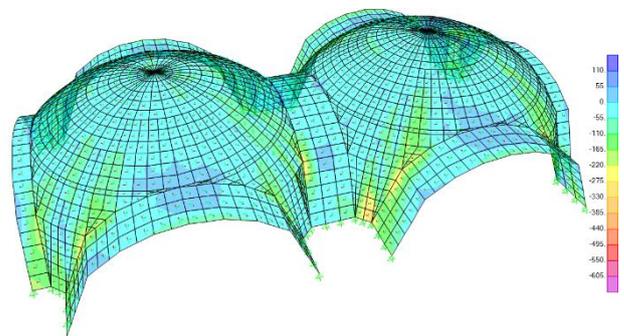
Figure 28. Photo of the sail vault on the first floor

Figure 29. Mesh of the double sail vault and stress for ultimate live load

The numerical analysis gives a structural safety factor of the existing sail vault equal to:

$$\eta = 1.078 > 1$$

The value apparently is higher than 1, but we should consider the variability of several parameters, which

could suddenly bring down the safety factor, and lead to the collapse. Then we decided to reinforce this double sail vault room with some chain bars which will increase safety. Two steel chain bars D=24mm have been foreseen for the common arch in the center of the room. In this case the new safety factor becomes:

$$\eta = 2.1 > 1$$

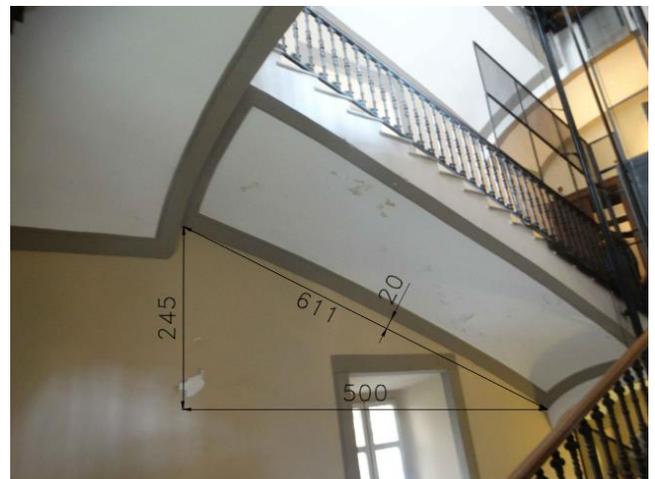
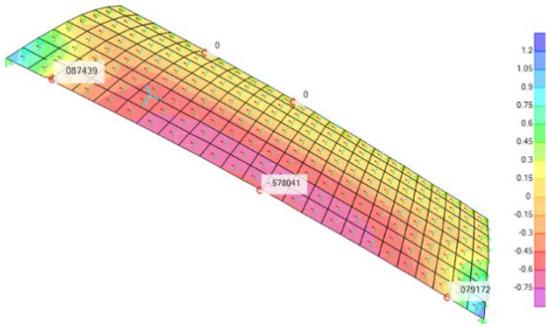
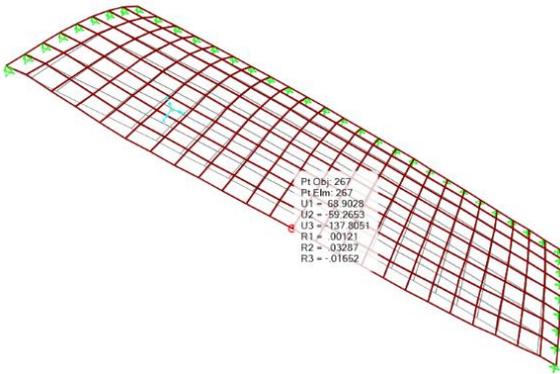
**Figure 34.** Roman-style rampant staircase and dimensions

The numerical analysis gives a total ultimate load of 335 kN, while the operating load (dead+live) is 128 kN. The ratio between ultimate live and operating live load is about

$$\eta=6$$

Since by code we need at least a safety factor of 1.9, it means that the staircase is safe enough, and doesn't need any reinforcement operation.
