A Proposal for the Restoration of the Satici Dwelling in Corum

Pınar KARAKURT¹, Özlem SAĞIROĞLU^{2,*}

ABSTRACT

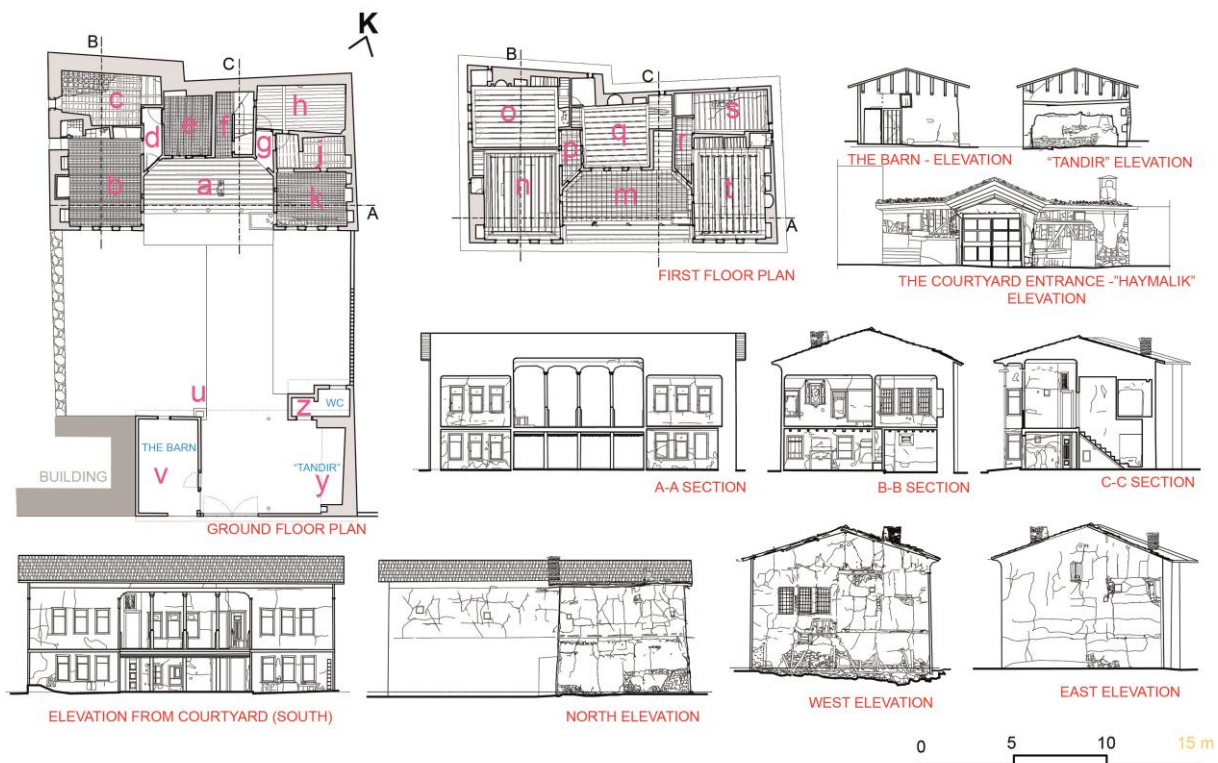
Figure 3. Measured drawing of Satıcı dwelling

The stairwell, winter rooms, and halls on the ground floor that connect to storage are opened to the *taşlık*. The wooden poles that carry the open sofa on the upper floor reach the *taşlık*, which is rectangular with beveled edges (Fig. 3a). The height of the ground floor is 220 cm. Two of the rooms are situated on the west and the east sides of the *taşlık*, and they are designed to be luminous and spacious with their windows opened to the courtyard. The room on the west side was used as a kitchen before the building was abandoned (Fig. 3b).

The room on the east was divided into two rooms (Fig. 3j, k). The other room on the north side is dark because its windows open to the *taşlık* (Fig. 3e).

All the rooms have architectural elements like furnaces, closets, niches, lamp stands, and abluion niches. Storage areas were designed in the back of the western and eastern rooms. The *mazgal* loop hole of the western storage room is original (Fig. 3c). There is an original window with wooden fences that opens to the stairs on the eastern storage room (Fig. 3h). Storage rooms are connected to the *taşlık* with halls (Fig. 3d,g). Another space that opens to the *taşlık* is the stair hall, which connects the *taşlık* and the open sofa (Fig. 3f).
