# Elasto-Plastic Deformation of a Liquid Ammonia Storage Tank

Göksel Saraçoğlu<sup>1</sup>

## ABSTRACT

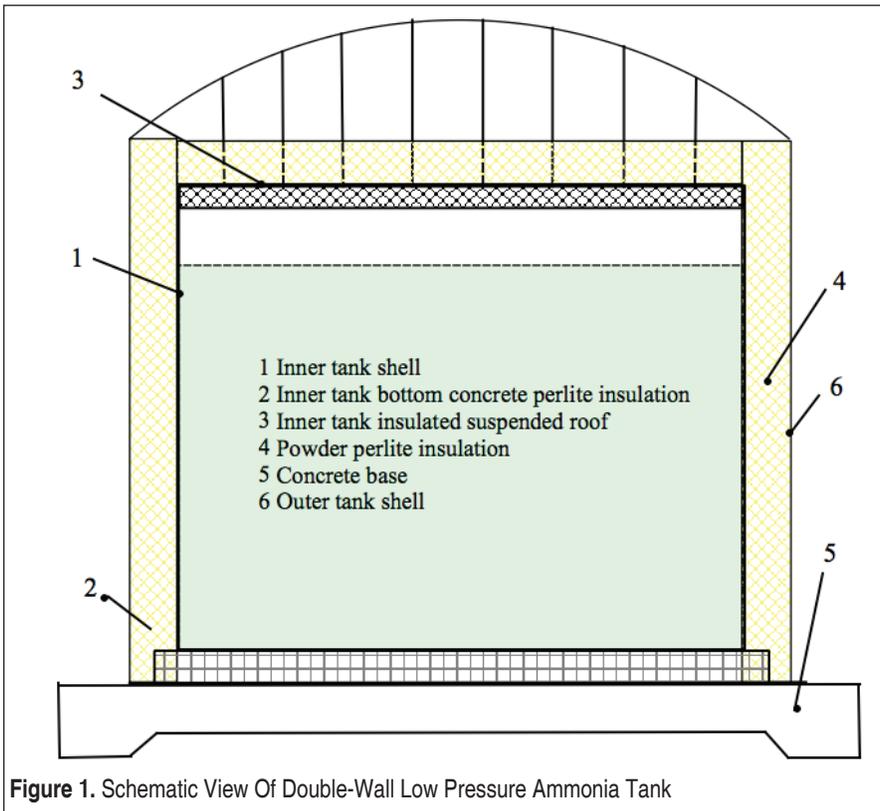
tomed tank with a 10,000 tonnes capacity, constructed according to API Standard 620 and 650 [1, 12] and in which anhydrous liquid ammonia at  $-33^{\circ}\text{C}$  is stored (Figure 1). Perlite-based insulation materials are used to maintain the temperature of the product between the two tanks.

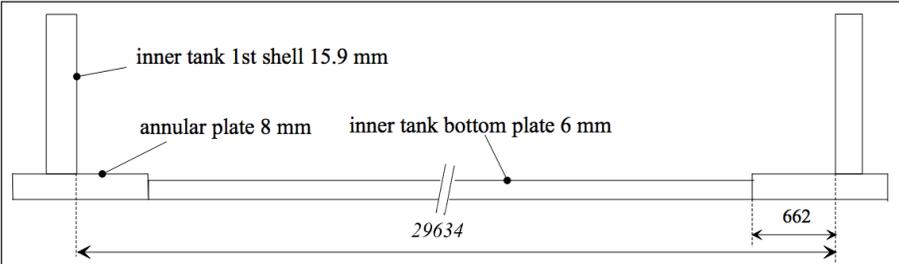
Figure 6. The Schematic Section of Inner Tank

The inner bottom diameter of the anhydrous ammonia tank is 29,634 mm. This length is the distance (diameter) between the inner surfaces of the first shell. In the part of this area adjacent to the inner shell, there is an 8 mm thick annular plate around the perimeter. Its width is 662 mm from the inner face of the first shell. The diameter of the 6 mm thick base is 28,310 mm (Figure 6).

The (common) force to restore this thermal contraction will be 0.0244 P as a result of Eq. 2. The lengths of the (each) 8 mm thick part ( $L_1$ ) and the length ( $L_2$ ) of 6 mm thick part of the strip are 668 mm and 28310 mm, respectively.

This imaginary strip will not be contracted due to the restraint of the first shell, despite the temperature difference of  $63^{\circ}\text{C}$ . So, Eq. 1 and 2 will be equal to each other. In this case, the force  $P$  will be 943 N. The principal stress that will occur in strip sections of 6 and 8 mm thickness will be 157 MPa and 118 MPa, respectively.

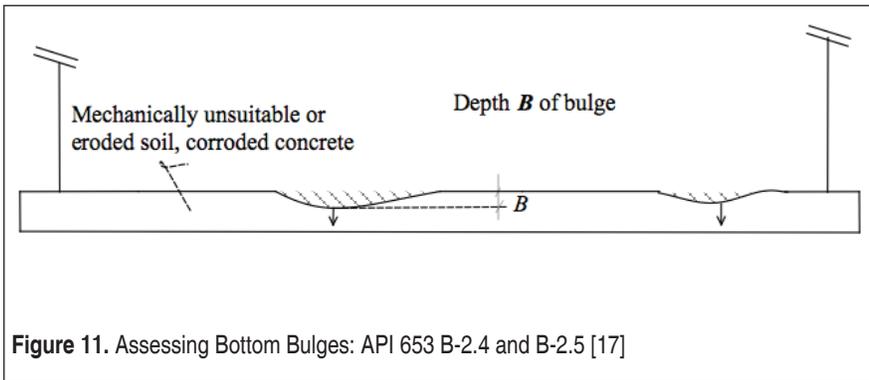
The fact that the bottom plate has a wavy structure at the end of plastic deformation can lead to some mistakes for the tank owners in the evaluation according to the Standard in the first place. The wavy structure of the bottom plate was evaluated as the 'bulges' specified in Annex B2 of the API Standard 653. Therefore, it was concluded that the bottom plate should be renewed as it exceeds the bulge limit specified by the Standard. But, bulge is a subject related the erosion of the insulation material under the bottom plate. The recess or bulge is dangerous when the tank is full because there is no contact between the floor (bottom) plate and the structure below it (Figure 11). However, there is no erosion problem in the sub-insulation structure of the tank in question and is related to the plastic deformation of the bottom plate.

The bottom plate consists of a number of plates that are overlap welded on each other. A limit of plastic deformation due to thermal stress is also specified in B4.2 of the Code. In the Code, it is stated that those that have undergone 2-3% plastic deformation should be replaced.

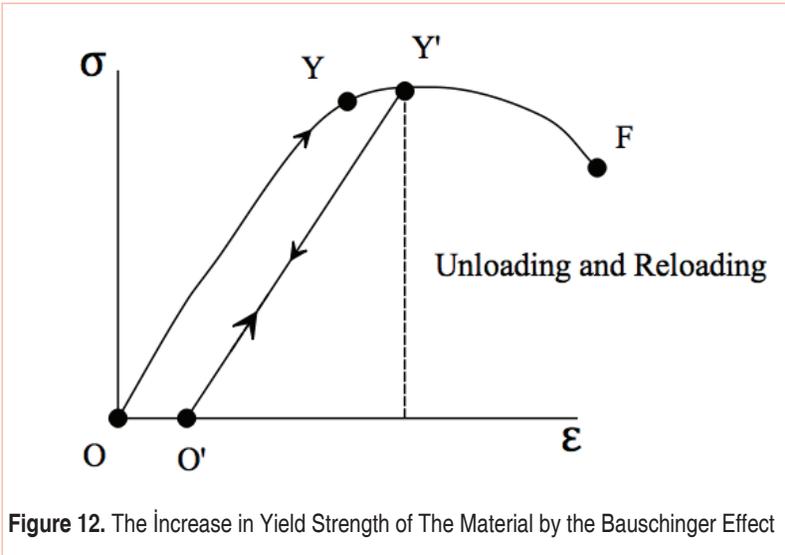
As seen in Figure 12, when a stress  $Y'$  above the yield stress  $Y$  is applied to a material and the stress is removed, the elastic stress path of this material under the stress will now be  $OYY'$ , the new yield strength  $Y'$  and plastic deformation  $OO'$  [19].

A material that has exceeded its yield strength or has undergone plastic deformation is not completely in an undesired condition. However, it should be noted that the area under the stress-strain curve gradually decreases as a result of plastic deformation. The curve follows the path  $O'Y'$ , and the area  $OO'YY'$  is lost. The API-653 Code

requires the replacement of the relevant bottom plates in the case of an average of 2.5% plastic deformation. Assume that the yield strength of the bottom plate used in the tank is 265 MPa and a new yield strength of 358 MPa has been reached due to strain hardening, and in this case, the percentage of plastic deformation needs to be determined by using the Ramberg-Osgood criterion [20].
