Detection of Stone Material Deterioration in Historical Masonry Buildings by Observational Methods: Mardin Former American Missionary College

Lale Karataş¹

Mardin Former American College, which remains within the protected urban archaeological site in Mardin, is a unique cultural monument, which survives over the years, despite exposure to many environmental influences. A classification was made within the scope of the study, based on the deterioration patterns intended for the material deteriorations in the literature, to determine and document material degradation regarding the Former American College. Literature research, determination via observation, and documentation through photographing methods were used in the study. The information obtained was assessed via the descriptive and systematic analysis methods. The deterioration types obtained in the first stage of the study were obtained by carrying out an archive review regarding the stone material deterioration types. In the field research stage, Mardin Former American College was investigated and photographed. As a result of the observations, the deteriorations determined on the stone materials used in the building were

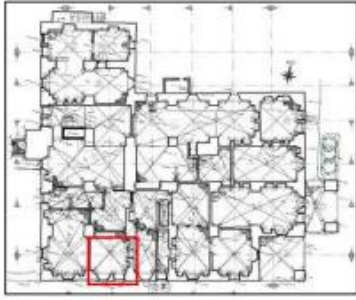
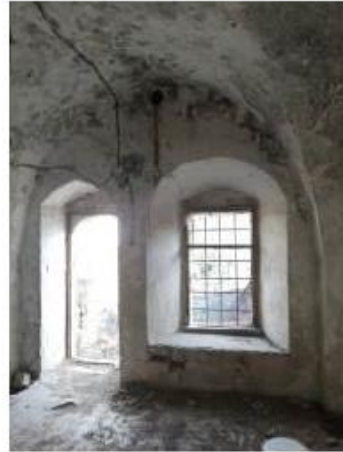
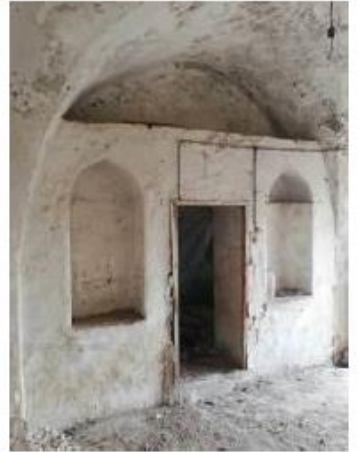
Damaged domes and vaults on horizontal carriers were examined. Fall of plasters and formation of moss due to humidity were not observed on the vaults, which are the horizontal bearings (Figure 14-15).

Figure 14. Examples of plaster fall on the vaults (Karataş,2022)
