## CORROSION OF INDUSTRIAL FRIT FURNACE REFRACTORIES: A POSTMORTEM STUDY

### ABSTRACT

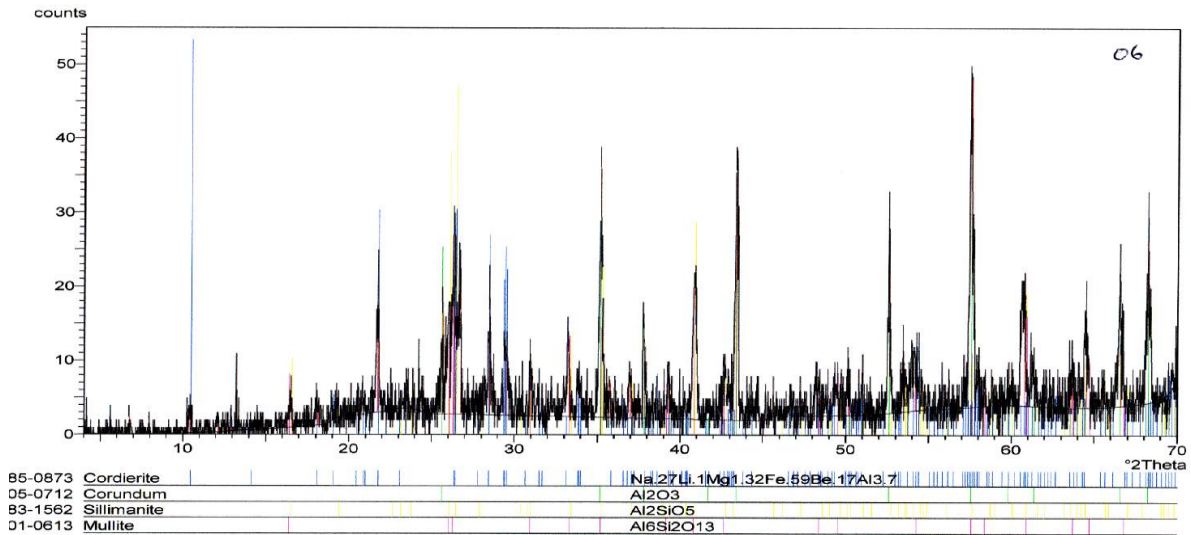
The XRD diffraction pattern of the unused refractory brick of the same type of the analyzed corroded brick is given in Figure 9. The major crystal phase was mullite with minor amounts of corundum and trace amounts of sillimanite and cordierite. The increased ratio of mullite to alumina in comparison to the corroded brick provided evidence of the higher dissolution rate of mullite with respect to alumina.

**Figure 9.** The XRD pattern of the unused refractory brick (GS-M-Unused)

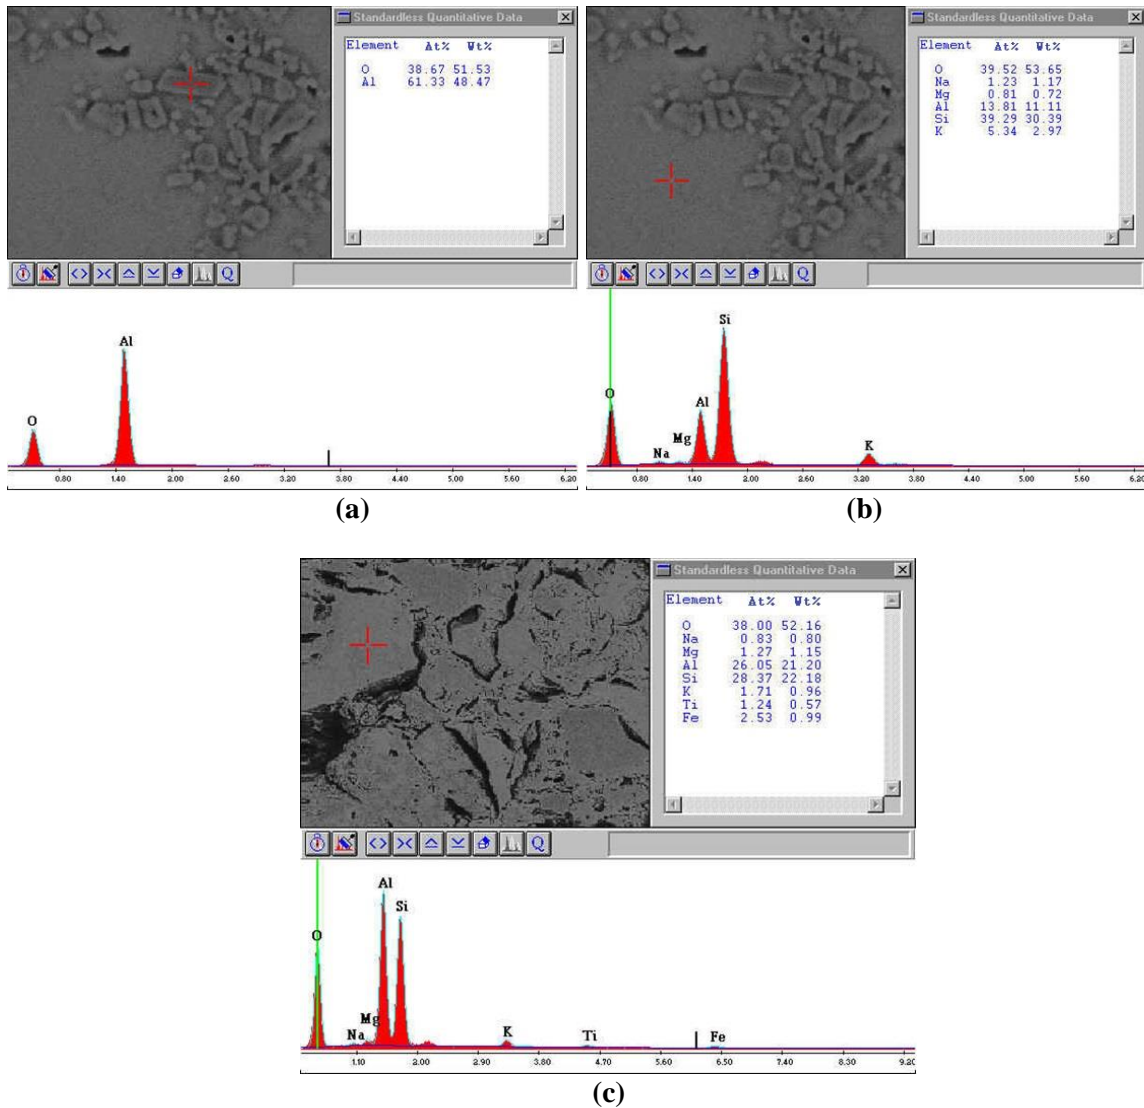
The RL-OM and SEM images of the unused brick are shown in Figure 10a and 10b. The EDS analyses results are given in Figure 11. The crystals of approximately 7 µm size embedded in the matrix were determined to be alumina (Figure 11a). The surrounding matrix was found to be of glass structure incorporating mullite crystals (Figure 11b) deduced by stoichiometric considerations. The EDS analysis of the grain inside the structure revealed that it comprised a mixture of corundum, mullite and glass. The small quantity of polyvalent elements Fe and Ti might cause first push exudation during the initial heating of the furnace leaving behind a porous structure as was the case of corroded brick. The lower porosity of the unused brick as compared to the corroded brick supported the exudation mechanism.

**Figure 11.** (a) EDS analysis of crystals of size ~ 7 μm embedded in the matrix of the unused refractory brick (b) EDS analysis of the glass matrix of the same unused refractory brick, (c) EDS analysis of a large grain in the structure
