Engineering Geological Assessment of a Slope Instability: A Case Study in the Guzelyali Region (Canakkale, Turkey) *Bir Şev Duraysızlığının Mühendislik Jeolojisi Değerlendirmesi: Güzelyalı Bölgesinde Bir Vaka Çalışması (Çanakkale, Türkiye)*

Guzelyali village, 20 km southwest of Canakkale city, is located on the shore of the Canakkale Strait (Dardanelles). The residential area located at the entrance to Guzelyali village has experienced landslides at different times since November 2001. In February 2013, the Güzelyalı landslide was triggered again due to severe rainstorms. As a result of the landslide, deformations and cracks formed in buildings, garden walls and the Canakkale-Guzelyali road. In this study, the aim was to determine the most appropriate improvement method to prevent landslides by determining the depth of the slip surface that caused the Guzelyali landslide and the geotechnical properties of the units. For this purpose, field observations, drilling, obtaining appropriate samples from these works for index and mechanical tests and monitoring studies by using inclinometers were carried out in order to evaluate the instability. As a result of inclinometer measurements,

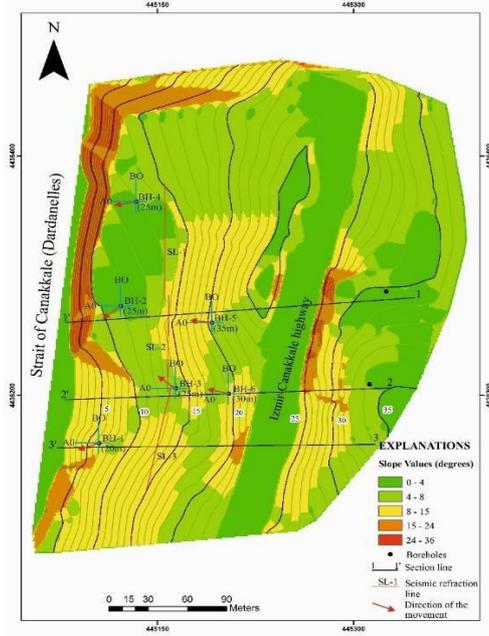
One of the important parameters for landslide analysis is topographic data. The general topographic and morphological features of the Guzelyali landslide area were evaluated using a digital elevation model created from the 1/1000 scale topographic map of the region. The toe area of the Guzelyali landslide is located on the shore of the Canakkale Strait (Dardanelles), and the distance between the crown area of the landslide and the toe area is approximately 250 meters. The topographic elevation of the landslide area ranges from 0 to 35 m. The slope of the study area generally varies up to 15°. However, perpendicular to the coast, the slope increases to about 25° and 36° (Figure 2).

Figure 2. Slope map of the study area with movement direction of the landslide based on the inclinometer data.

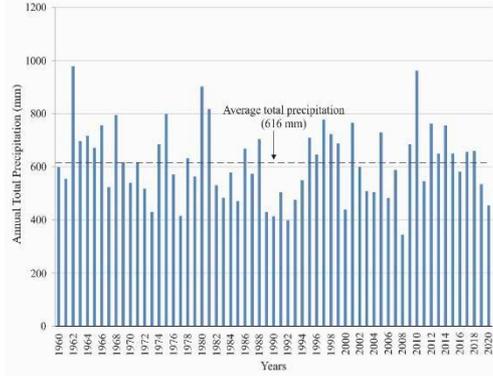
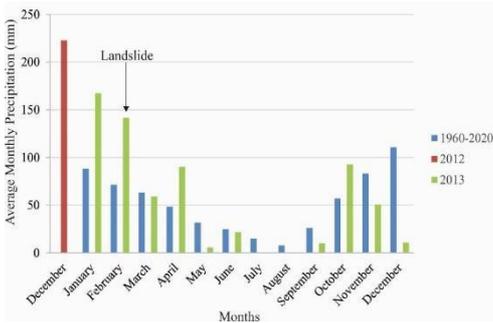
approximately 55 mm and 616 mm, respectively (Figure 3a). When the precipitation data recorded by Canakkale Meteorology Station is examined, the amount of precipitation falling in December 2012 and January and February 2013 was approximately twice as much as the average precipitation amount for the same months between 1960 and 2020. In other words, the total monthly precipitation values recorded by the Canakkale Meteorology Station were 222.7 mm, 167.4 mm and 141.6 mm for December 2012 and January and February 2013, respectively (Figure 3b). However, the long-term (years of 1960-2020) precipitation values for December, January and February obtained from Canakkale Meteorology Station were recorded as 110.8 mm, 88 mm and 71 mm, respectively.

Figure 3. a) Variation of annual precipitation values recorded in Canakkale meteorology station, b) histograms showing long-term (1960–2020 and 2013) monthly precipitation values for Canakkale.

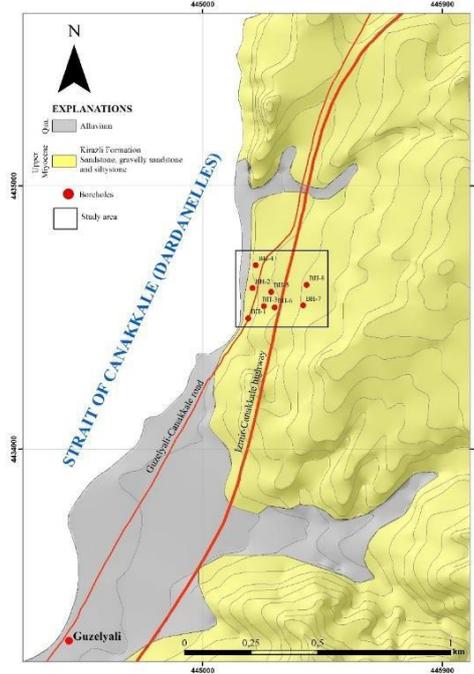
Figure 4. Geological map of the study area.
