Analysis of Stone Deterioration on the Facades of Hatuniye Madrasah

Citation: Biçen Çelik, A., Ergin, Ş., Dal, M. & Ay, İ. (2023). Analysis of stone deterioration on the facades of the Hatuniye Madrasah. *Journal of Architectural Sciences and Applications*, 8 (1), 355-369.

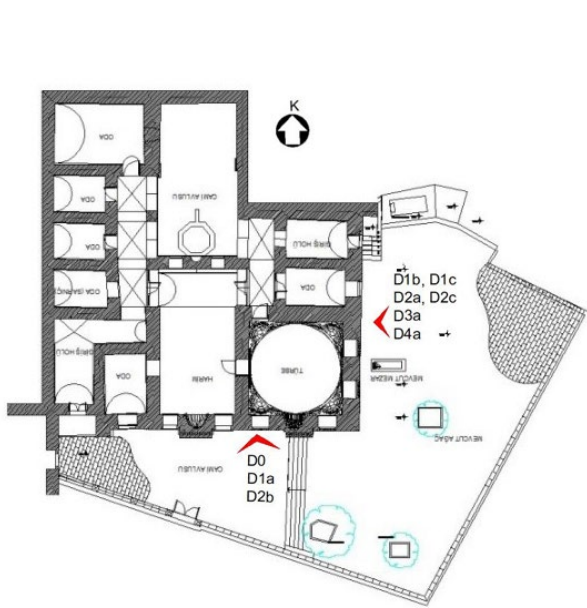
All types of deterioration occurring in Hatuniye Madrasah were analysed with the codes determined by X-Ray Fluorescence Spectroscopy (XRF chemical analysis method). The codes determined (Table 6), the representations of the selected stones on the plan (Figure 8) and on the façade (Figure 9) are given below. The main purpose of analysing the materials of historical buildings is to obtain information about the physical and chemical composition of the materials as well as the production technology (Karataş, Alptekin & Yakar, 2022).

Figure 8. The plan representation of the stones selected for the use of XRF chemical method for the deterioration of Hatuniye Madrasa

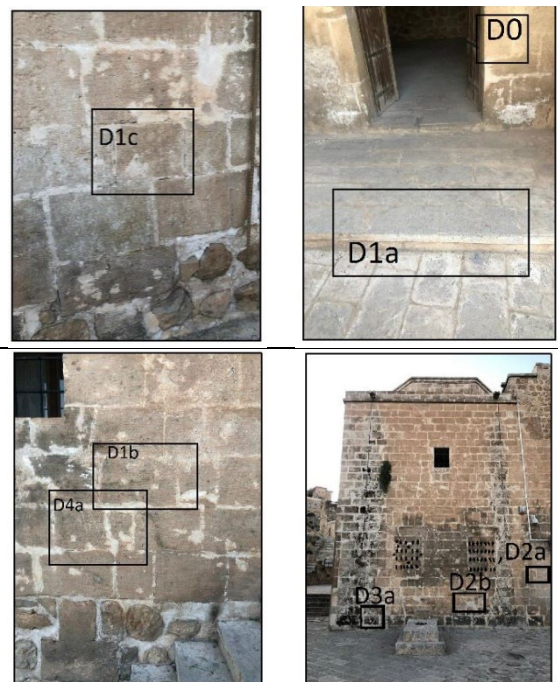
Figure 9. Demonstration of the stones selected for the use of XRF chemical method for the deterioration of Hatuniye Madrasah on the façade

The results of the analysis of the physical deterioration in Hatuniye Madrasah according to XRF analysis method are given in Table 7. According to the results of the analyses, while the SiO₂ ratio in stone D0 was 7.93%, this ratio was 26.27% in stone D1b. In addition, while the SO₃ ratio in D0 stone, which is determined as clean stone, is 28.83%, this ratio is lower in other stones. The high rate of SO₃ causes damage to the stones as a result of air pollution. No serious changes were observed in other components. In stones with different mineral contents, physical degradation such as joint failure,
