## Geomorphological deformation examples induced by the February 06, 2023, Pazarcık earthquake (Kahramanmaraş, Türkiye)

Hüseyin Turoğlu<sup>a</sup>

Osman Sarıgül<sup>b</sup>

DOI: 10.17211/tcd.1313551

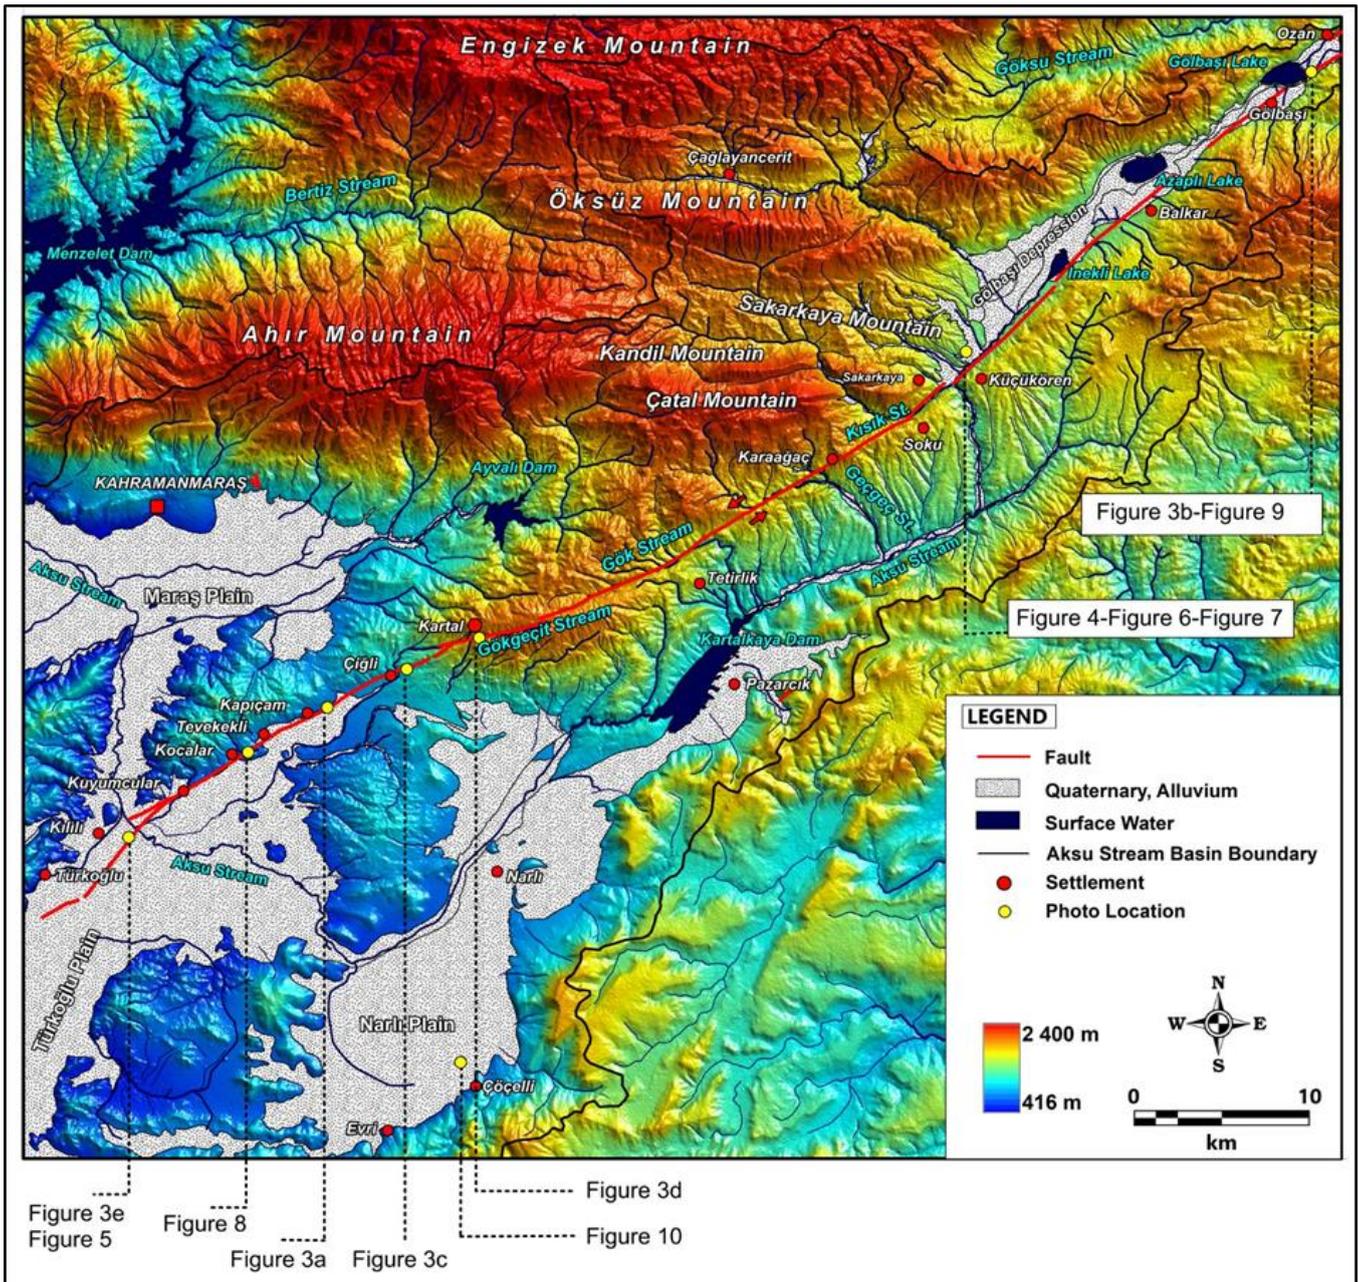
Figure 2: EAF Pazarlık segment and locations of described geomorphological deformation samples of the tectonic movement.

Although its main direction is SW-NE, the  $\pm 85$  km long left-lateral strike-slip fault shows a loose sinusoidal curvature (Figure 2). While the surface rupture of the left lateral strike-slip fault is roughly in the SW-NE direction between Türkoğlu and Çiğli, it makes a slight turn towards ENE in the Çiğli-Kartal section and continues roughly in the WSW-ENE direction. The surface fracture then turns NE in the vicinity of Sakarkaya slightly and is followed in this direction in the Gölbaşı depression. The strike of the fault in Gölbaşı depression is
