## Investigation of the Damages Due to Heavy Earthen Roofs on Masonry Buildings during the Kahramanmaraş Earthquakes

### ABSTRACT

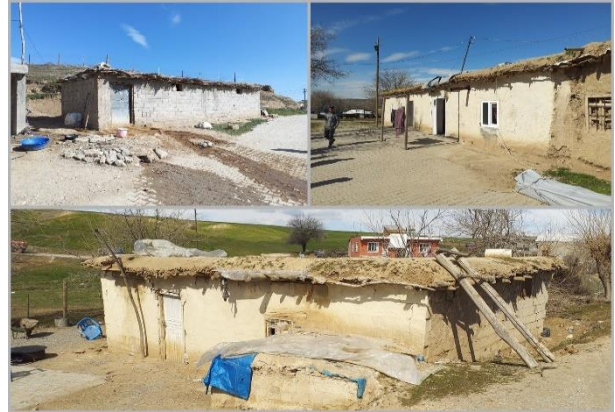
In the examinations carried out in the region, samples of heavy earthen roofs that were not damaged at all were also found. Examples of heavy earthen roofs that have never been damaged are shown in Figure 15.

**Figure 15.** Example of heavy earthen roof with no damage
