ISSN: 2667-8764 , 5(2), 248-271, 2023

Analyzes of Stone Deterioration on the Facades of the Şehidiye Madrasah in the Central District of Mardin Province

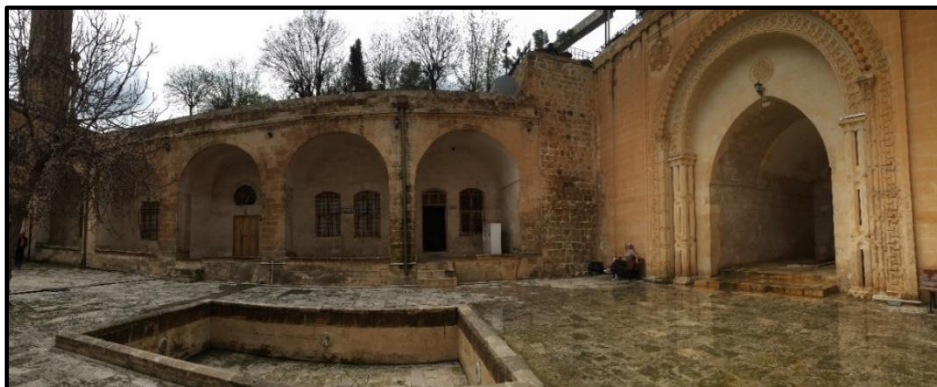
Figure 5. Facade photographs of Şehidiye Madrasah

Cracks in stones can result from weather conditions and petrographic properties. Additionally, vibrations arising from natural catastrophes like earthquakes, fires and frost may also lead to cracks on stone surfaces (ICOMOS, 2008). As a consequence of the weather in Mardin province, the structure experienced thermal shock, resulting in capillary cracks in the limestone which comprises the primary material of the structure (Figure 5a). The façade of the building exhibited joint failure (Figure 5b and Figure 5c) and fragmentation (Figure 5d and Figure 5e), likely due to surface abrasion caused by dust grains carried by the wind (Figure 5f) over an extended period.

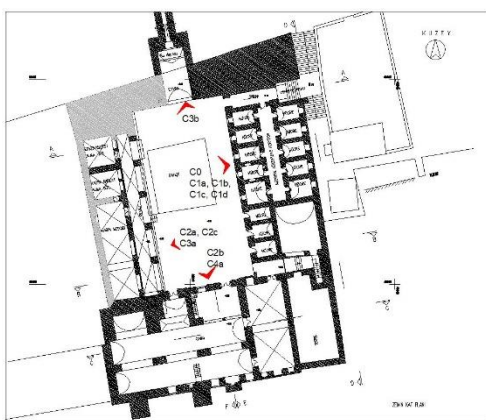
All forms of damage that happened in the Şehidiye Madrasa were examined using codes determined by X-Ray Fluorescence Spectroscopy (XRF chemical analyze method). The codes found (Table 7), along with depictions of the chosen stones on the blueprint (Figure 10) and on the front (Figure 11), are provided below. The primary aim of examining the stone structure of historic buildings is to identify the physical and chemical elements present in the stone material and respond accordingly (Karataş, Alptekin & Yakar, 2022).

Figure 10. The plan representation of the stones selected for the use of XRF chemical method for the deterioration of Şehidiye Madrasah

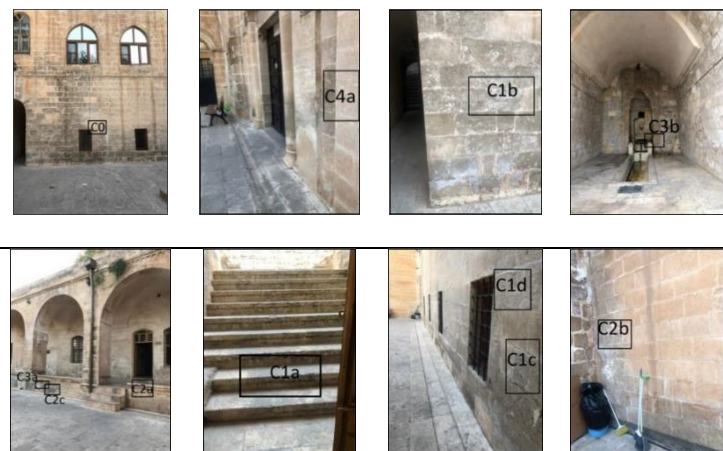
Figure 11. Demonstration of the stones selected for the use of XRF chemical method for the deterioration of Şehidiye Madrasah on the façade
