## Evaluation of Earthquake-Related Damages on the Reinforced Concrete Buildings due to the February 6, 2023, Kahramanmaraş-Türkiye Earthquakes

Zeliha TONYALI<sup>ID</sup>, Adnan KIRAL\*<sup>ID</sup>

\*Recep Tayyip Erdogan University, The Faculty of Engineering and Architecture, Department of Civil Engineering, 53100 Rize, Türkiye

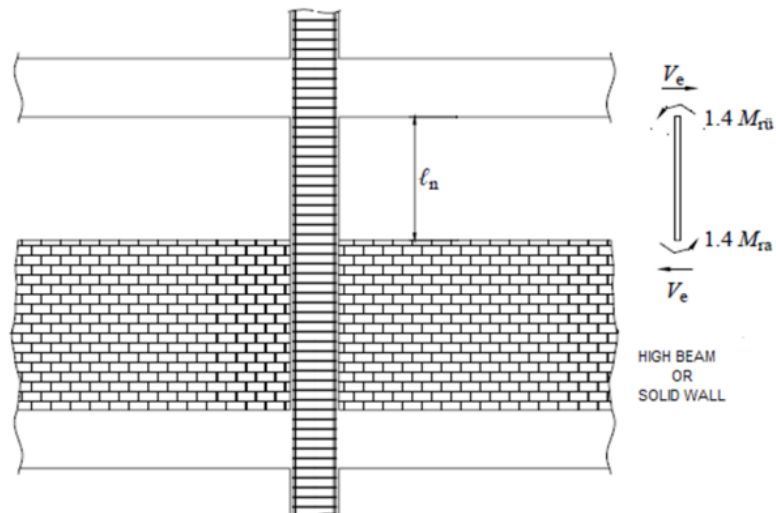
**Figure 12.** Shear force calculation for transverse reinforcement in accordance with the latest Turkish code (TBEC, 2019)

failure. This type of critical failure is shown in Figure 11. Calculating the shear force for transverse reinforcement in accordance with TBEC (2019) is given in 12, where  $M_{bottom} = 1.4M_{ra}$ ,  $M_{top} = 1.4M_{r\ddot{u}}$ ,  $V_e$  and  $l_n$  indicate calculated shear force and the length of the short column, respectively.
