## Architectural Heritage After the February 6th Kahramanmaraş Earthquakes: Preliminary Observations on Historical Masonry Structures

Sedef KOCAKAPLAN SEZGIN<sup>1\*</sup>

, Özden SAYGILI<sup>2</sup>

<sup>1</sup> Bursa Technical University, Faculty of Engineering and Natural Sciences, Department of Civil Engineering, Bursa, Türkiye<sup>2</sup> AtkinsRéalis, Leeds, United Kingdom

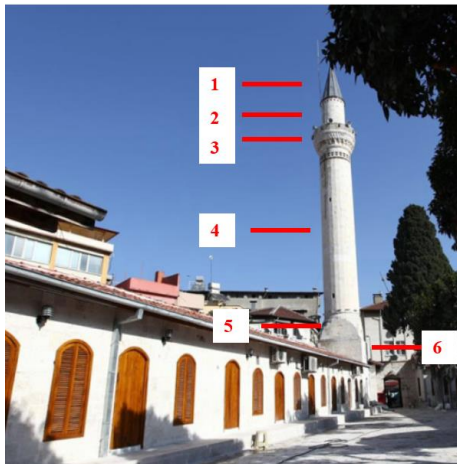
**Figure 15.** The Grand Mosque of Antakya before the Kahramanmaraş Earthquakes and details of a typical minaret (Antakya Municipality, 2015).

Due to their height and slender nature, these structures are vulnerable to seismic forces, which can cause them to sway and potentially collapse.
