Art-Sanat

Architectural Investigation and Material Characterization of Byzantine Brick Masonry Church: A Case Study of the Üç Ayak Church

Merve Başgül¹ & Şerife Özata²

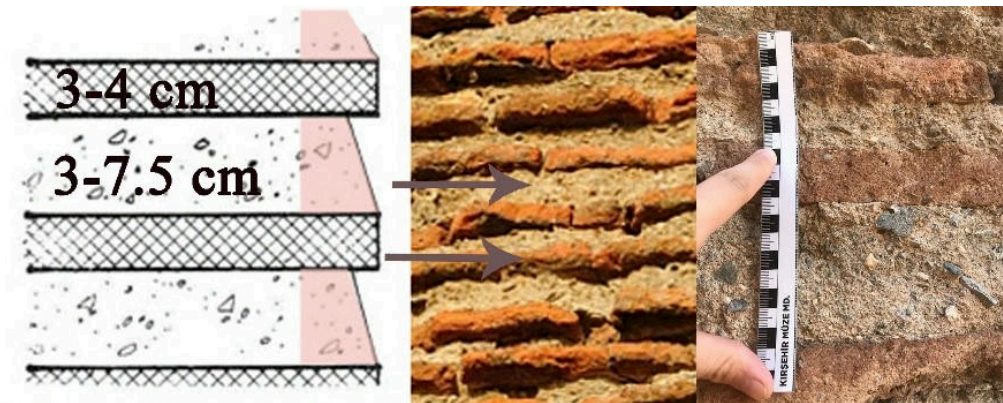
Figure 6: (a) Structural wall detail of Üç Ayak Church.

The foundations, plinth, and upper-inner parts of the west façade of the Üç Ayak Church were constructed using rubble stone, whereas the rest of the building was made entirely of brick material. The masonry building was constructed using the hidden brick technique, which was developed in the 11th century³⁵. Thus, the use of the hidden brick technique in the construction of this edifice serves as a strong indication that it belongs to the 11th century. The bricks used in the construction were mostly 35 cm x 35 cm in dimension, with occasional use of larger 70 cm x 35 cm bricks. Nevertheless, in exceptional instances, certain bricks were noted to measure 21x35 cm. The thickness of the bricks ranged between 3 and 4 cm, and the mortar used between the bricks was observed to be around 3-7.5 cm thick (Figure 6). Furthermore, the mortar used had a soft consistency and a dirty white, which differed from the present-day lime mortars. It is observed that to protect the soft mortar, a thinner layer of more durable and red mortar was added in front of it. This application applied to mortar joints is called weathered or struck pointing. Since the mortar applied for struck pointing is red, which is different from the main mortar, it is thought that it contains ground brick dust fragments and therefore has pozzolanic properties.

The used technique and type of mortar are unique features that have not been found in the wall craftsmanship that was discovered in the Üç Ayak Church.
