## ENGINEERING SEISMO-GEOLOGICAL JUSTIFICATION OF THE BAYIL LANDSLIDE IN 2018

### Objective

Determining the contours of a probable landslide-prone territory based on the method of engineering seismic exploration and studying the deep structure of fractured environment.

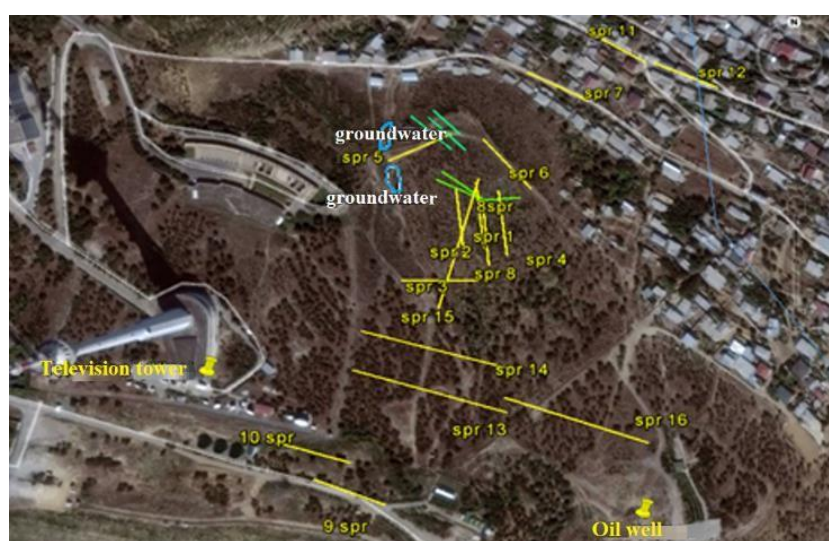
Fig. 3. Scheme of seismic profiles in the study area (16 different profiles developed)

16 seismic profiles were built and processed in the area. Profiles 1, 2, 4, 5, 6 and 15 were constructed by cutting through the fractured zone observed in the area. Profiles № 1÷12 have a length of 55 m, and profiles № 13÷16 - 115 m.
