## Structural analysis of Ahlat Emir Bayındır Bridge

There are many historic buildings belongs to many civilizations in the Ahlat province. The fact that these structures survive for a very long time is directly related to the construction techniques of these structures. Emir Bayındır Bridge is one of the buildings that could stay solid. With this study, it is aimed to investigate the behavior of the bridge under earthquake effect. First of all, general information is given about the bridge. In this study, structural analyzes were carried out for the Ahlat Emir Bayındır Bridge after on-site inspections. Information about the damage that occurred over time in the bridge is given in this study. Observation based structural analysis form has been created for the bridge. A finite element model of the bridge was created with the help of on-site measurements. Analyzes were made for the created finite element model in different load cases. The obtained results were interpreted and recommendations were made.

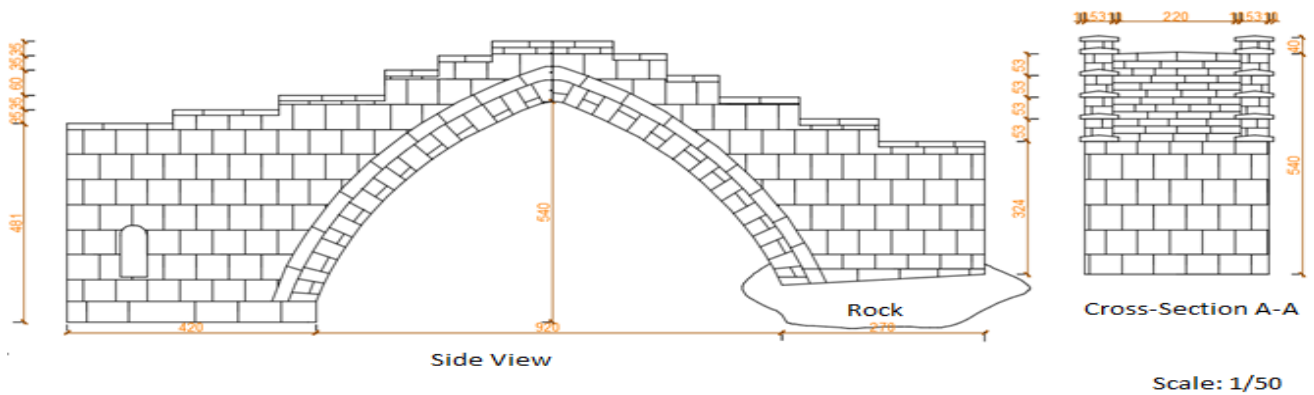
Figure 3. Dimensions of the inspected bridge

The total length of this bridge is 45 meters, the main body length is 16.10 meters, the span width is 9.20 meters and the height of bridge is 6 meters. The structural analysis based design of the bridge, which is considered in the study, is shown in Figure 3.

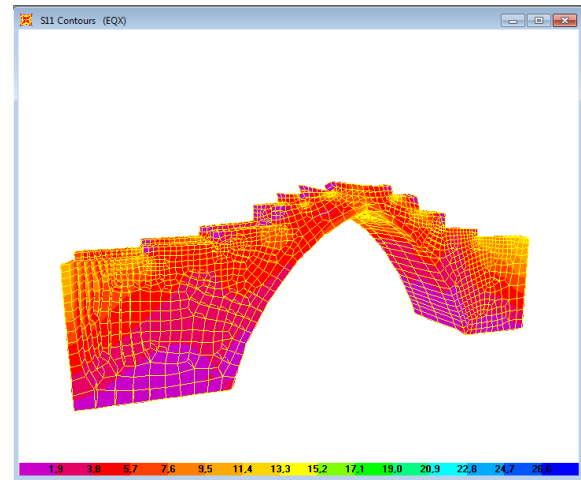
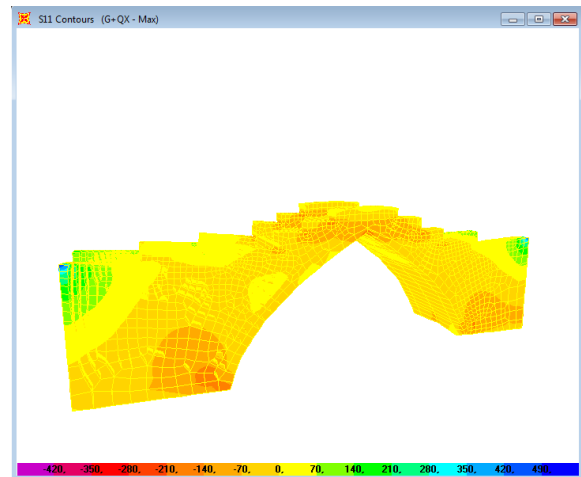
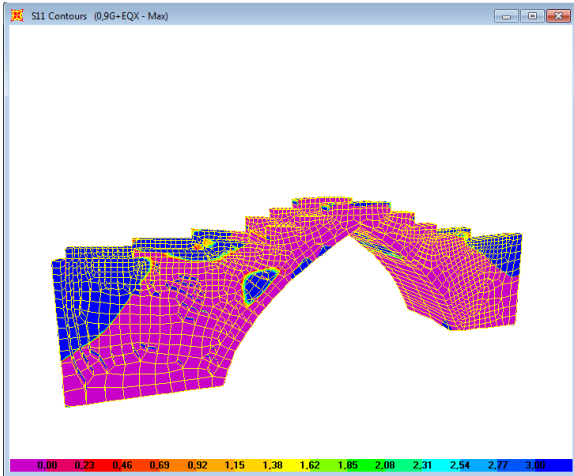
The stress diagrams obtained for different load cases for S11 which is the vertical stress values in the X direction are shown in Figure 8.

**Figure 8a.** S11 stress values for EQX load cases

**Figure 8b.** S11 stress values for G+QX load cases

Figure 8c. S11 stress values for 0,9G+EQX load cases

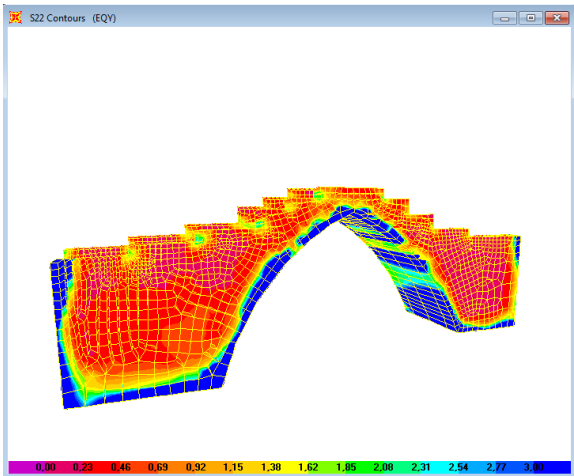
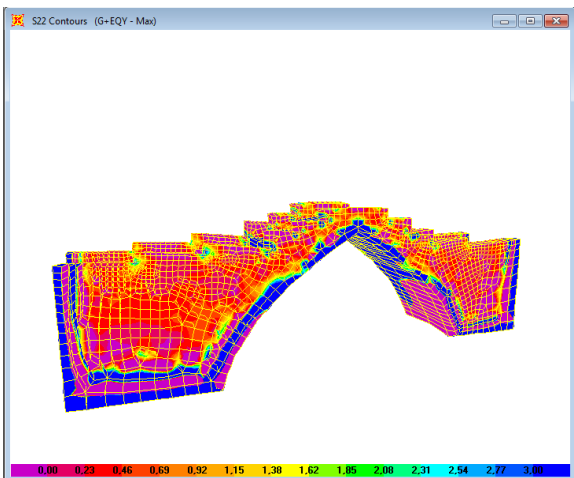
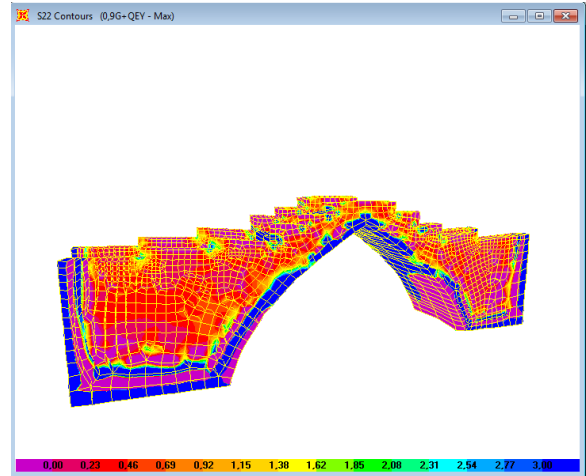
The stress diagrams obtained for different load cases for S22 which is the vertical stress values in the X direction are shown in Figure 9.

Şekil 9c. S22 stress values for 0,9G+EQY load cases

Şekil 9a. S22 stress values for EQY load cases

Şekil 9b. S22 stress values for G+EQY load cases

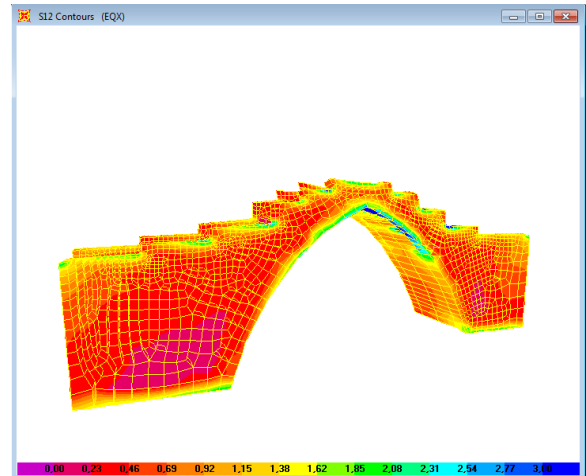
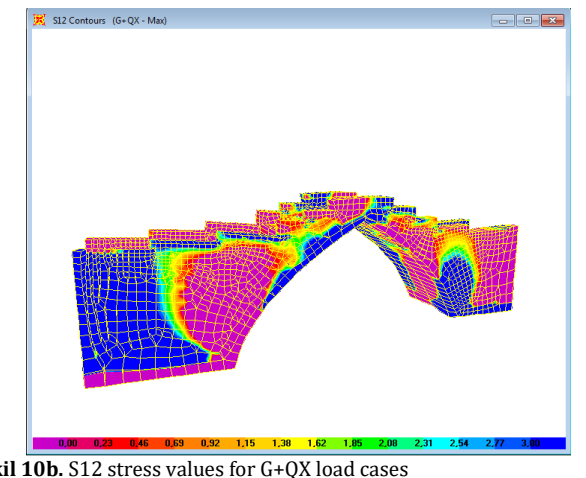
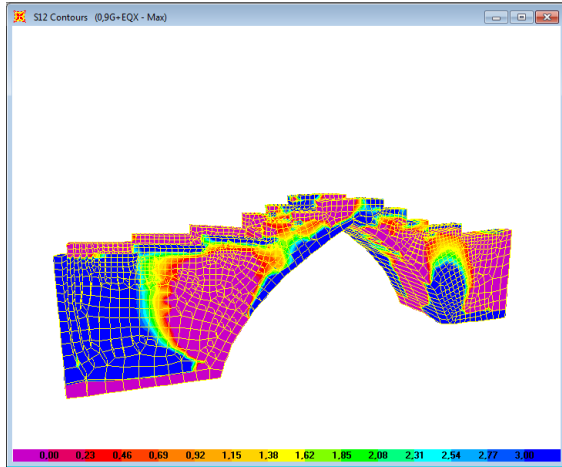
The stress diagrams obtained for different loading cases for S12 which is the shear stress values in the X-Y direction are shown in Figure 10.

Şekil 10a. S12 stress values for EQX load cases

Şekil 10b. S12 stress values for G+QX load cases

**Şekil 10c.** S12 stress values for 0,9G+EQX load cases

It can be observed that according to the different loading conditions considered in the study, the maximum tensile stress is 0.526 MPa, the maximum compressive stress is 0.492 MPa and the maximum shear stress is 0.204 MPa.

All of these stresses were obtained from G + 0.3 QEX + QE<sub>y</sub> load case. Stresses that may occur on the bridge can be carried without any problems. However, calculations can be made on the bridge in future studies in order to different earthquake effects. Damages that may occur on the bridge over time, must be observed and timely intervened and by this way, bridge should be transferred to the next generation.
