# A Proposal for Sustainable Urban Conservation and Rehabilitation of Ulucanlar District, Ankara

Özlem SAĞIROĞLU<sup>1\*</sup>, B. Işık AKSULU<sup>1</sup>

<sup>1</sup> *Department of Architecture, Gazi Univ., 06570, Ankara, Turkey*

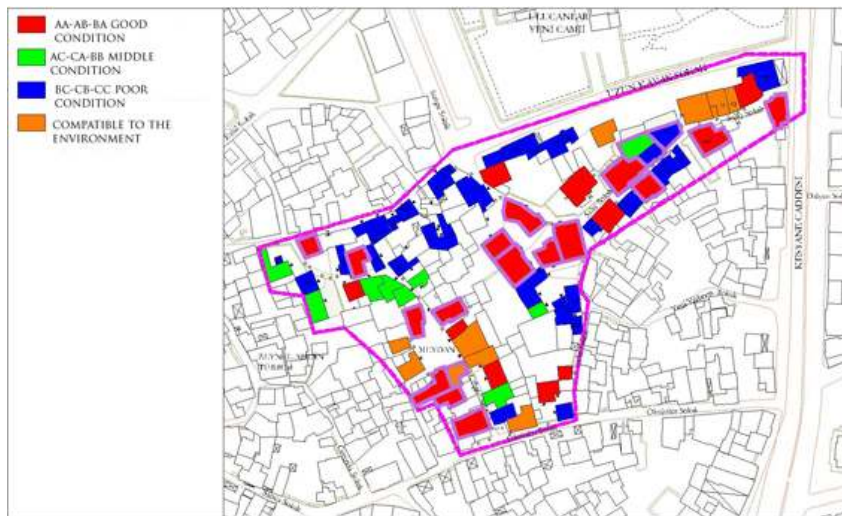
Fig.7. Architectural value - decisions

The study area also includes buildings that have retained their original architectural character. Most of the buildings that remain in good condition are registered buildings in terms of scarcity, characteristics

or quality. In addition, there are also buildings designed in harmony with the scale of the neighborhood and existing buildings, based on a reconstruction plan to protect the neighborhood and privacy.

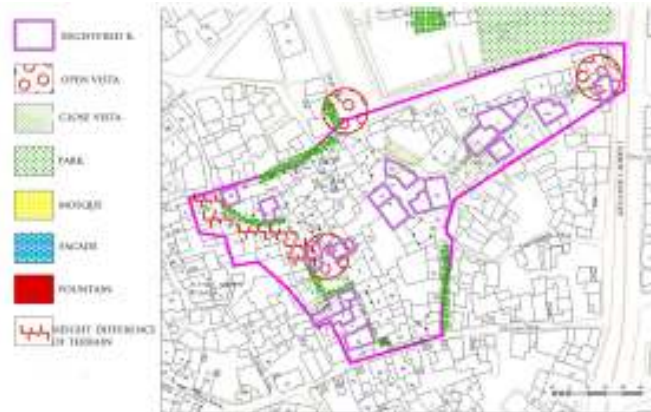
Fig.11. The environmental values of the study area

Looking at potentials and opportunities of the study area, it is seen that many streets and buildings have trained their historical features. Sympathetic renovation should be conducted for these buildings, streets and street elements; further detriment of those buildings damaged by environmental effects should be eliminated based on projects prepared by a specialized team based macro scale assessment; environmental factors such as litter, intense traffic and deficiency of children's playgrounds should be improved; open – closed spaces should be developed to ensure socialization; while doing all this, it should be ensured that interventions appropriate for the traditional texture are conducted and decisions are taken which will not result in long-term deterioration of the texture.

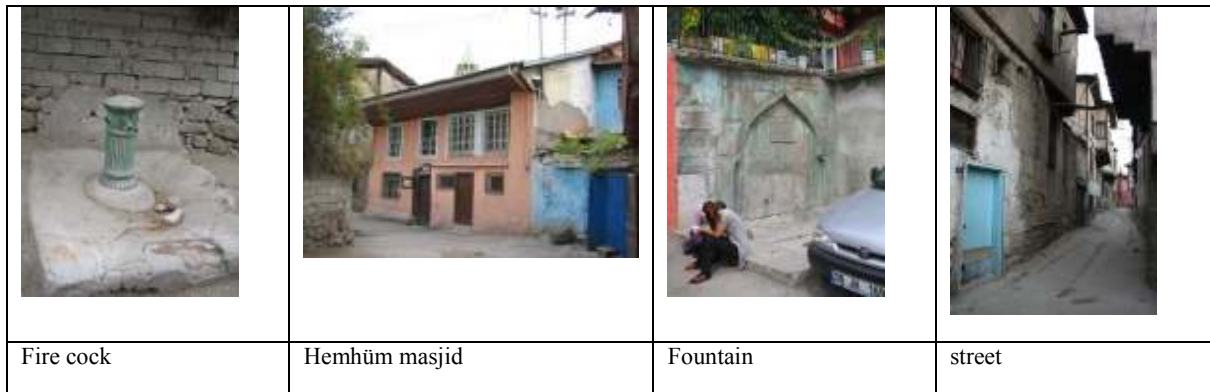
Fig. 13. The examples of the historical texture, structure and materials from the study area

are problems resulting from atmospheric effects, traffic, vandalism and social problems originating from the residents and users. These are increasingly difficult to remedy and individual problems should be identified for each building, projects should be prepared and necessary precautions should be taken.

There is the urgency of preparing restoration suggestions which provide minimum comfortable conditions for houses which are the parts composing the whole within historic texture. It is possible to adopt policies to encourage the building owners back to live in the area and to thereby ensure the sustainability of restoration works conducted in the area. These
