Academic Platform Journal of Natural Hazards and Disaster Management (APJHAD)

Volume 5 Issue 1, June 2024

Title	Authors	Pages	
An Innovative Retrofitting Technique of an Industrial Prefabricated Building Without Evacuation	Suat Yıldırım, Yüksel Ilkay Tonguc	1	29
Cloudbursts Strike over Foothills Himalaya of Uttarakhand, India: A Case Study from Maldeota, Dehradun District	Sushil Khanduri	30	45

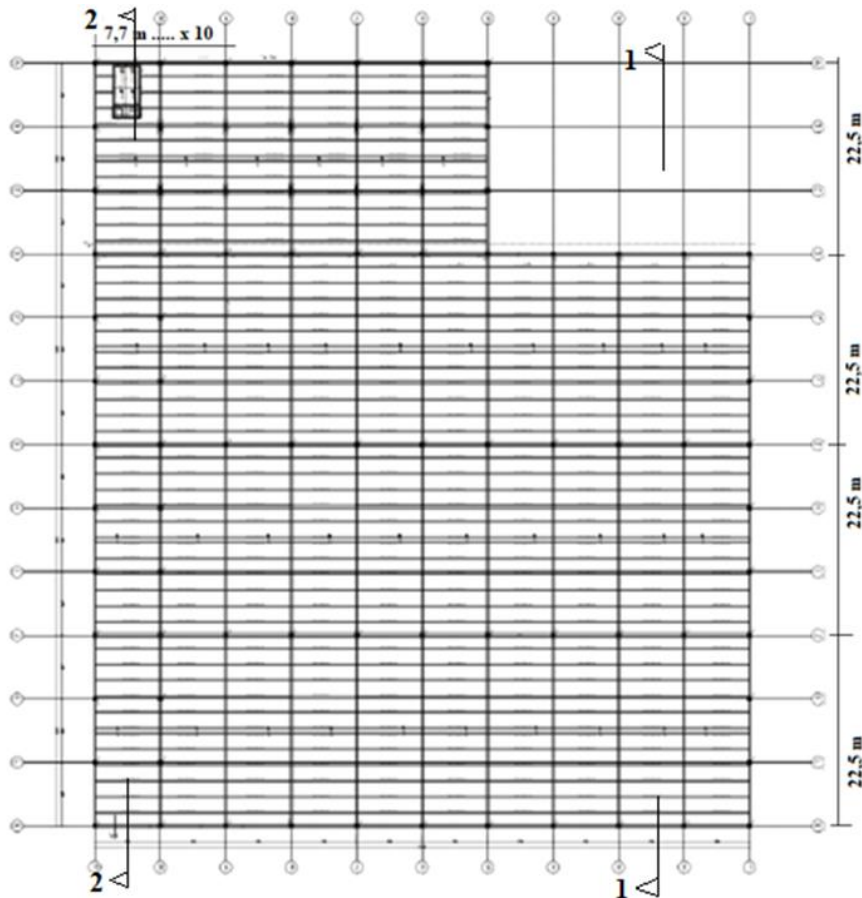
Figure 1. Plan view of the building

The analysis has identified potential stability issues within the building structure. While one direction of the building features a pin-connected frame system (Figure 2), the other direction lacks a complete framing system (Figure 1). This deficiency relies solely on girders to connect the individual frames, rendering it susceptible to instability under earthquake loads in this direction.

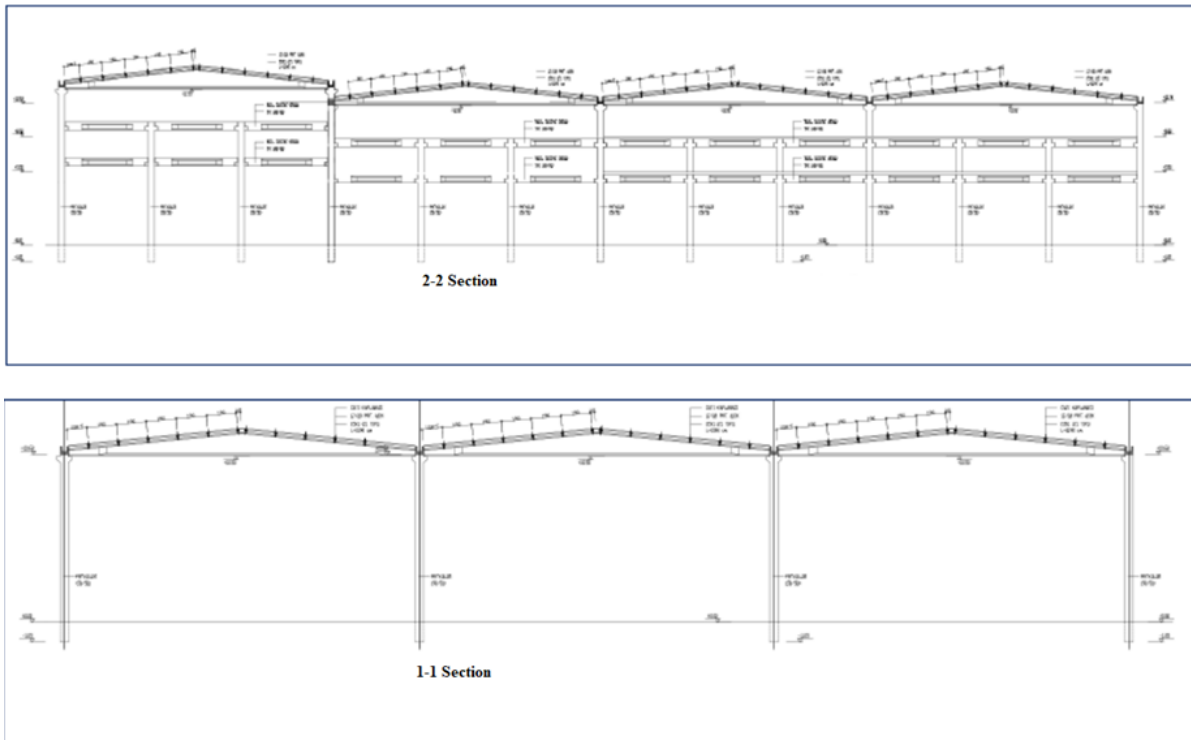
Figure 2. Section views of the building

The assessment analysis revealed that while building columns meet the rotation and shear criteria for the desired Limited Damage Level (SH) under the DD-2 earthquake level, beams do not. Additionally, the building exhibits excessive story drift exceeding the limits for the SH level. This significant displacement, particularly concerning for a building height of 12,0 meters (Figure 2), poses a potential risk of damage to non-structural walls and elements.

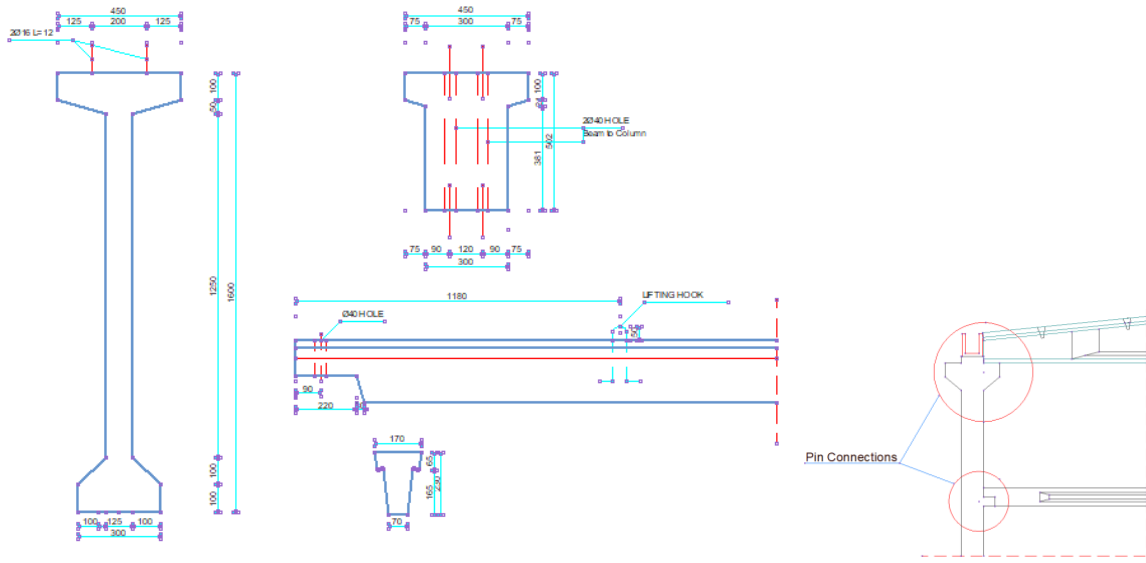
Figure 23. Pin connection of girder to beam and beam to column

Additionally, pin connections of girder-beam and beam-column (Figure 23) are checked for DD-1 earthquake level for overturning and pin failure. They are both determined as safe for retrofitted buildings.

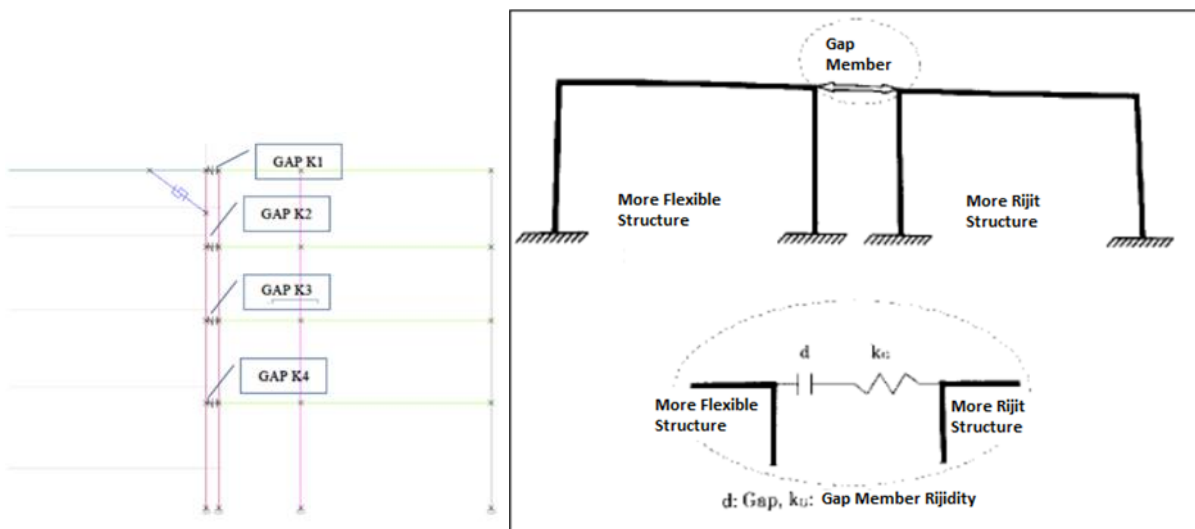
Figure 27. Gap member modeling in Etabs.

X-direction displacement of Block B1 decreased to 129 mm after retrofitting with dampers, but it still exceeds the existing space of 50 mm between the two blocks. This discrepancy suggests a potential for pounding to occur during seismic events. To further investigate this concern, a time history analysis was performed. For this purpose, inelastic spring HERTZ modeling is preferred and gap members are modeled between two adjacent blocks as seen in Figure 27.

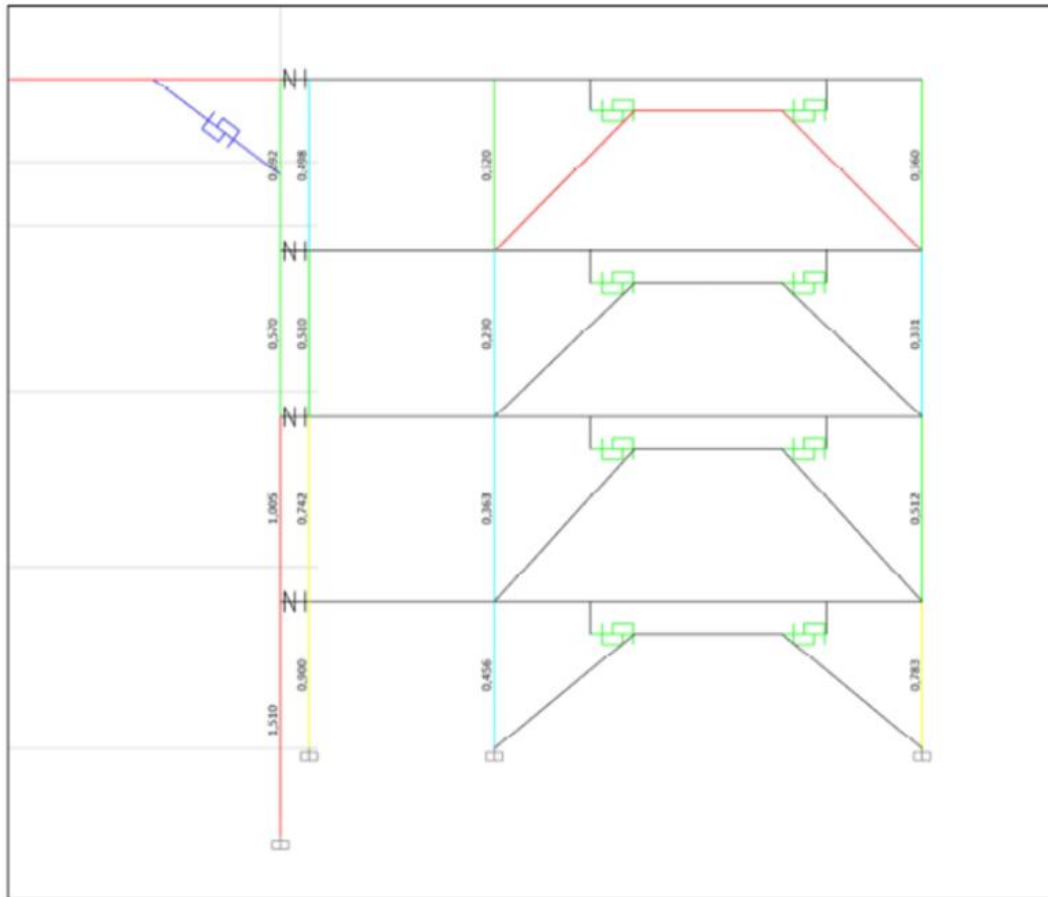
Figure 29. Demand capacity ratios of two blocks under pounding forces

Demand-capacity ratios for the columns under pounding forces were checked and found to be acceptable, with a maximum value of 1.5 (Figure 29). This indicates that the columns have sufficient capacity to withstand the pounding forces without exceeding their yield strength. This represents a significant improvement compared to the pre-retrofitting state, where the demand-capacity ratios due to pounding forces were significantly higher, reaching 4-5. This confirms that the increased damping provided by the friction dampers effectively addressed the pounding issue, ensuring the safety and stability of both blocks during seismic events.
