EVALUATION OF THE CURRENT CONSERVATION STATE OF THE GÖKTAŞLI MOSQUE, MANİSA

MANİSA, GÖKTAŞLI CAMİ'NİN GÜNCEL KORUMA DURUMUNUN DEĞERLENDİRİLMESİ

Suna BÜYÜKKILIÇ KOŞUN * - Mine HAMAMCIOĞLU TURAN **

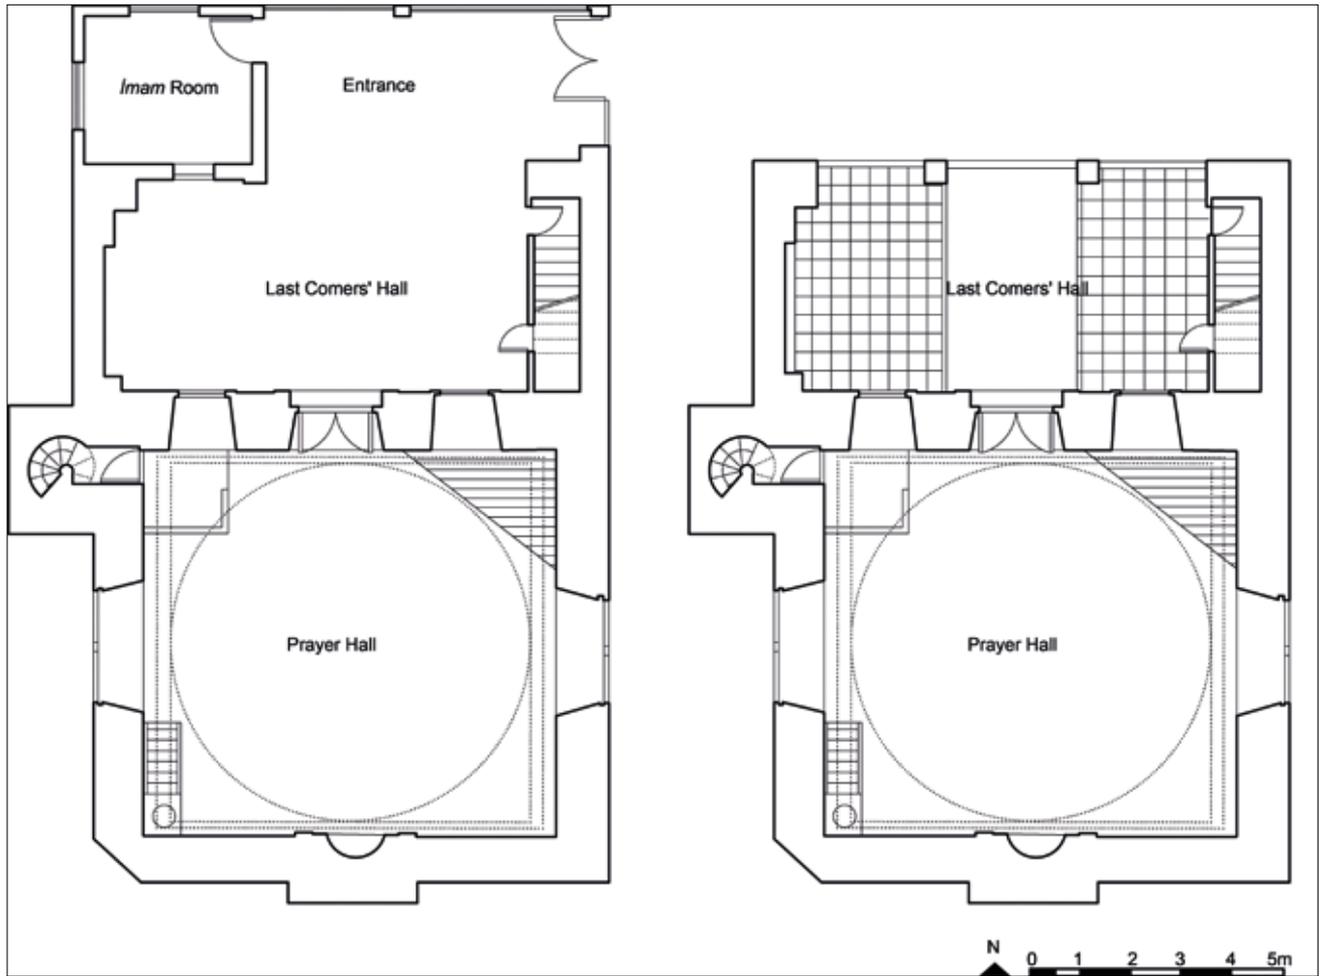
Figure 5 - Plan drawings of Göktaşlı Mosque showing the states in 2008 (left) and after 2013 restoration (right) (Revised from RDPF). / Göktaşlı Cami'nin 2008 yılındaki (sol) ve 2013 restorasyonu sonrasındaki (sağ) durumunu gösteren plan çizimleri (Vakıflar Bölge Müdürlüğü'nden yeniden düzenleme).

If these interventions are mentioned in detail (Figure 5 and 6), removal of entrance and imam room adjacent to the northern façade of the building, and removal of *Şadırvan* at the northeastern part of the courtyard (2/3) were proposed in the restoration project and both of them were realised as proposed. The removal of balustrades on the courtyard wall (1/3) is an intervention unproposed at the restoration project, but realised. Cleaning interventions such as cleaning of plaster covering addition on the exterior surfaces of the walls of the Prayer Hall, cleaning of ceramic tile addition at the *Mihrab* Niche and at the bottom parts of the exterior surfaces of the walls of the Prayer Hall, cleaning of paint addition at the pilasters on both sides of the main entrance door, at the casings, and at the *Minber*, and cleaning of timber covering addition at the bottom parts of the interior surfaces of the walls

of the Prayer Hall were realized as proposed in the restoration project (3/3). Brick lime mortar at the joints at the walls, window placed at the northern wall of *Mahfil* for Women, wall of *Mahfil* for Women, gypsum cornice at the Prayer Hall, and gypsum cornice/lath at the Prayer Hall were reintegrated. In spite of these are reintegration interventions realized as proposed in the restoration project (5/7), excessive mortar usage; unqualified workmanship, and inappropriate color stemming from rose-pink mortar usage are observed at the walls. Damaged saw tooth eaves made out of brick are covered with plaster addition and sill coverings are reintegrated with cement mortar instead of mosaics proposed at the restoration project (Photo, 12). Thus, these reintegration interventions (2/7) are placed in the group proposed but realized with different detail. Besides them, deteriorated bricks at the walls, under and over roof tiles at the roofs, iron railing at the windows at the northern wall of Prayer Hall, paint at the main entrance door of Prayer Hall and minaret door, iron door at the courtyard entrances, floor covering at the Prayer Hall, repair plaster and paint: covering with brick lime plaster and paint (Last Comers' Hall), repair plaster and paint: covering with brick lime plaster and paint (Prayer Hall) were renewed and all applied as proposed (8/11). Brick lime plaster seen at the *Pabuç*, transition elements from *Pabuç* to body, cornice of *Şerefe*, *Şerefe* and *Petek* of minaret interventions were renewed as plastered and white painted. This is a proposed intervention at the restoration project but it is applied with different detail; some sharp corners and pointed arches are plastered as rounded corners and semicircular arches (1/11). Other renewals are unproposed but realized interventions (2/11): renewal of timber balustrades at the *Mahfil* for *Müezzin* and renewal of timber post and lintel at the opening for the balcony of *Mahfil* for Women. Cement mortar addition at the walls was altered with brick lime mortar, metal sheet covering at the *Kulah* of minaret was altered with lead covering, concrete capping at the courtyard walls was altered with travertine capping, masjid space at the courtyard was converted into fountain, imitation brick floor covering was altered with brick covering and mosaic floor covering was altered with travertine at the Last Comers' Hall, form of the roof of the Last Comers' Hall and *Mahfil* for Women mass was altered, and mosaic floor covering at the courtyard was altered with travertine. These are alterations proposed at the restoration project and applied as proposed (7/11). Alteration of iron joinery at the eastern and western façades with wooden joinery with same proportions and sizes, and alteration of wall bordering the graveyard with a threshold were proposed but proportions were changed at the alteration of iron joinery with wooden joinery intervention application and in spite of the threshold was applied to the bordering of the graveyard, iron balustrades were put on it after the restoration by collecting money from the community and charitable people. It is seen that
