THE RISKS OF NONSTRUCTURAL BUILDING COMPONENTS IN THE CONTEXT OF EARTHQUAKE AND PEDESTRIANISED STREETS IN HISTORIC CITY CENTERS: ISTANBUL BEYOGLU CEZAYIR STREET CASE

İlke CİRİTÇİ

Gül YÜCEL

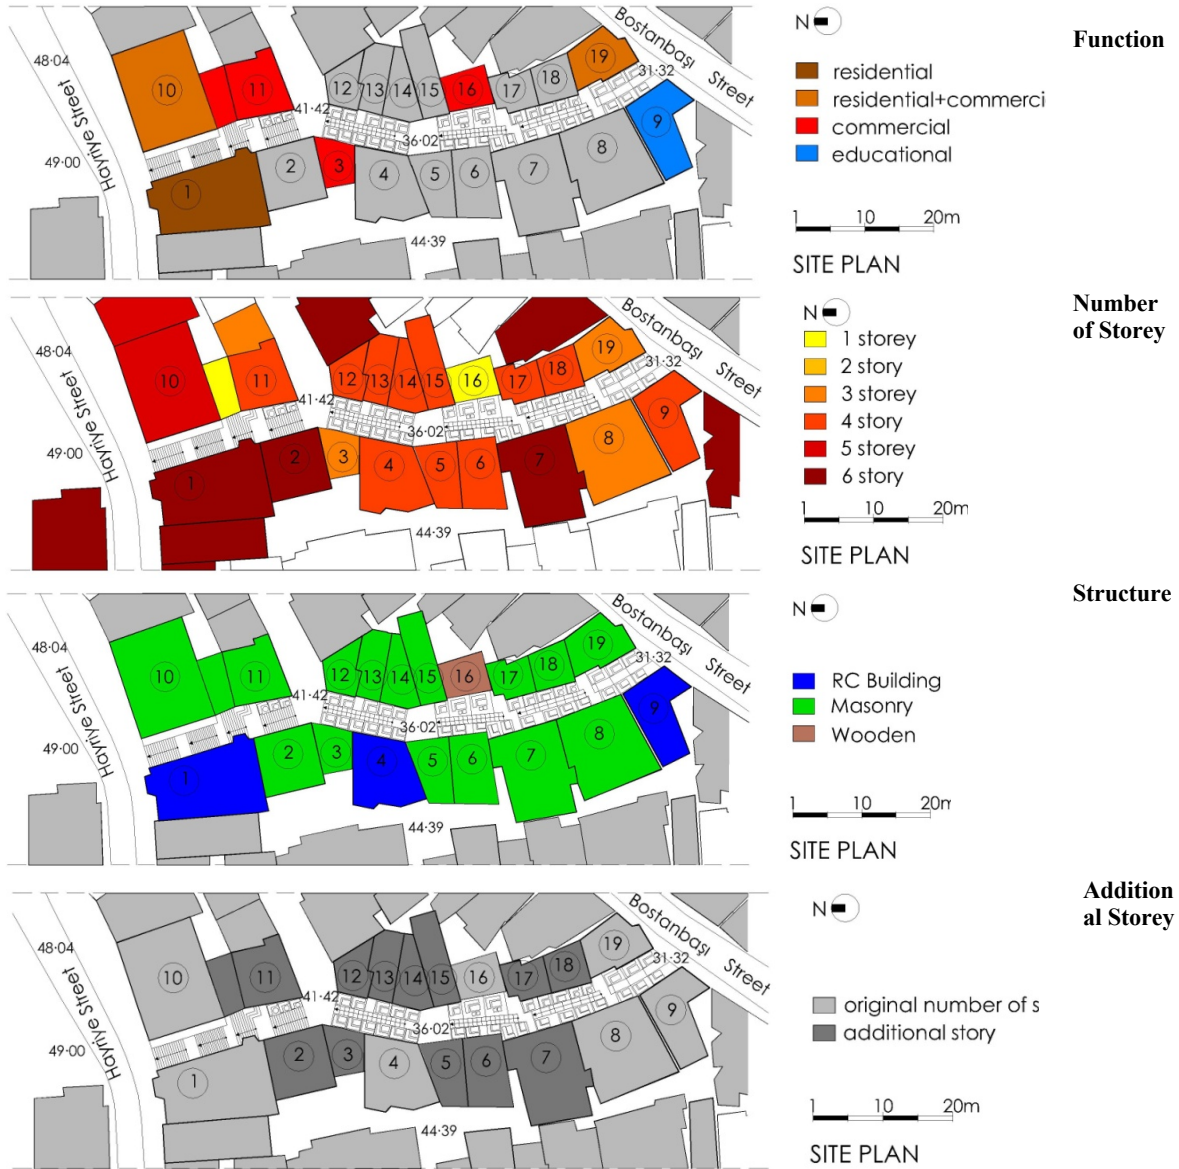
Fig. 5 – Cezayir Street building specifications (prepared by Gül Yücel)

Cezayir Street is a step street and some part of which is steep in a changing order. The form of the street with steps can also be seen on historical maps (Fig. 4). The buildings are mostly historical buildings with masonry structure. Few examples are reinforced concrete structure and are easily differs from façade layout. The ground floors of the buildings on both sides along the street are for long-term use as restaurants (Fig. 5). Ground floor of the buildings on the street is protected by canopy, sunshades within different techniques and materials, mounted on the façade (Fig 7).

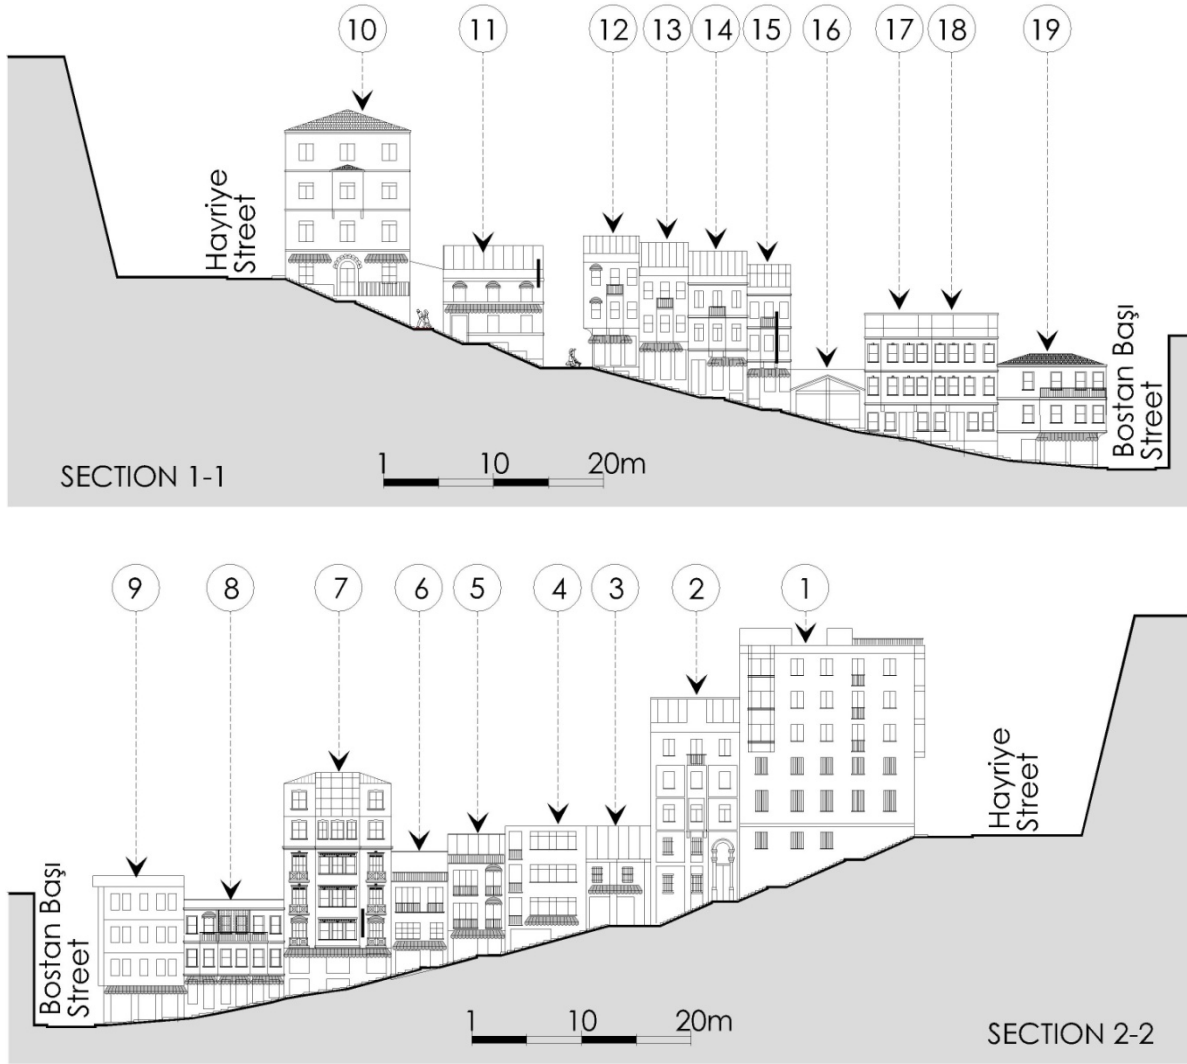
Fig. 6 – Cezayir Street siluets with each sides (prepared by Gül Yücel)

Terrace areas with covered glazing have been added to some of the buildings where ground floors mostly serve as cafes and restaurants, and there have been changes in the original plan types (Fig. 6, Fig. 7). With all these structural and physical changes; Cezayir Street has become one of the most visited entertainment venues in Beyoğlu district. According to Başat's (2007) study on culture, consumption and entertainment venues on Istiklal Street, Cezayir Street is one of the three regions where space uses are concentrated in this sense (Başat, 2007).
